Single Family Residence

Draft Report of Cause of Stair Failure

2013

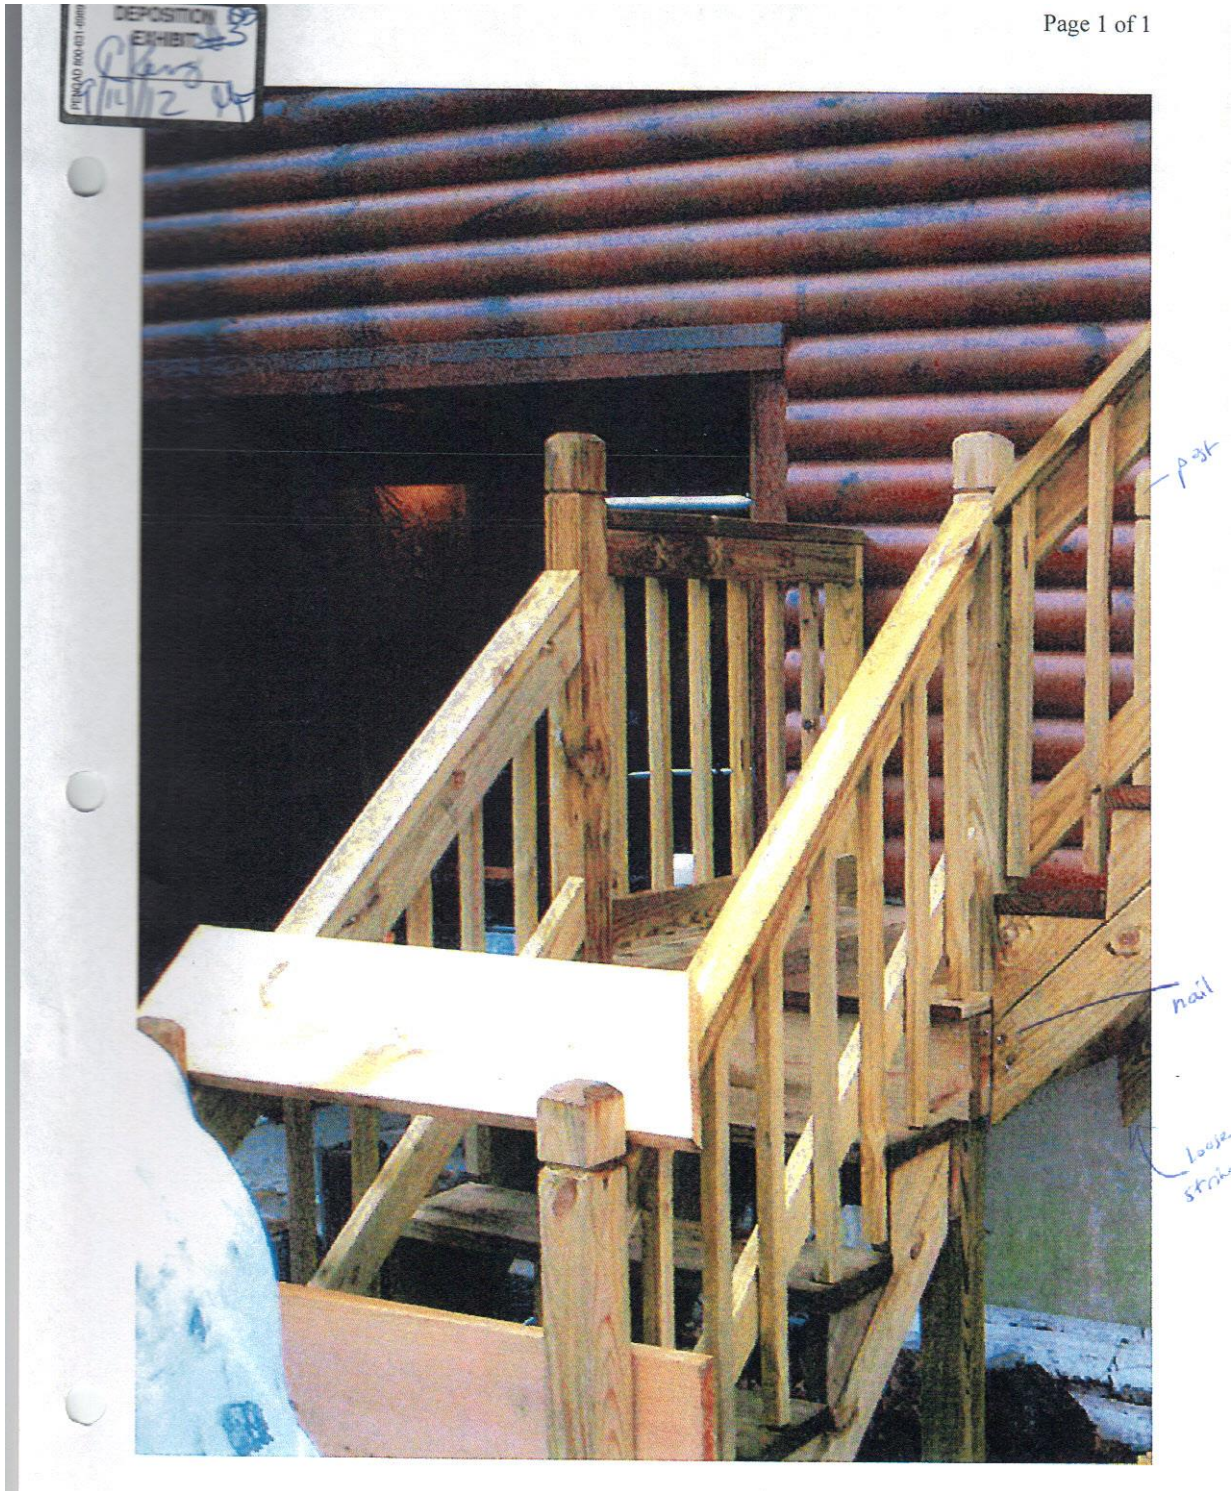
Exhibit 1 at Deposition:

Photo 100_0988 was cropped when shown as Exhibit #1 at 9/14/12 deposition of carpenter. Detached inboard stringer (adjacent to house) was cropped out of the exhibit photo. Detached center stringer is barely visible in exhibit photo.

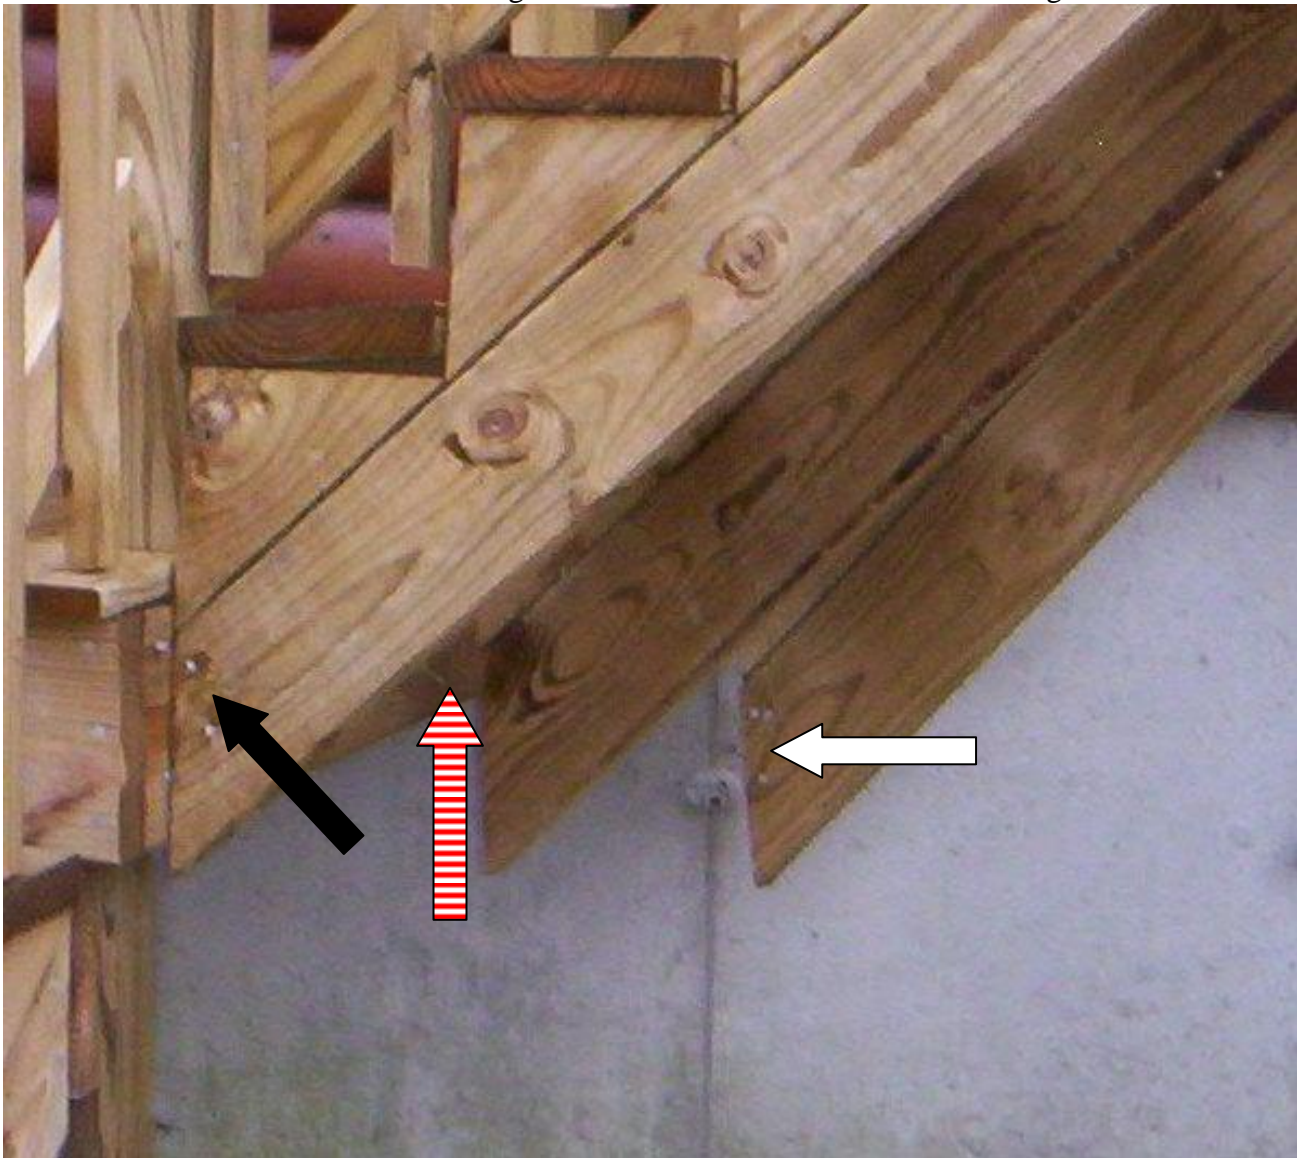
Close-up of stringer attachment area within Photo 100_0988:

Inadequate connection of the stair stringers to the landing header was the proximate cause of the stair failure. The loading experienced by the stair would not have caused a competent stair to fail. The carpenter did not build stairs that were capable of withstanding the loads required by the building code.

Stairs failed when two of the three stringers detached from header at lower landing as shown:

The inboard stringer (adjacent to the house, but not attached to the house) was toe-nailed to the landing header with three nails on the visible outside. These three nails can be seen in photo above at white horizontal arrow. There were no toe nails on the house side of the inboard stringer. On the back side of the landing header, there is evidence of three nails originally installed through the header into the end of the stringer. These nails are no longer present. Empty holes once containing nails are visible and shown in photos below.

The center stringer also detached from the landing header. There is no evidence of toe-nails in this photo. There is a nail from the backside of the landing header into the end grain of the stringer (red/dashed vertical arrow). This nail is loaded in withdrawal. Loading nails in withdrawal creates a weak connection that cannot be relied upon. During my examination, I found evidence of three nails through the back side of the landing header into the end grain of the center stringer. No evidence of toe nails was found on the center stringer.

Outboard stringer, furthest from house did not detach. It is attached to landing header with two toe-nails (black angled arrow).

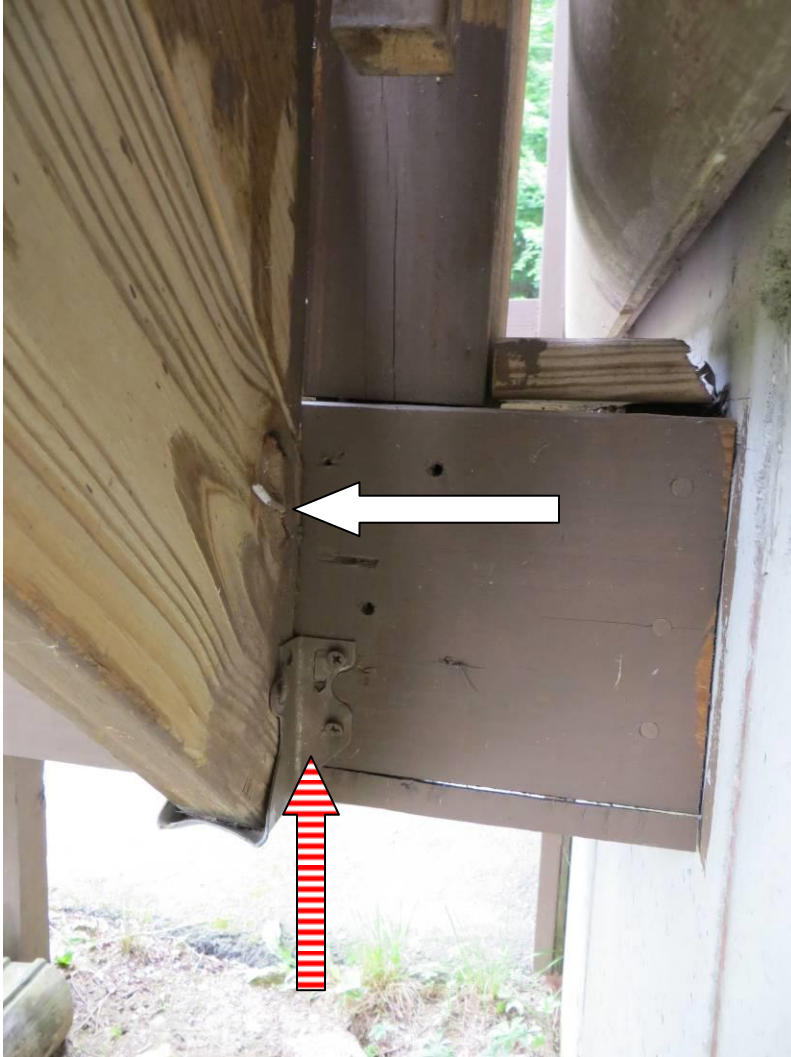
House side of inboard stringer (not painted)

No evidence of toe-nails driven through the house side of the inboard stringer into the landing header. One of the toe-nails driven from the other side of the stringer did not penetrate the landing header, but came through the stringer on the opposite side (white arrow). This nail provided no support. Newly installed metal hanger connects stringer to landing header (red/dashed vertical arrow). Hanger installed is intended for floor joist and not a stringer. Hanger is improperly installed.

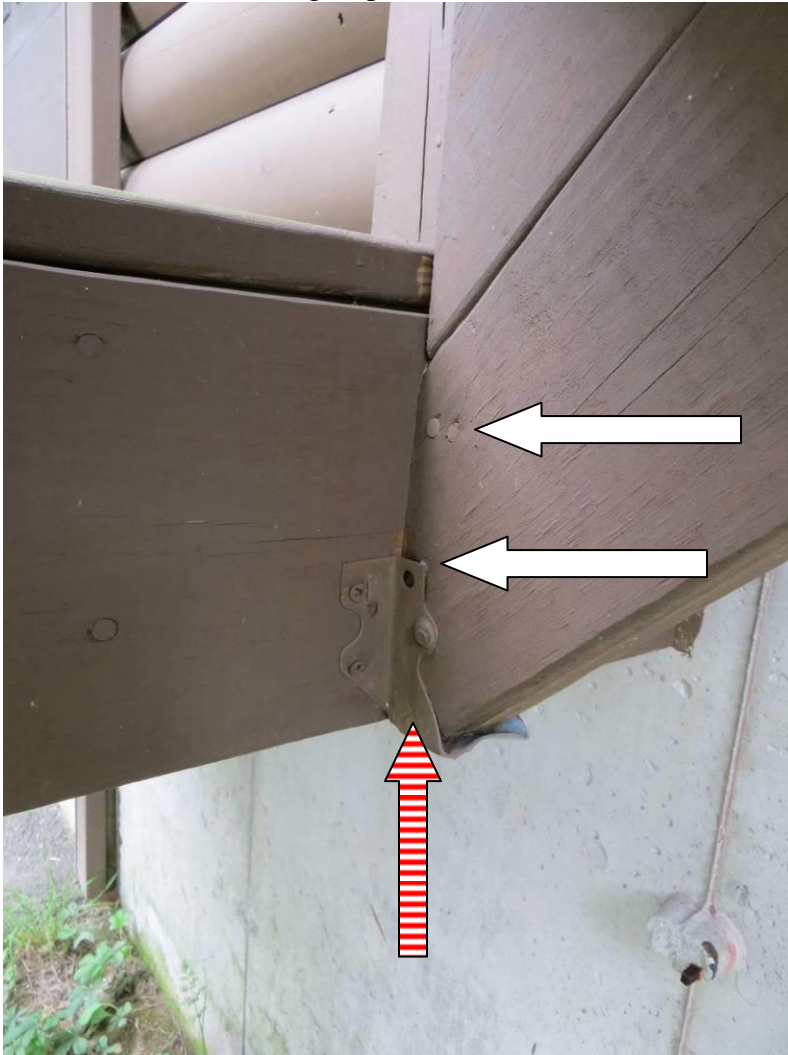
Outside of inboard stringer (painted):

Three toe-nails were driven from the outside of the stringer into the landing header (white arrows). Newly installed metal hanger connects stringer to landing header (red/dashed vertical arrow). Hanger installed is intended for floor joist and not a stringer. Hanger is improperly installed.

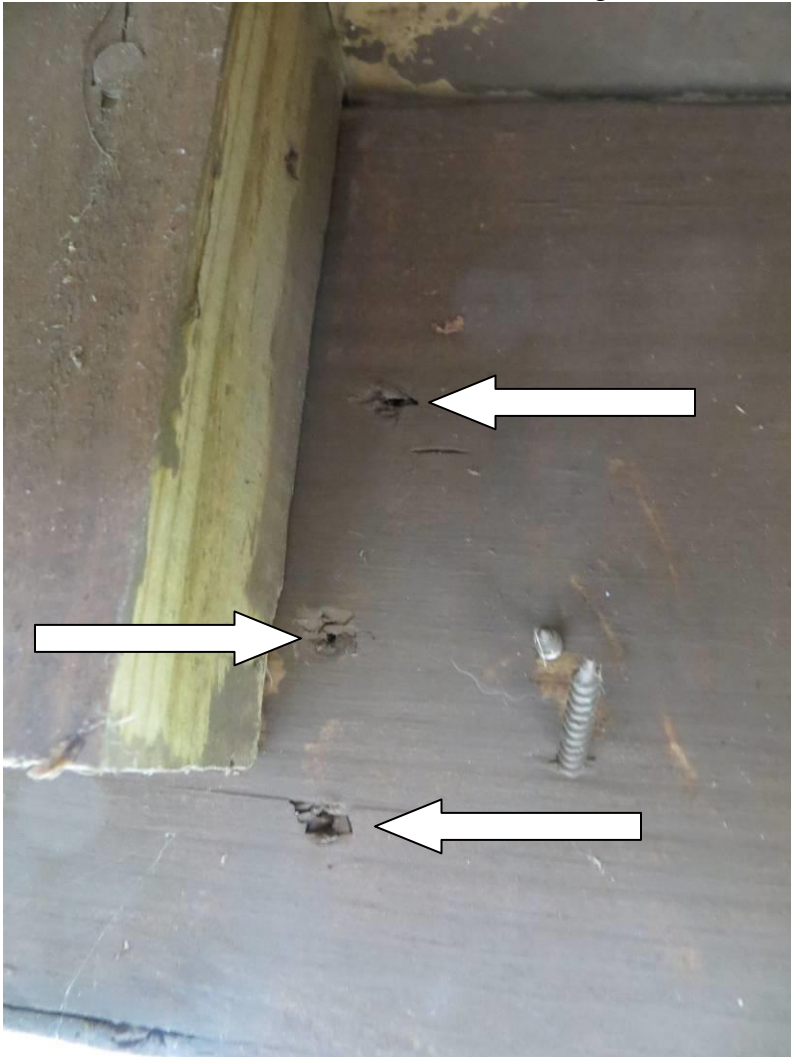
Inside of header at attachment of inboard stringer:

Evidence of three nails driven through landing header into the end grain of the inboard stringer (adjacent to the house) is shown by white arrows. Nails were not reinserted after hanger was installed. Note screws from new hanger protrude through single layer 2" x 8" header.

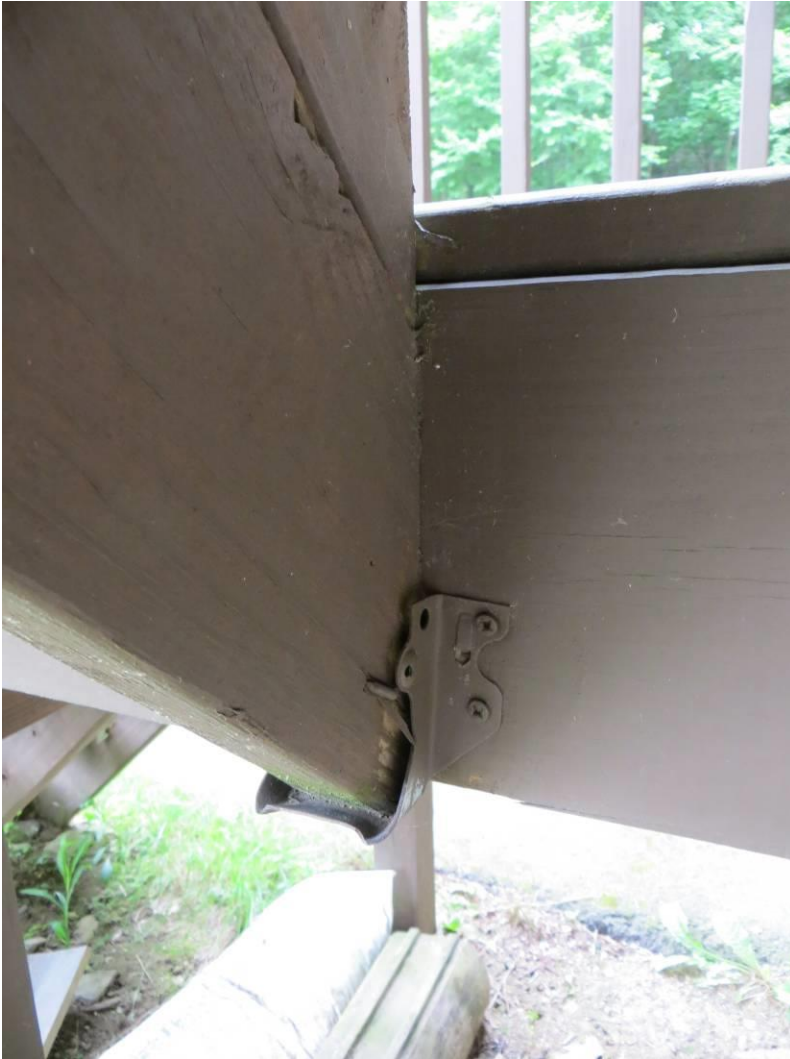
House side center stringer:

No evidence of toe-nails driven through the house side of the center stringer into the landing header. Newly installed metal hanger connects stringer to landing header. Hanger installed is intended for floor joist and not a stringer. Hanger is improperly installed.

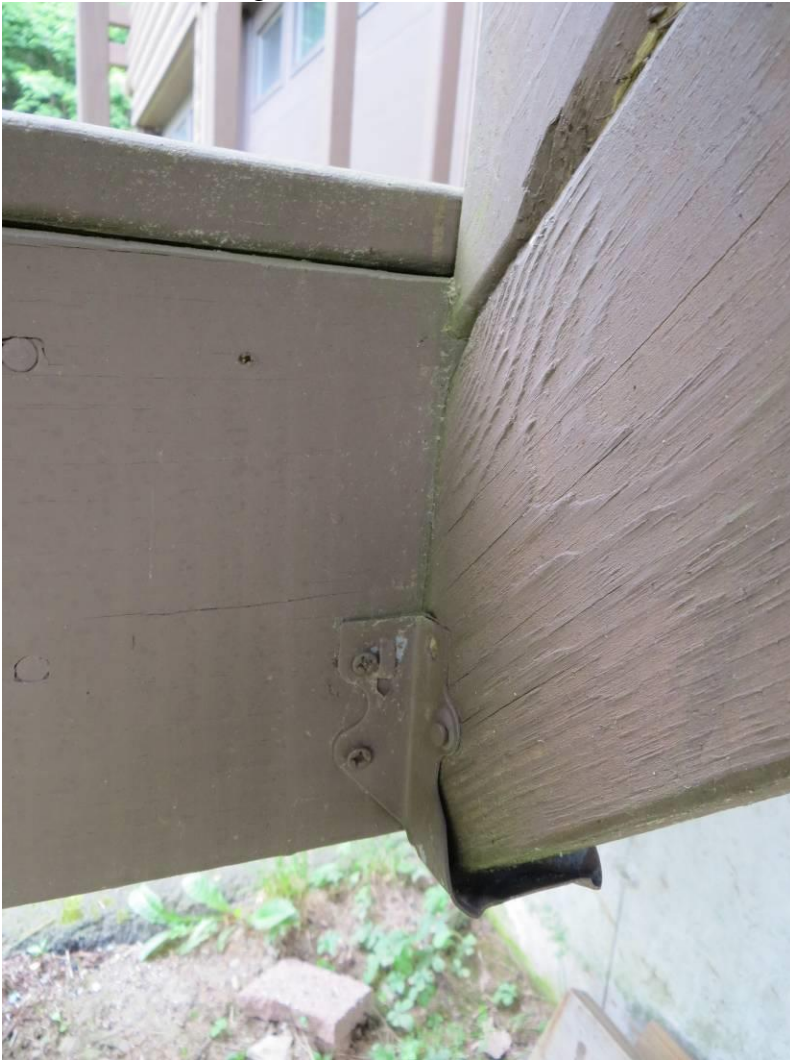
Outside center stringer:

No evidence of toe-nails driven through the outside of the center stringer into the landing header. Newly installed metal hanger connects center stringer to landing header. Hanger installed is intended for floor joist and not a stringer. Hanger is improperly installed.

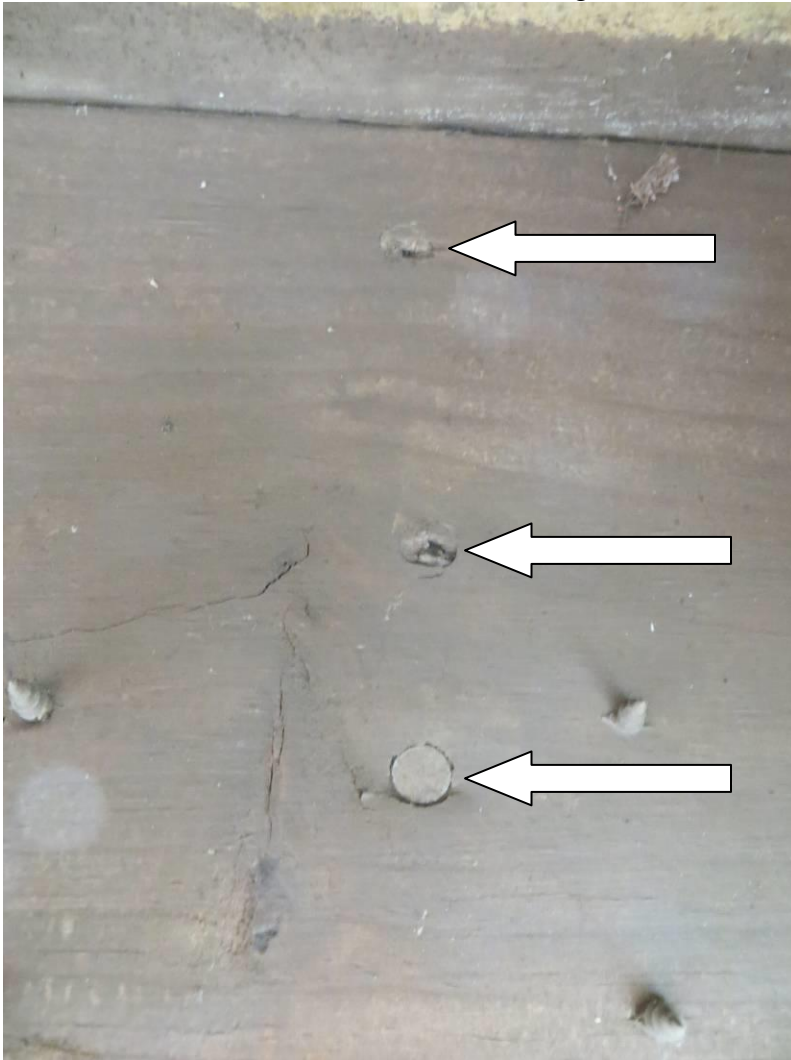
Inside of header at attachment of center stringer:

Evidence of three nails driven through landing header into the end grain of the stringer adjacent to the house is shown by white arrows. Top two nails were not reinserted after hanger was installed. Note screws from new hanger protrude through single layer 2" x 8" header.

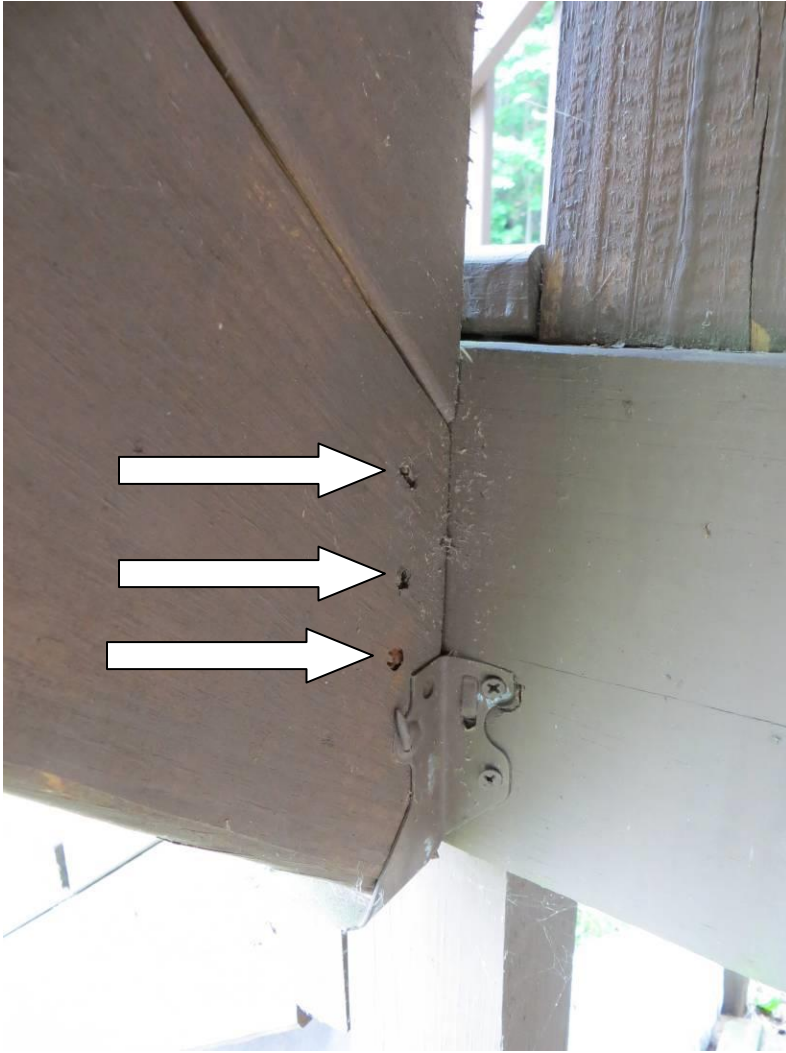
House side outboard stringer:

Evidence of three toe-nails driven through the house side of the outboard stringer into the landing header is shown by white arrows. Newly installed metal hanger connects stringer to landing header. Hanger installed is intended for floor joist and not a stringer. Hanger is improperly installed.

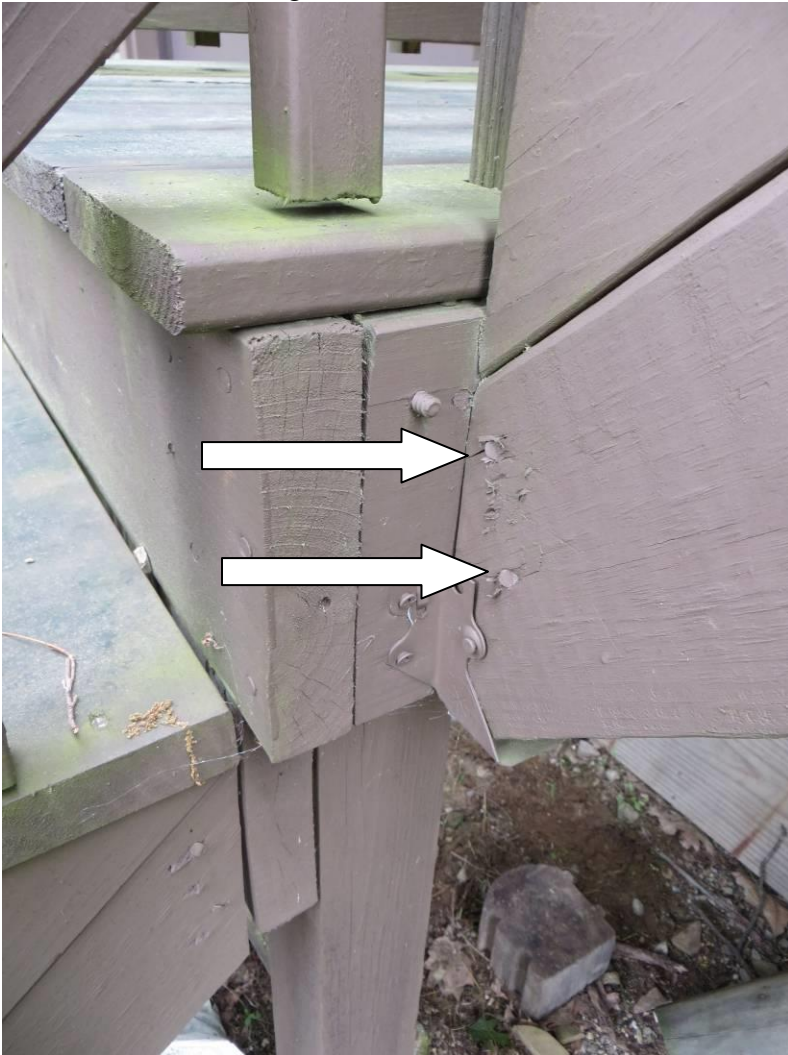
Outside outboard stringer:

Evidence of two toe-nails driven through the outside of the outboard stringer into the landing header is shown by white arrows. These two toenails are also visible in the photo taken by owner just after the stair failure (see above). Newly installed metal hanger connects outboard stringer to landing header. Hanger installed is intended for floor joist and not a stringer. Hanger is improperly installed.

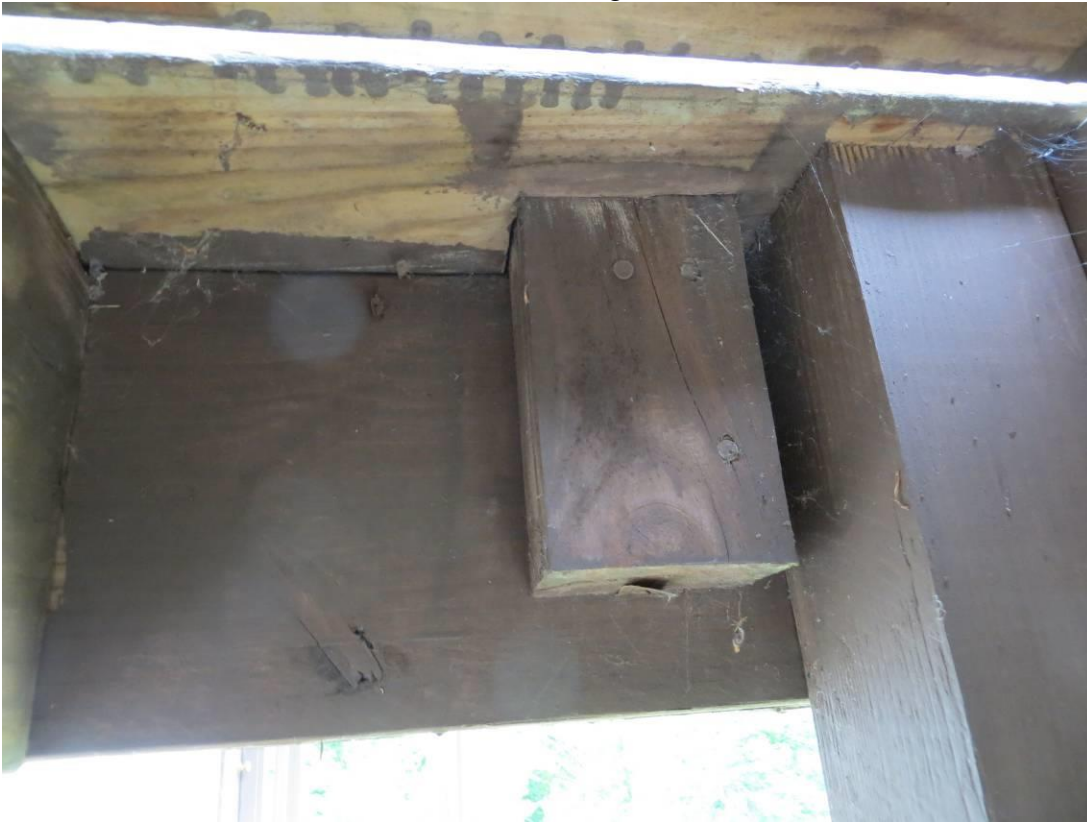
Inside of header at attachment of outboard stringer:

No evidence of nails driven through landing header into the end grain of the outboard stringer is visible due to railing posts.

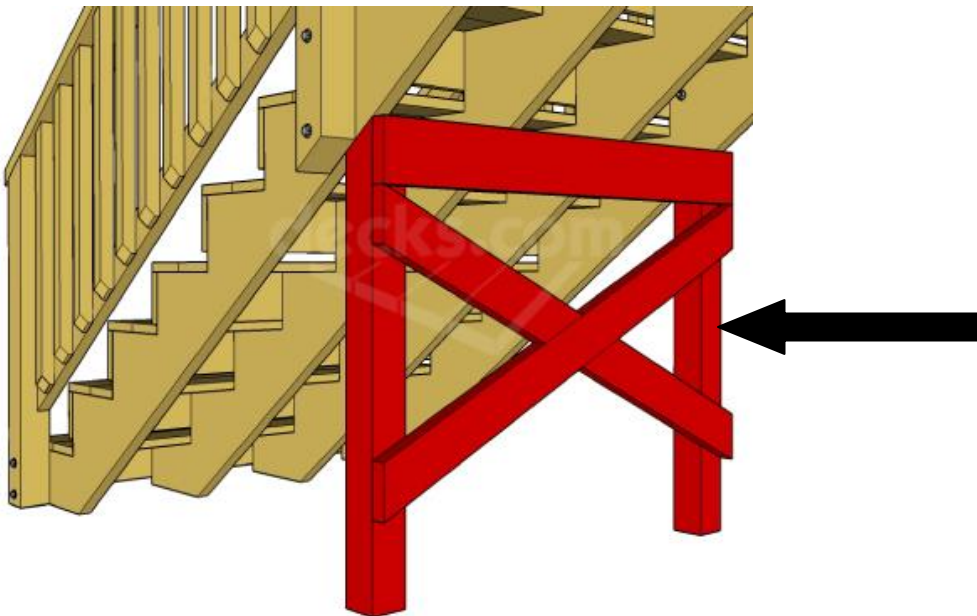
In his deposition, carpenter mentioned that he installed a header under the stair stringers for support. There is no evidence that a header was ever installed under stair stringers. The diagram below shows a typical header configuration in red as indicated by black arrow.

There are no nail holes or other indications anything was installed near the mid-span of the stair stringers. If such a header were installed, there is no interference with a door to the garage under the stair stringers.
