RESERVE ANALYSIS REPORT

Boston Condominium Trust

Boston, Massachusetts Version 1 June 19, 2018

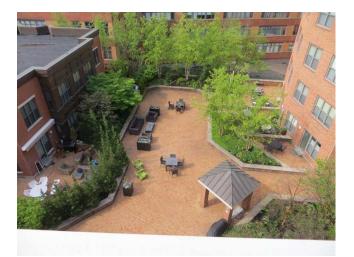
Component covers underground parking garage roof.

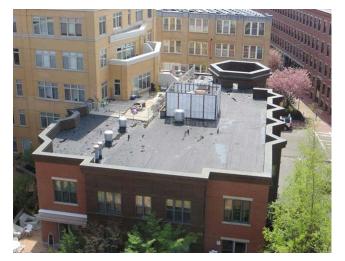
Component covers EPDM roof membranes on all buildings that are about 2/3 through their useful life.

Emerson roof was in generally good condition on lower roofs. Upper roof had numerous patches near cooling tower due to damage from high heel shoes. No major issues noted. There were limited areas where air pressure from building has detached the fully adhered membrane. No current issues with roof per management.

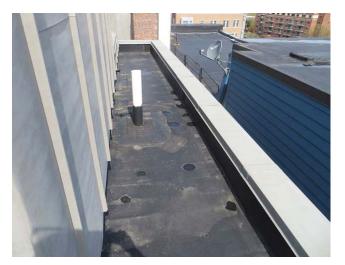
Component covers EPDM roof membranes on all buildings that are about 2/3 through their useful life.

Vose roof was in generally good condition. No major issues noted. No current issues with roof per management.

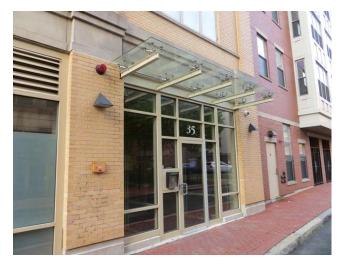
Component covers glass canopies at entrance to E and H lobbies. No issues reported by client. Pricing from similar associations.

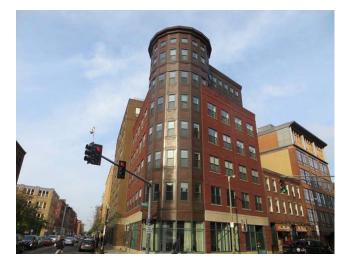
Component covers sealants between copper and adjacent materials.

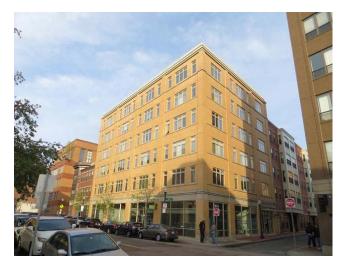
Reserve component is unfunded. If large specific repairs are perfomed in the future components can be added similar to the sealants for copper and steel areas.

Condition of exterior building cladding appeared good during site visits. No specific current issues were noted. Currently the association is spending about \$15,000 annually from operating budget on cladding maintenance. Currently it is assumed that this budget will cover minor brick repointing that may be encountered. A separate brick component can be added as the building ages.

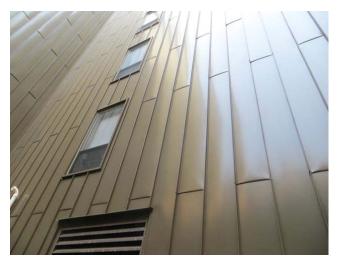
Component covers painting of steel siding and trim areas of all buildings with brush and roll method.

Condition of exterior building cladding appeared good during site visits. No specific current issues were noted. Currently the association is spending about \$15,000 annually from operating budget on cladding maintenance.

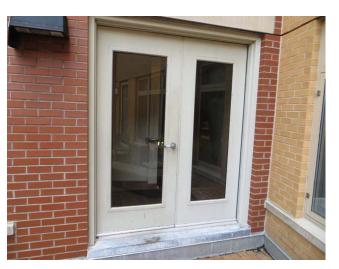
Component represents high use exterior common doors to courtyard over parking garage. Doors were in good condition during site visits and no problems were reported by client. Doors will need periodic painting and replacement of wear items (hinges, handles, etc.) to achieve useful life.

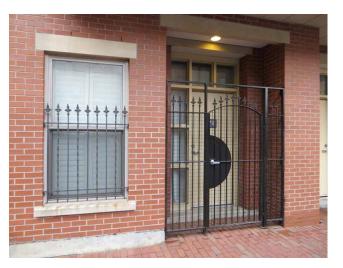
Component covers steel pedestrian gates at three townhouse entry doors and stairwell exit on ______ Street. Gates at townhouses were added in improve security in 2016 for \$6000 per client. Gates were in good condition during site visits. Townhouse gate and fixed section measure approximately 76" x 84" tall. Stair exit gate measures 42"x84" tall. Regular painting/maintenance will insure gates achieve their useful life. Placed-in-service date set at 2016 for all gates. Stair gate will get low usage.

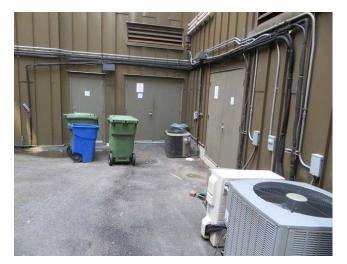
Component covers exterior common steel doors in all three buildings. Allowance covers repairs to hinges and handles on three year interval. With proper maintenance, doors should last indefinitely. Consistent painting is critical to prevent corrosion. Many of these doors receive low use.

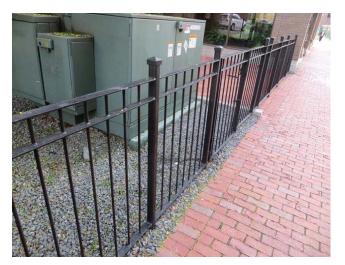
Component covers painted 42" tall black picket fence at H courtyard sides. Fence integrates with existing fence surrounding adjacent parking lot not owned by the association.

Railings are original to building and were in generally good condition during site visits. Some evidence of corrosion was evident and should be addressed. Regular maintenance will insure railings achieve their useful life. Chain link fences between roof terraces are listed separately.

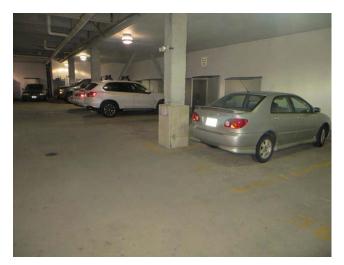
Per client, garage slabs have been sealed with penetrating sealer. Application is on annual basis from operating budget.

Currently unfunded component covers re-conditioning and sealing of concrete garage floor surfaces. Component does not include complete replacement of concrete. Occasional repairs should be addressed by operating budget on asneeded basis. Floors were in good condition at site visit.

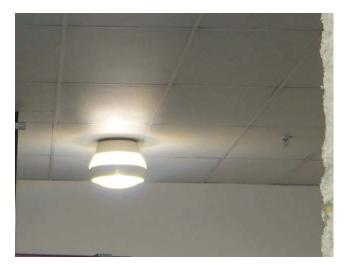
Component covers garage lighting. Lighting was in good condition at site visit. Conversion to LED bulbs for reduced energy use and less frequent bulb replacement is recommended.

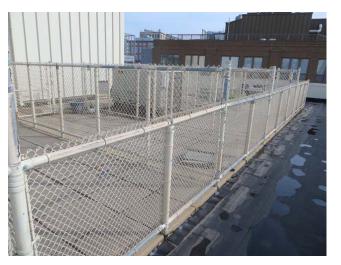
Component covers beige painted galvanized fencing at roof terraces.

Fencing is original to building and was in generally functional condition during site visits. Extensive areas of peeling paint were evident on top fence rails and top of chain link mesh. This is currently an aesthetic issue. Steel railings at roof terraces are listed separately.

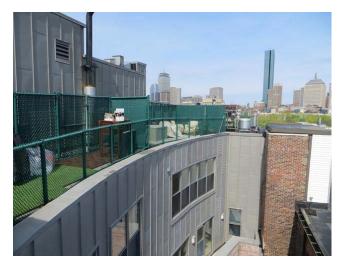
Component covers green painted galvanized fencing at V roof terraces. 60 in. tall fences have green vinyl privacy slats.

Fencing is original to building and was in generally functional condition during site visits. Some areas of peeling paint were evident on top fence rails and top of chain link mesh. This is currently an aesthetic issue. Steel railings at roof terraces are listed separately.

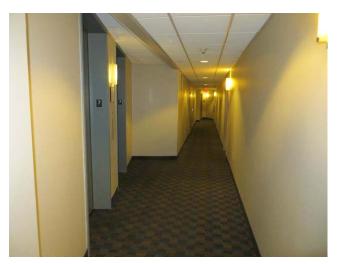
Component covers replacement of suspended ceilings in hallway areas. Minor repairs of specific damage should be covered by operating budget.

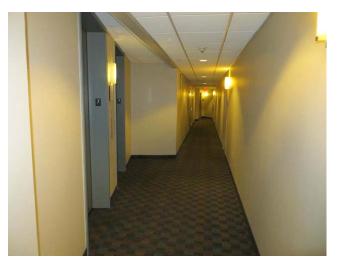
Component covers all association carpet and vinyl baseboard in unit hallways and garage lobby.

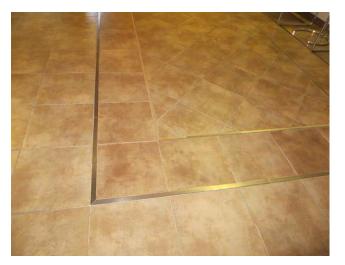
Component covers tile floors and walls in building lobbies. No loose or cracked tiles were observed. Removal of existing tile is difficult to estimate. Cost of materials chosen to replace the current tile can also vary widely.

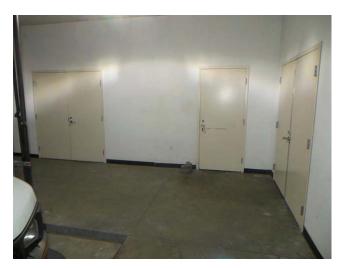
Component covers interior common steel doors in all three buildings. Allowance covers repairs to hinges and handles on three year interval. With proper maintenance, doors should last indefinitely. Many doors receive very low use.

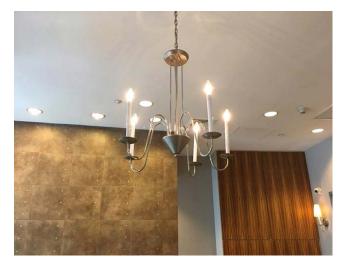
Component covers interior lobby area lighting in all three buildings. Lighting was in good condition at site visit. Conversion to LED bulbs for reduced energy use and less frequent bulb replacement is recommended.

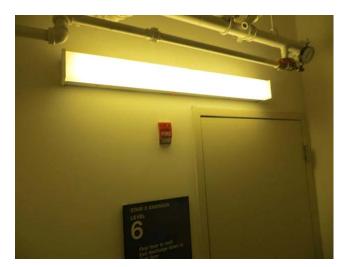
Component covers stairwell lighting in all three buildings. Lighting was in good condition at site visit. Conversion to LED bulbs for reduced energy use and less frequent bulb replacement is recommended.

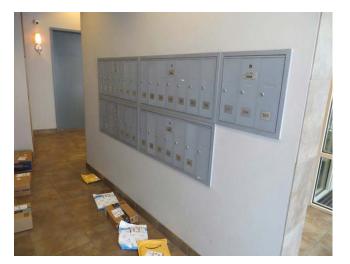
Component covers Salsbury Industries USPS-STD-4B+ recessed mailboxes in building lobbies. Mailboxes were in good condition at site visit.

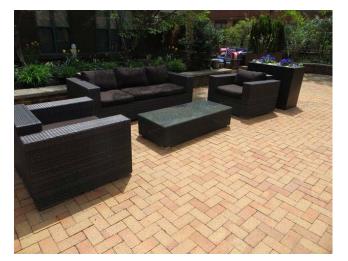
Component covers furnishings on parking garage rooftop courtyard. Furnishings were in good condition at site visit.

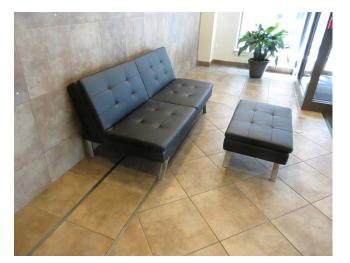
Component covers furnishings in building lobbies. Furniture was in good condition at site visit. The remaining life of this component has been extended due to its condition at our most recent site visit.

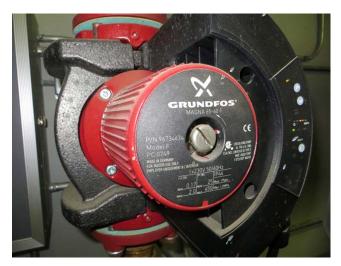
Component covers Grundfos pumps that circulate boiler water within Caravan boilers. Pumps are controlled with variable frequency drives. These pumps are secondary to the main heat pump water pumps listed as separate component.

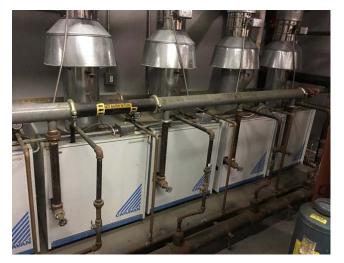
Slant/Fin Caravan GG-399 HEC modular gas-fired boilers provide hot water for heating each building. Capacity is approximately 400,000 btu per boiler per Ken Vertullo. 80% efficiency boilers are atmospherically-vented through wall.

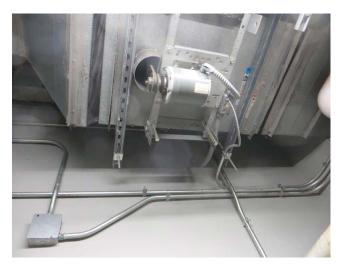
Component covers fans bringing combustion air into mechanical room for water heaters and boilers. Fans are inconsistent between buildings. Generall allowance used.

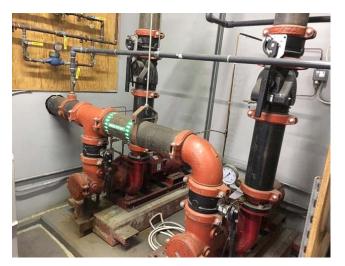
(2) 10 hp motors power pumps to circulate condenser water within the cooling tower and heat exchanger in each building. Pumps can circulate 400 gpm in E and 300 gpm in H and V. The system can operate with only one motor/pump in a building if the other motor/pump fails. Cost obtained from similar 10 hp motor and pump combination with variable frequency drive. It is difficult to predict exactly when motors of pumps will fail. Useful life extended due to operation experience.

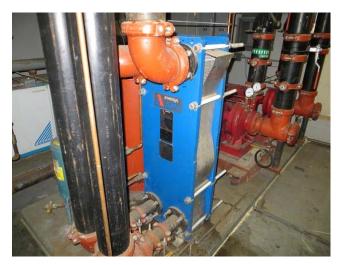
Component covers stainless steel heat exhangers for heat pump cooling water supply in summer.

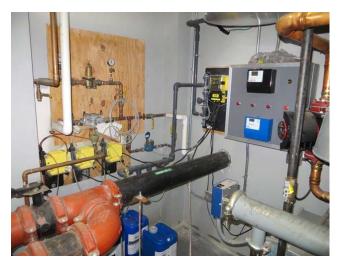
Component covers water treatment system for cooling tower in each building.

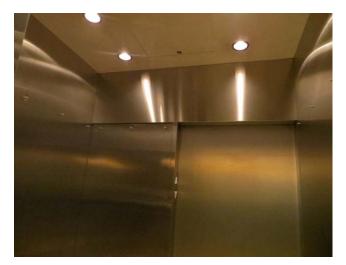
Component cover refurbishment of (6) elevator cabs. Cabs are essentially identical in the buildings. Cabs were in very good condition at site visit. The remaining life of this component has been extended due to its condition at our most recent site visit.

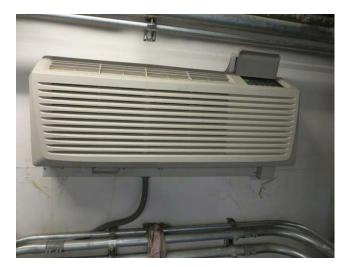
Component covers LG PTAC (packaged terminal air conditioners) supply cooling and heat to elevator machine rooms.

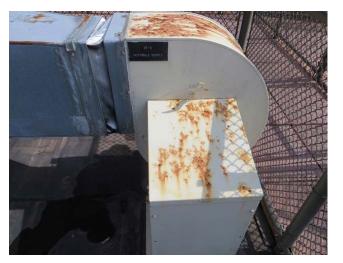
Component covers fan supplying air to stairwell vestibules in all three buildings during an emergency. Fans are tested periodically. Little specific information available. No issues reported.

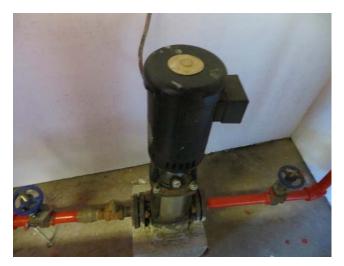
Component covers fire sprinkler jockey pumps is in sprinkler equipment rooms of the three buildings. Pump maintains wet sprinkler pipes at approximate target pressure to aid in sensing if a sprinkler head discharges. Jockey pump also eliminates need for main fire pump to run to maintain system pressure.

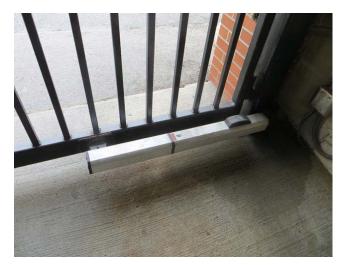
Component covers actuators for iron gate at garage ramp entrance to lower parking garage. Gate measures approximately 16' wide x 9' 6" tall

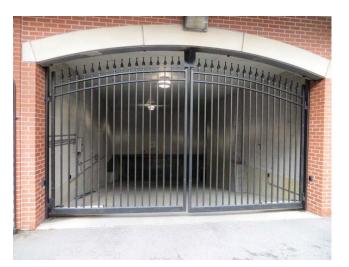
Component covers iron gate at garage ramp entrance to lower parking garage. Gate measures approximately 16' wide x 9' 6" tall.

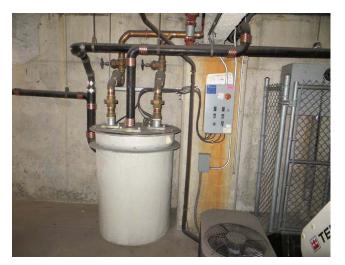
Component covers sewage ejector pumps for parking garage floor drains. Oil, sand, and salt water are pumped to sanitary sewer. No issues reported by management.

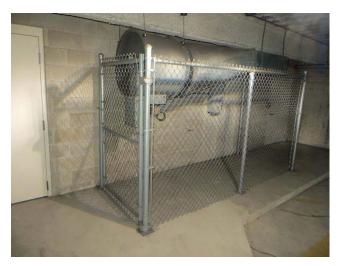
Component covers fan supplying fresh air to lower level parking garage to insure that carbon monoxide levels are safe.

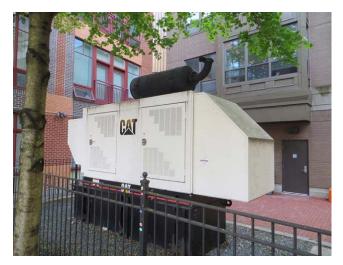
Component covers generator and peripheral equipment.

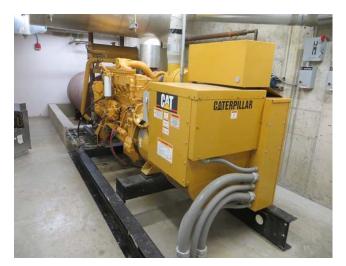
Component covers generator and peripheral equipment.

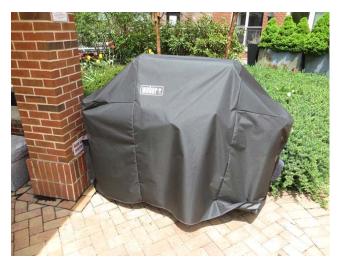
Component covers Weber 1810001 grill on roof courtyard. Placed-in-service 2008 per label.

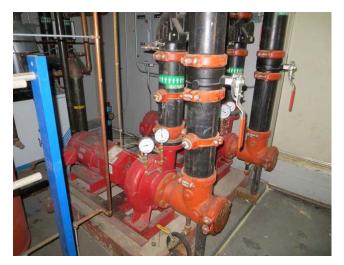
(2) motors power 300 gpm pumps that circulate circulate condenser/boiler water to heat pumps in each building. Pump motor sizes: 7.5 hp V; 10 hp H; 15 hp E. Average cost for 10 hp motor used. The system can operate with only one motor/pump.

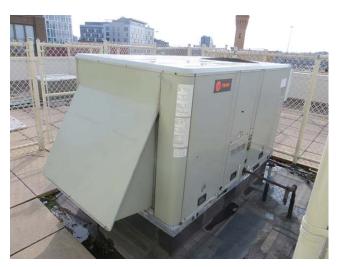
Component covers Trane roof top units providing heating and cooling in common hallway areas in all buildings. There are (4) units:

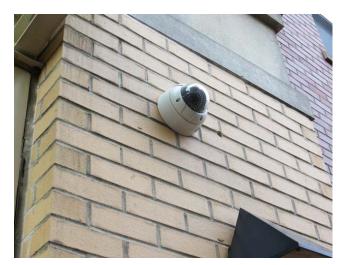
Component covers combined surveillance system for the three buildings and garage.

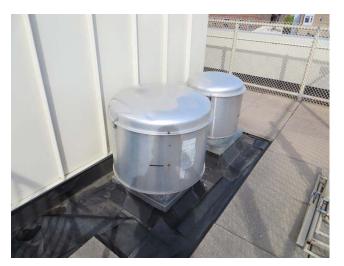
Component covers roof top mushroom fans exhausting air from various areas of buildings.

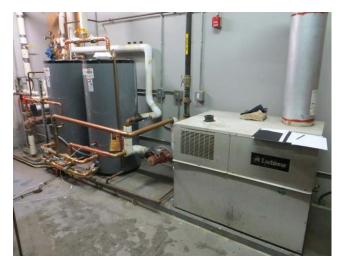
Component covers motor and pumps to circulation domestic hot water through buildings.
