RESERVE ANALYSIS REPORT

Sample Condominium

Boston, Massachusetts

February 16, 2021

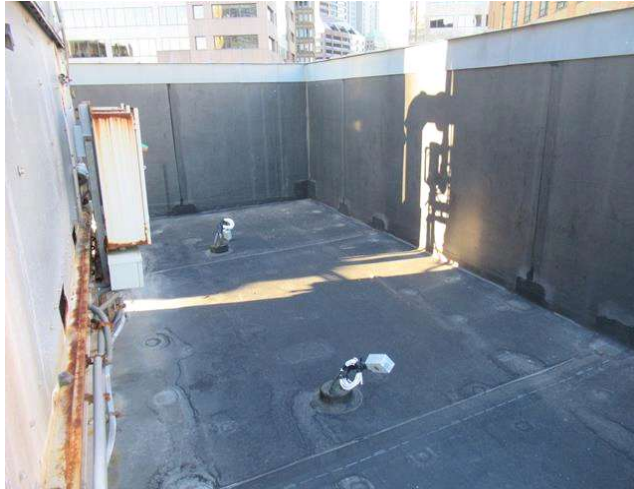
Component budget covers allowance for one-time life extension measures for original EPDM (ethylene propylene diene terpolymer) membrane roof. Original roof is in generally good condition. Patches noted on some roof areas. Some recent repairs at parapet wall caps have been needed, per service contractor. Additional areas are in need of seam reinforcement and localized replacement. Additional roof extension measure components can be added in future reserve study updates as roof gets closer to the end of useful life.

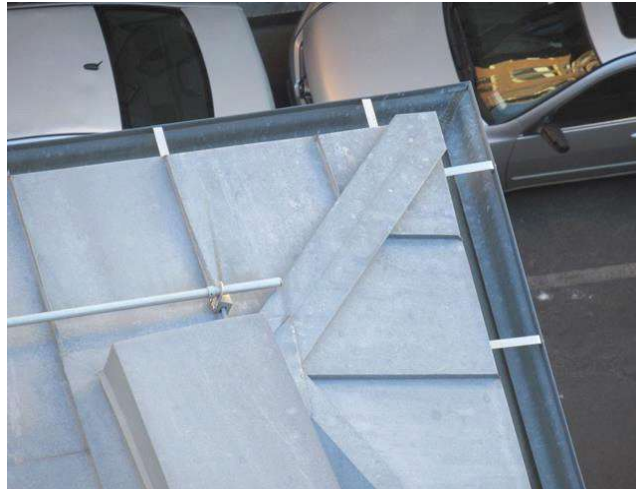
Component budget covers gutters and downspouts installed along front cornice and roof mechanical penthouses. Gutters and leaders are galvanized steel. Gutters and downspouts were in good condition during site visit.

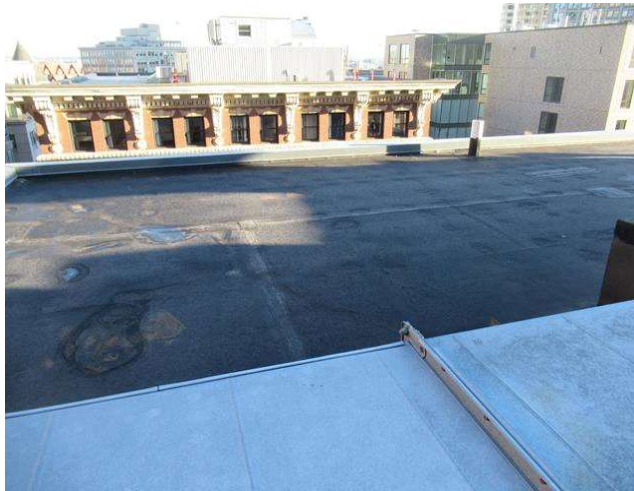
Component budget covers EPDM membrane roofs on building. EPDM is an extremely durable synthetic rubber roofing membrane (ethylene propylene diene terpolymer) widely used in low-slope ("flat" roof) buildings.

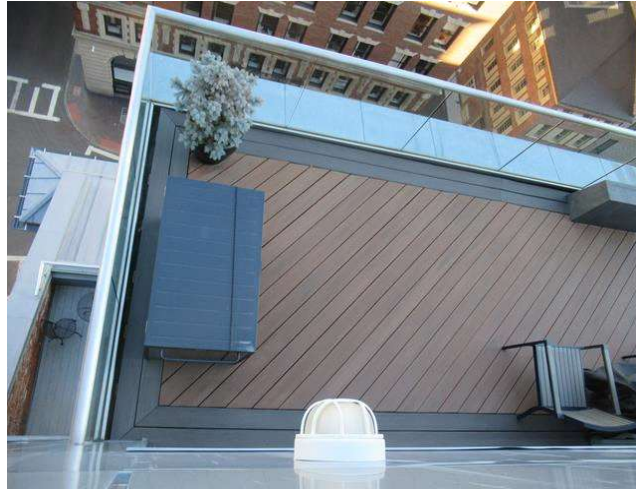
Component budget covers replacement of EPDM (ethylene propylene diene terpolymer) membrane roofs under roof terraces on 7th, 8th, and 9th floors. No access to roofs or construction details were available at site visit. No issues reported.

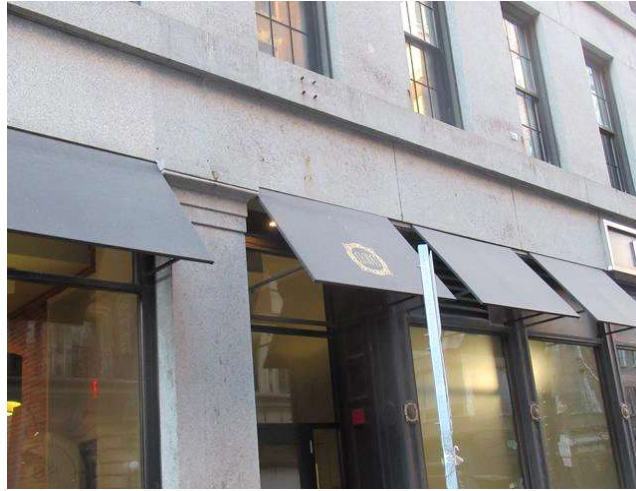
Component budget covers replacement of awnings over main entry door and adjacent windows. Awnings were in good condition at site visit. The actual date this component was placed into service is not available. For budgeting purposes, this date has been estimated based on its condition at our most recent site visit.

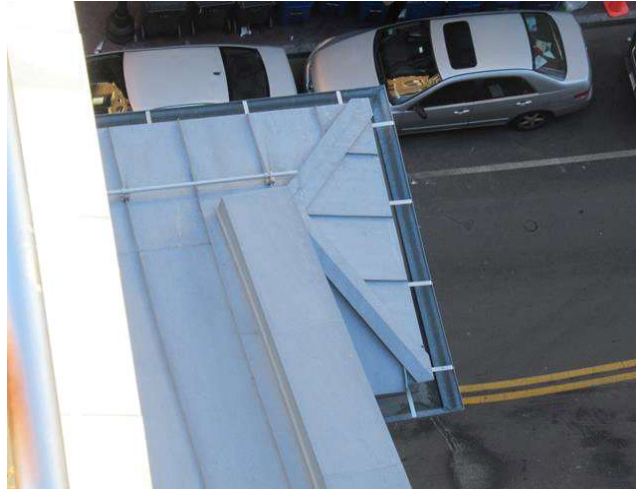
Component budget covers galvanized steel standing seam roofs, parapet caps, and wall panels. Unpainted galvanized steel appeared to be in good condition at site visit. No leaking issues reported.

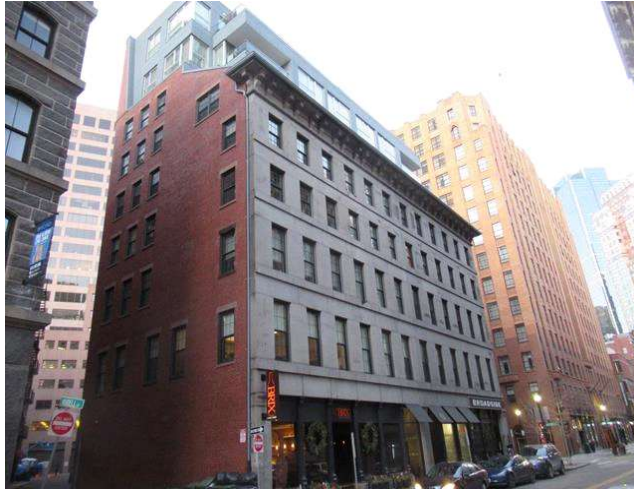
This component budget covers inspections of entire building exterior to comply with City of Boston Façade Ordinance 9-9.12. Inspections are required every 5 years for buildings more than 70 feet tall. Building is about 115 feet tall. More costly inspections are required for buildings greater than 125 feet tall. Cost per similar building in Boston. Date of last inspection is currently unknown.

Repairs are covered by separate component.

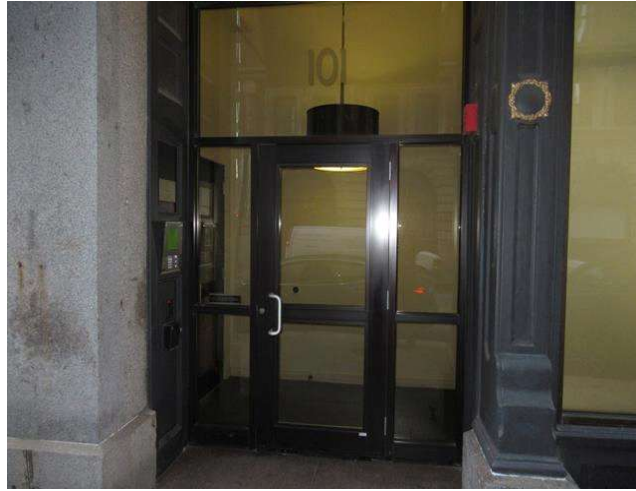
Component budget covers exterior aluminum frame full view commercial main entry door. Door was in good condition during site visit with no issues reported by client. Door is protected by awning and recessed into building. The remaining life of this component has been extended due to its condition at our most recent site visit.

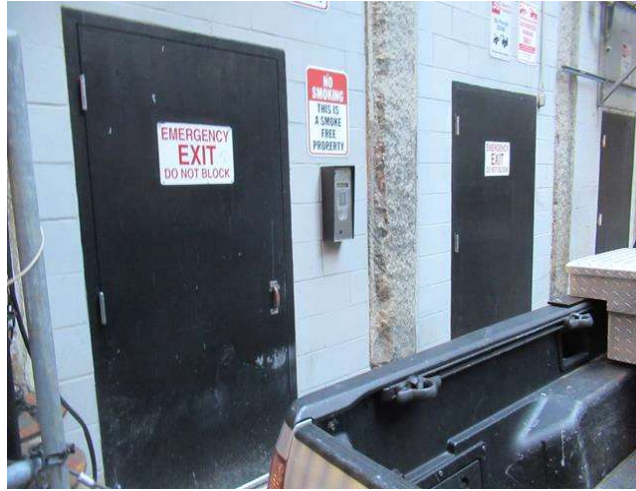
Component budget covers periodic replacement of exterior flush steel doors for building rear egress and roof access starting in 2028. Doors were in good condition during site visit. As infrastructure ages, allowance should be adjusted in future reserve study updates.

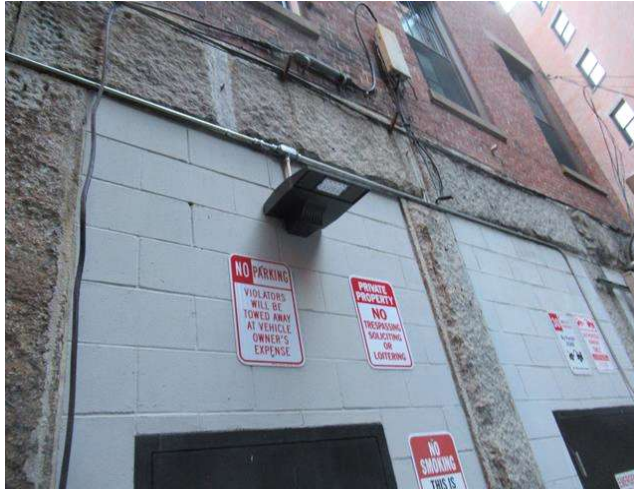
Component budget covers wall and ceiling mounted exterior lighting. Lighting was in good condition at site visit. Roof terraces were not accessible at site visit. Quantities are estimated for these areas based on photos taken.

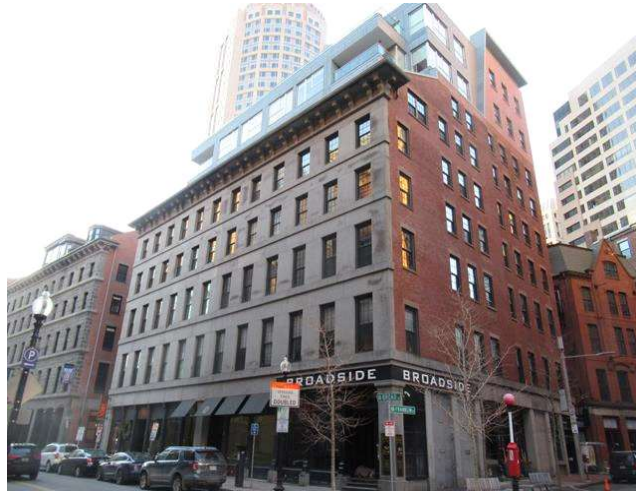
Component budget covers the recommended inspection and major masonry repairs starting in 2048 after initial 25 year inspection and repair in 2033. Annual inspections should guide the frequency and extent of major and minor repairs. A percentage of masonry is expected to be repaired every 15 years. Component includes any repairs required for cast stone cornices.

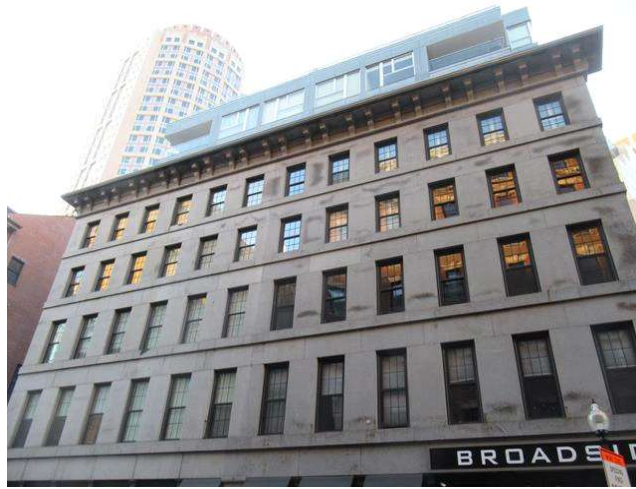
Component budget covers the initial recommended major masonry repairs after approximately 25 years. A percentage of granite and brick areas are expected to be repaired at that time. Component includes any repairs required for cast stone cornices.

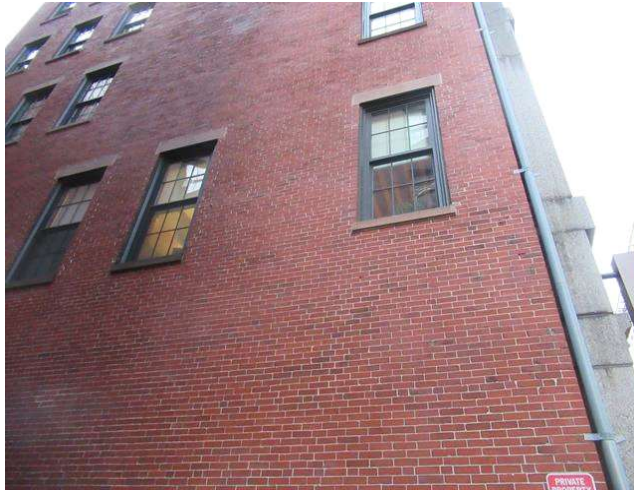
Component budget covers minor masonry repairs starting in 2024. Repairs typically include repointing damaged areas and replacing sealants to maintain water resistance. Cleaning and sealing brick surface in targeted areas may also be required. Major repairs are covered by separate component.

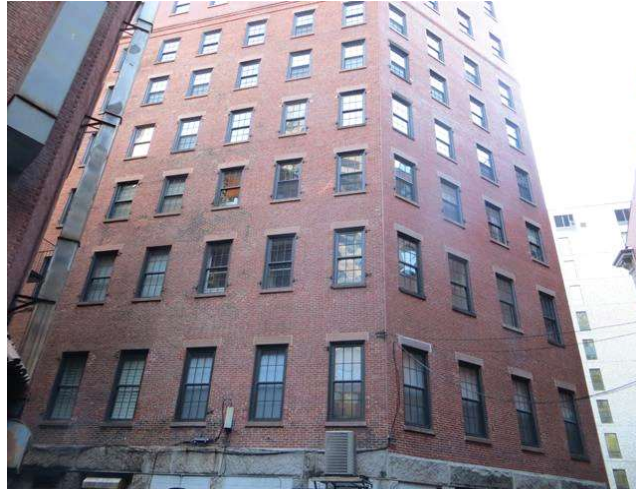
Component budget covers initial sealant and minor masonry repairs. Repairs typically include repointing damaged areas and sealing penetrations. Cleaning and sealing brick surface may also be required. Ongoing minor repairs are covered by separate component.

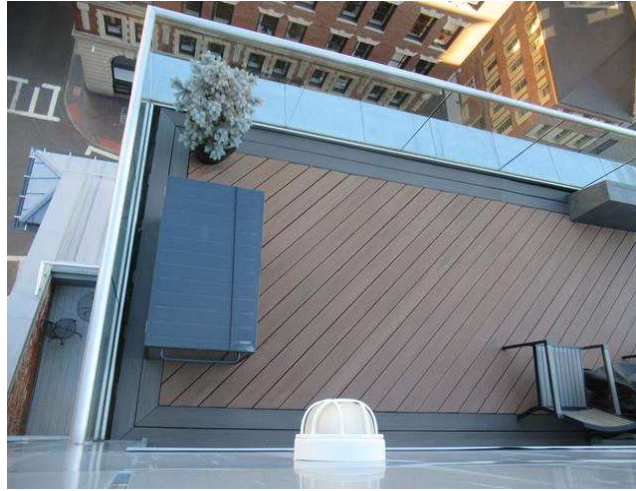
Component budget covers exterior terrace decks with composite or wood deck boards. Monolithic decks are non-structural and installed on sleepers over membrane roof. Terrace decks were not accessible during site visit. Decks have various types of decking installed.

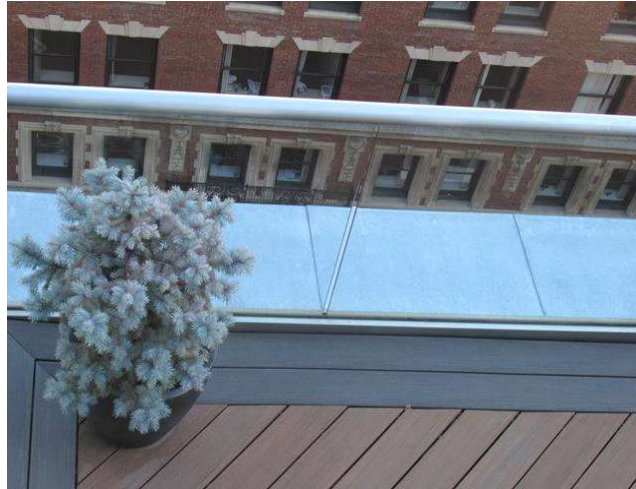
Component budget covers glass railings located at unit roof terraces. Railings could not be directly accessed, but appeared to be in good condition as observed from ground and roof at site visit.

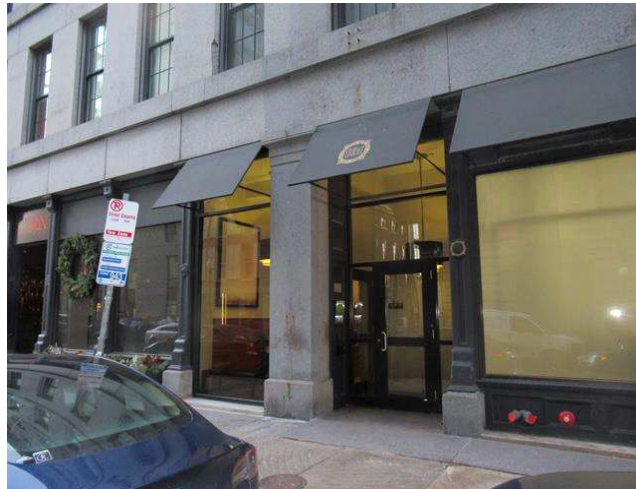
Component budget covers exterior commercial aluminum-framed common store front windows adjoining main entrance. Windows were in good condition during site visit and no problems were reported by client.

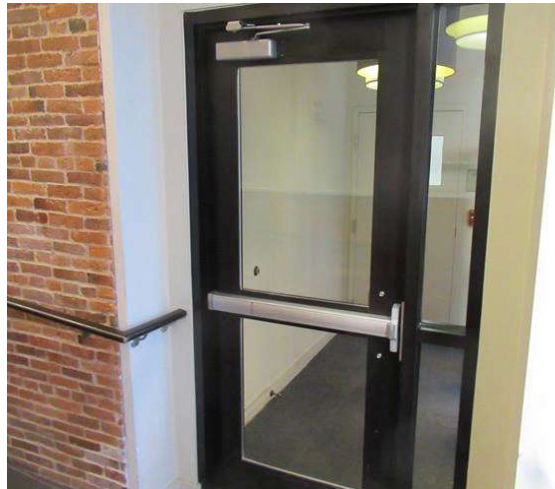
Component budget covers interior vestibule full glass aluminum door into main lobby. Door was in good condition at site visit.

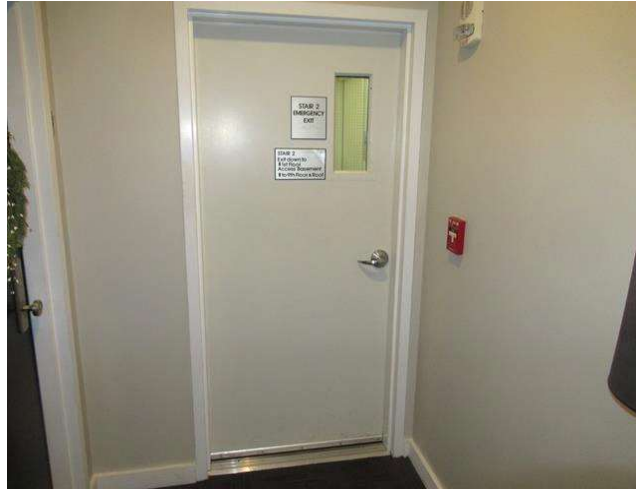
Component budget covers interior common steel doors in stairwells, hallways, closets, and mechanical rooms. Doors were in good condition at site visit. Door life will vary with usage. It is unlikely that all interior doors will be replaced at one time. There are approximately 48 doors in the building.

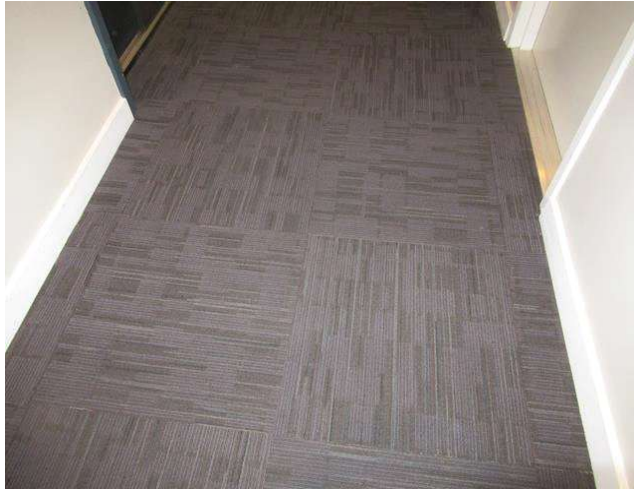
Component budget covers carpet tile flooring in unit hallways. Carpet tiles were installed in September 2016 at a cost of \$10,000, per client, and were in good condition at site visit. Quantity includes 15% waste factor. Useful life of carpet tiles increased because soiled tiles can be replaced easily. Cost updated for inflation.

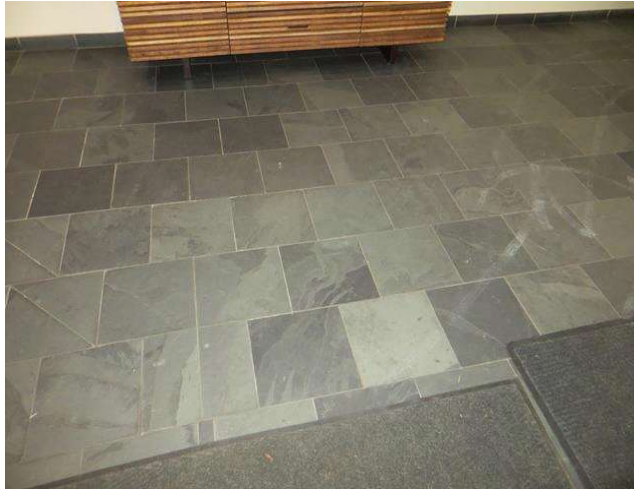
Component budget covers stone tile in main lobby areas. Tile was in good condition. No loose or cracked tiles were observed. Cost for removal of existing tile is difficult to estimate. Cost of materials chosen to replace the current tile can also vary widely.

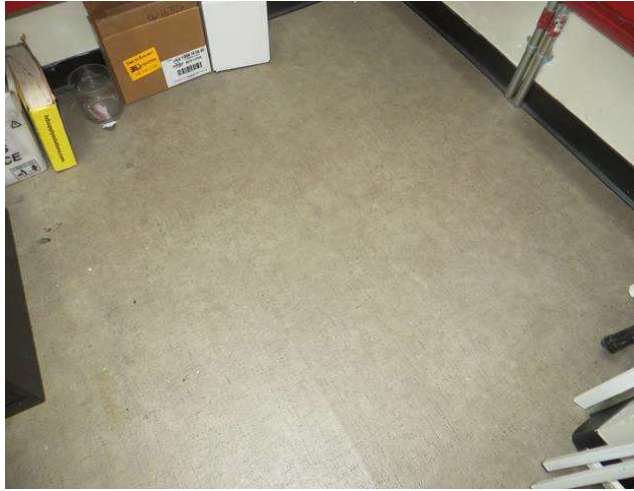
Component budget covers sheet vinyl flooring in stairwell vestibules and fire command center closet behind concierge desk. Vinyl was in good condition. Quantities include 15% waste factor.

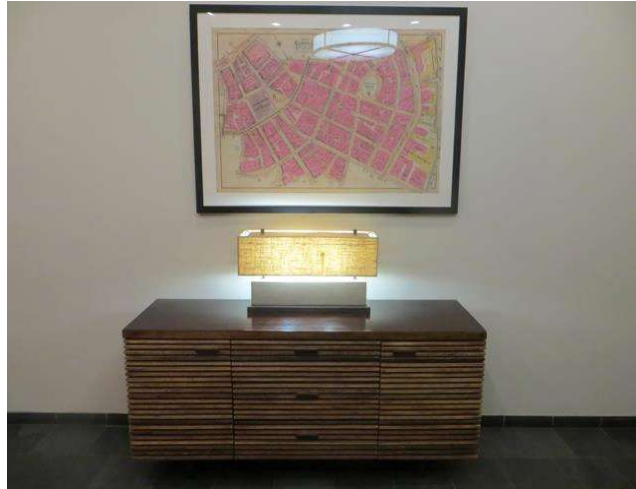
Component budget covers allowance for replacement of furnishings in main lobby and mirrors in unit hallways. Furnishings were in good condition at site visit. Replacement furnishings may vary widely in price, based on selections. Wall artwork is currently unfunded.

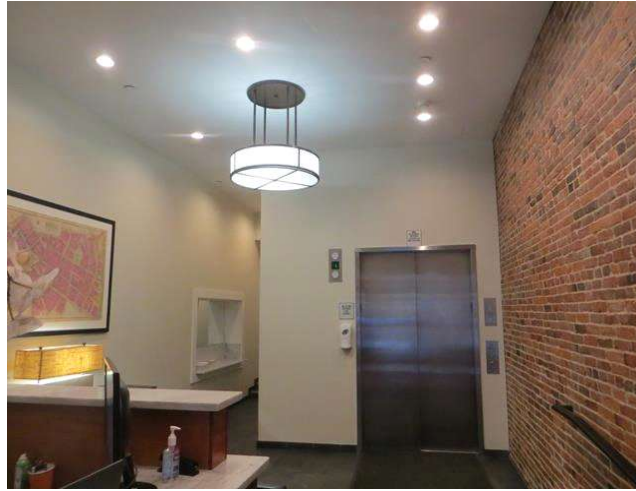
Component budget covers interior 1st floor lighting in main lobby area and mail room. Lighting was in good condition at site visit.

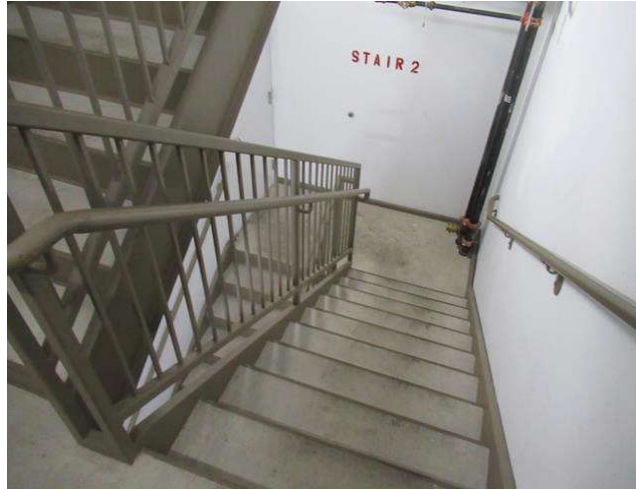
Component budget covers basement, stairwell, and stairwell vestibule lighting in building. Lighting was in good condition at site visit.

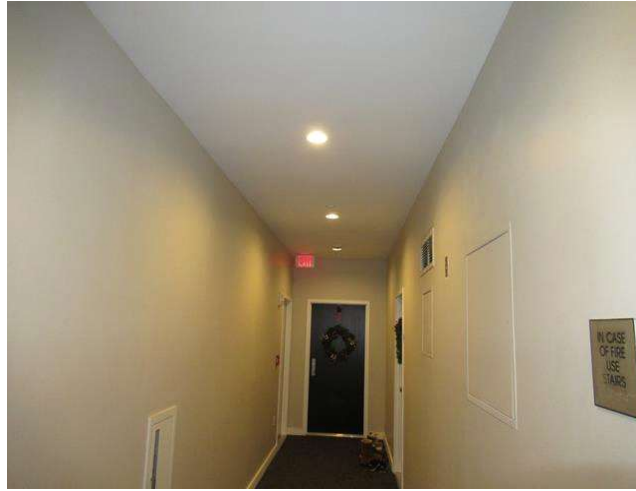
Component budget covers unit hallway lighting on all floors. Lighting was in good condition at site visit.

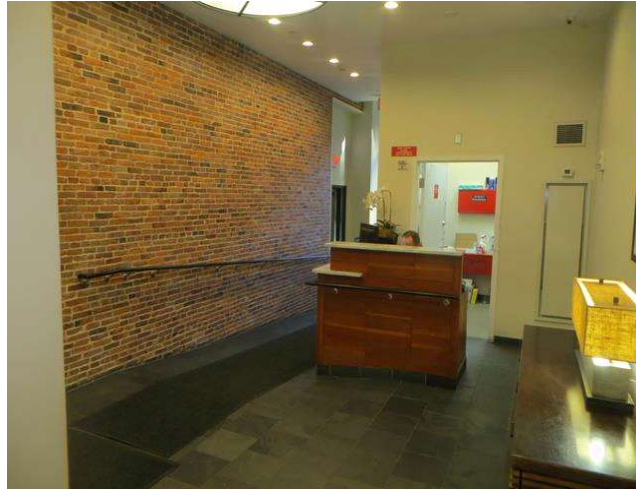
Component budget covers renovation of main lobby. Space was in good condition at site visit. Flooring, furnishings, and lighting are covered by separate components.

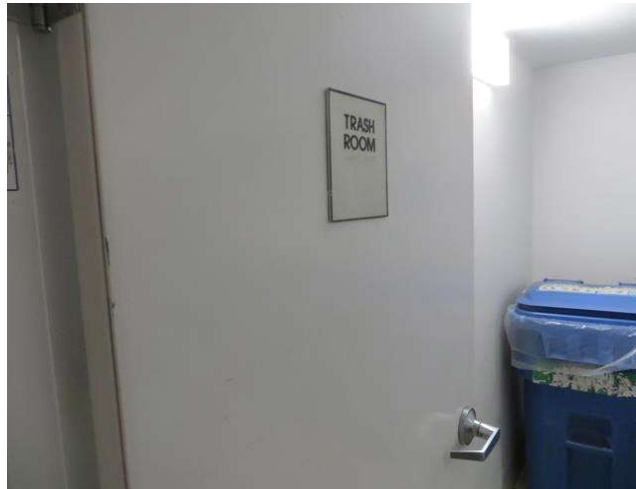
Category	030 Building Interior	Quantity	1 total
Photo Date	January 2021	Unit Cost	\$5,000.00
		% of Replacement	100.00%
		Current Cost	\$5,000.00
Placed In Service	01/08	Future Cost	\$7,608.09
Useful Life	30		
		Assigned Reserves at FYB	\$0.00
Remaining Life	17	Monthly Member Contribution	\$11.44
Replacement Year	2038	Monthly Interest Contribution	\$0.02
		Total Monthly Contribution	\$11.46

Component budget covers allowance for general signage throughout association.

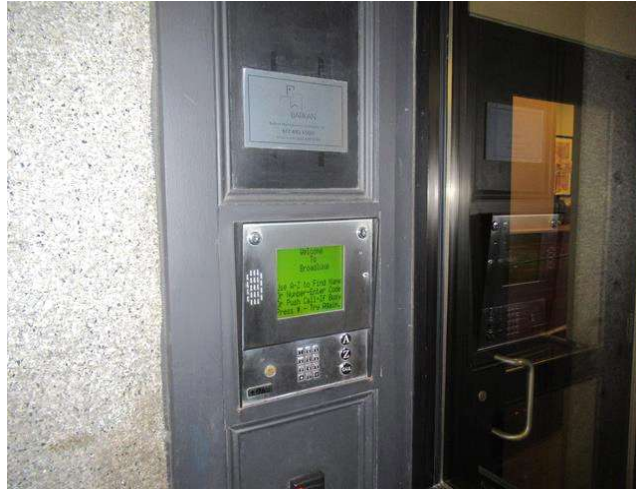
Component budget covers replacement of access control system at front entry door. No issues reported. Pricing assumes that wiring within buildings can be reused.

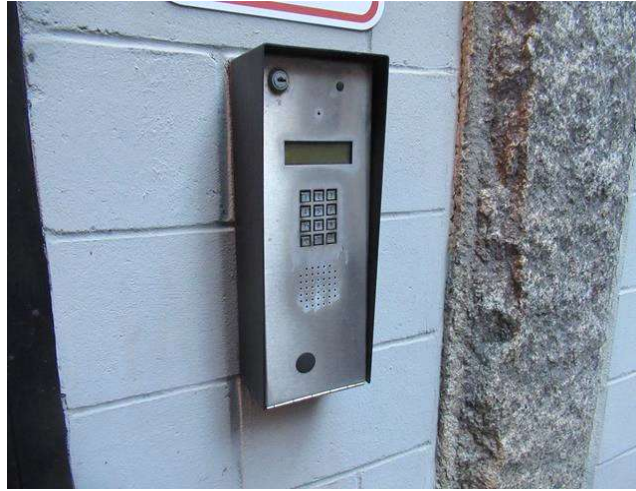
Component budget covers replacement of access control system at rear entry door. No issues reported. Pricing assumes that wiring within buildings can be reused.

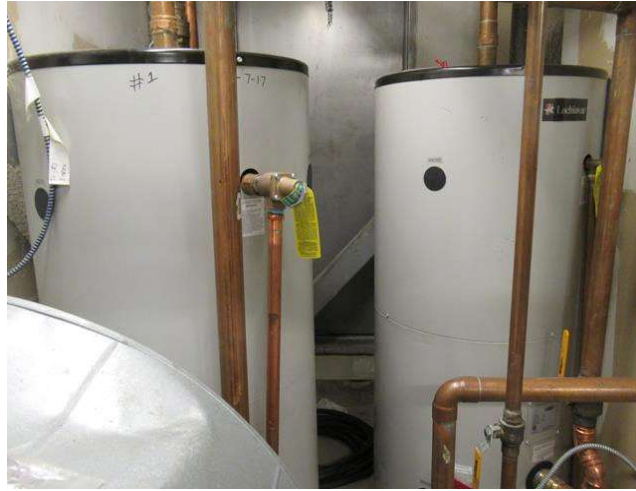
Component budget covers 119 gallon indirect domestic water heater tank installed in 2017. Useful life typically 10-15 years, depending on city water quality. Based on original tanks failing in 9 and 11 years, useful life set at 10 years.

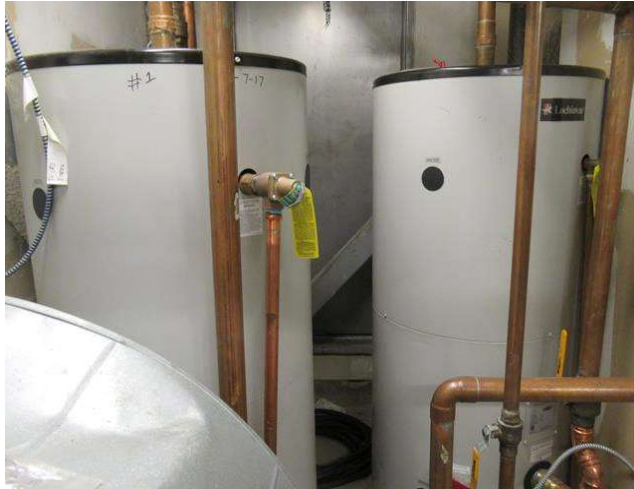
Component budget covers 119 gallon indirect domestic water heater tank installed in 2019. Useful life typically 10-15 years, depending on city water quality. Based on original tanks failing in 9 and 11 years, useful life set at 10 years.

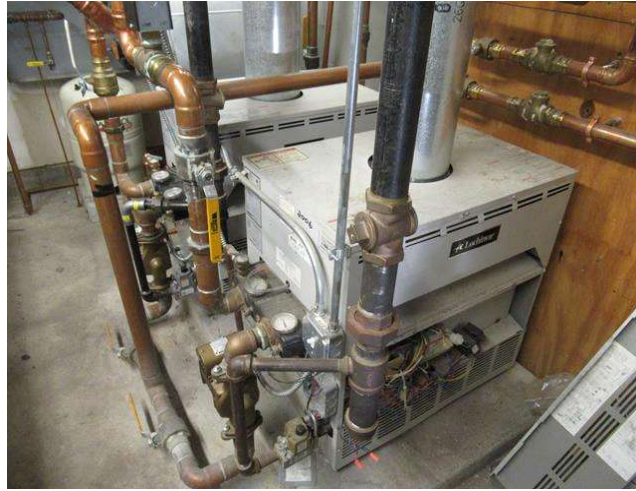
Component budget covers Lochinvar CWN270PM standard-efficiency boiler installed at initial construction providing domestic hot water for building through indirect water heater tanks listed separately.

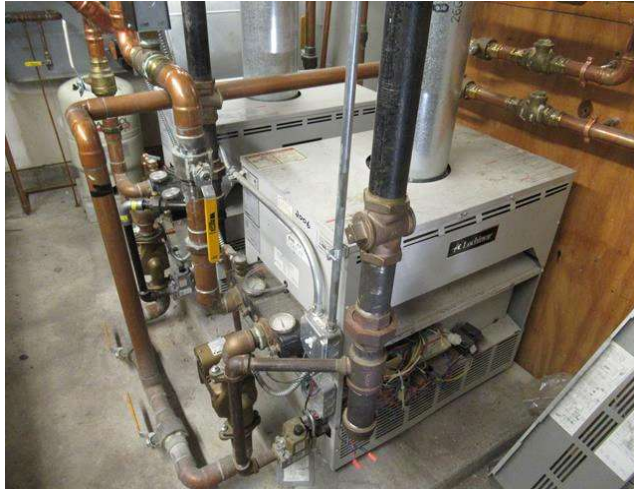
Component budget covers Lochinvar CWN270PM standard-efficiency boiler replaced in 2019. Boiler provides domestic hot water for building through indirect water heater tanks listed separately.

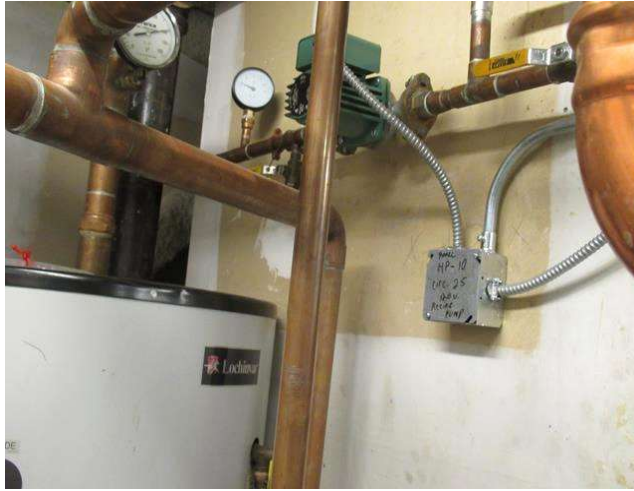
Component budget covers 1/2 HP pump circulating hot water through the building. Pump was replaced in 2018, per service contractor.

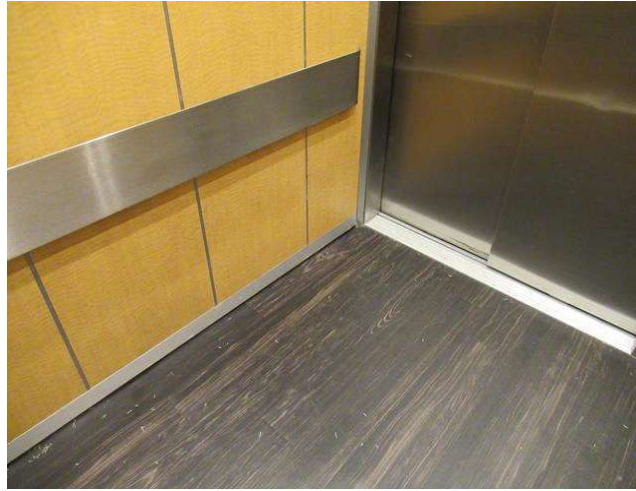
Component budget covers refurbishment of elevator cab. Cab was in good condition at site visit. Frequency of cab refurbishment is mainly an aesthetic decision. The remaining life of this component has been extended due to its condition at our most recent site visit.

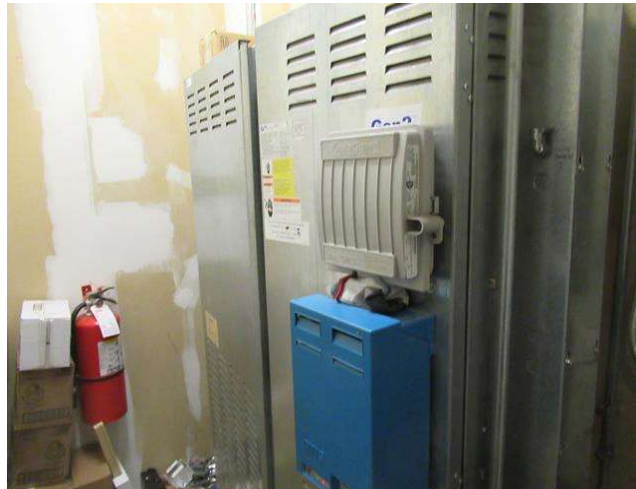
Component budget covers modernization of machine room-less traction elevator. Elevator was functioning normally at site visit. Since there is no machine room, elevator mechanical machine is located at top of hoistway and was not accessible during site visit.

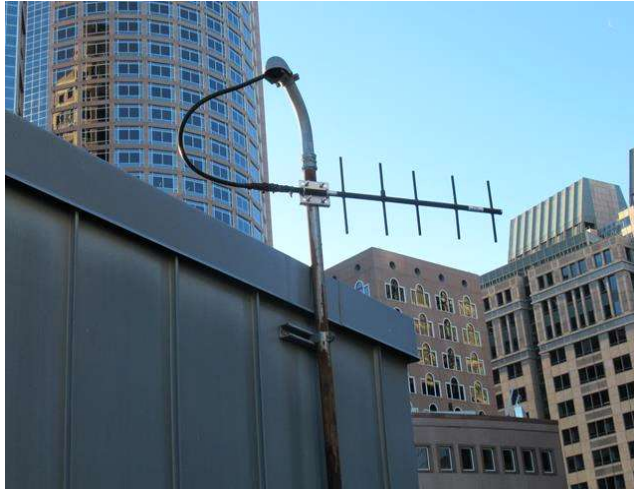
Component budget covers bidirectional antenna (BDA) system for emergency responder communication. No issues reported. Antenna is original, per client. Price per similar association.

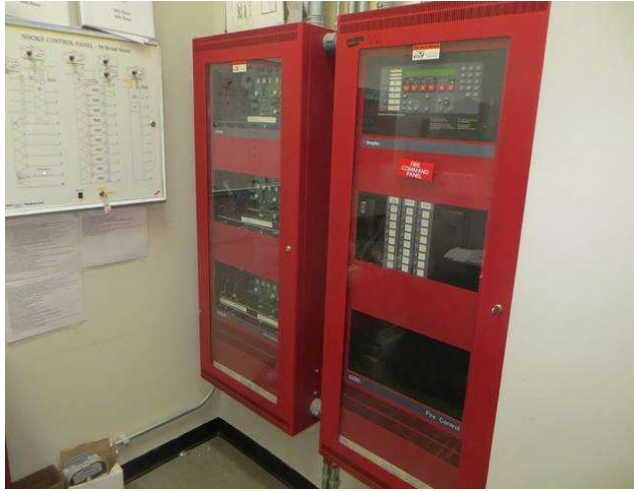
Component budget covers main parts of fire alarm system. The fire alarm system is composed of main fire alarm panel, smoke control panel and fire annunciator. Component does not include re-wiring, pull stations, fire emergency lights, heat detectors, or horns. Replacement of peripheral devices is currently done on an as-needed basis. Funding for these devices can be added if desired.

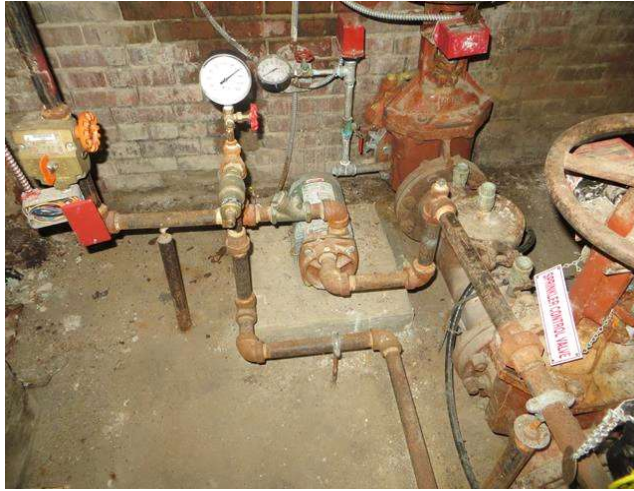
Component budget covers fire sprinkler jockey pump. Pump maintains wet sprinkler pipes at approximate target pressure to aid in sensing if a sprinkler head discharges. Jockey pump eliminates need for main fire pump to run to maintain system pressure. If sprinkler system has low leak/loss rate, pump may only run once a week.

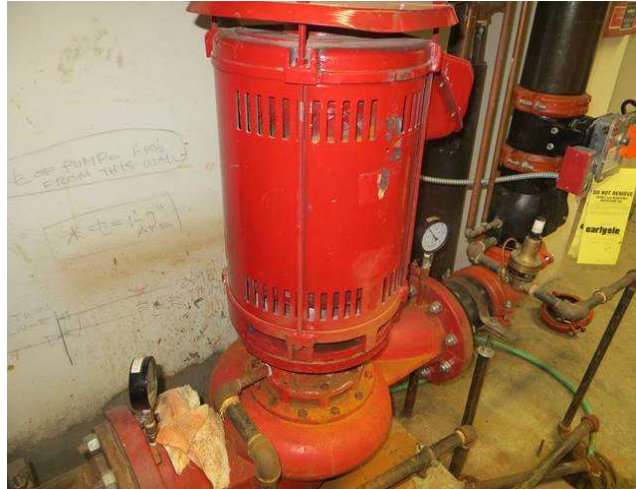
Component budget covers replacement of 50-HP fire pump & controller. No issues reported. Useful life extended to reflect pump rebuild component listed separately.

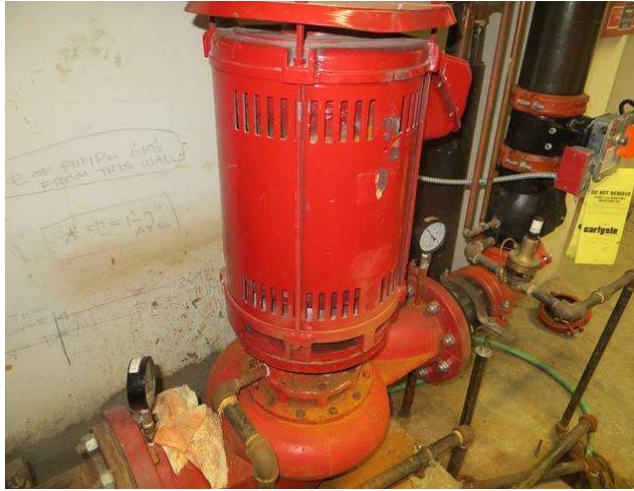
Component budget covers rebuild of 50-HP fire pump. No issues reported. Pump replacement component listed separately.

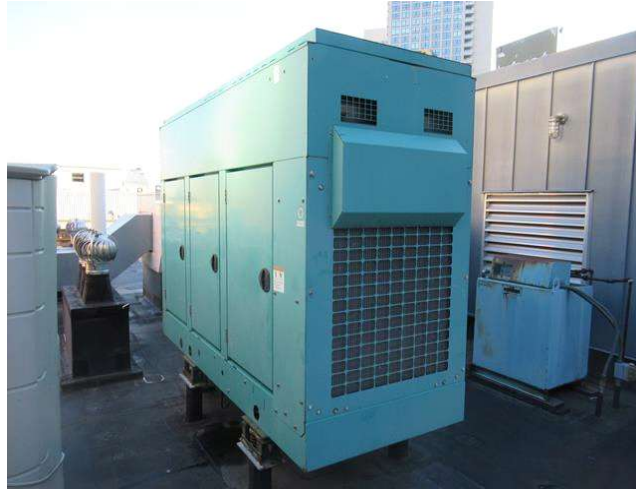
Component covers Cummins generator and peripheral equipment. Diesel-powered generator is rated at 200 kW. Generator was in good condition at site visit.

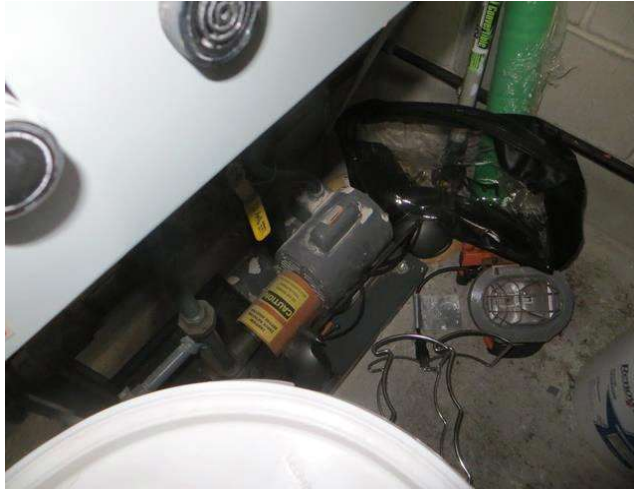
Component budget covers automatic fuel oil transfer pump and control panel. No reported operating issues. Area around pump and tank should be kept clear and not used for storage.

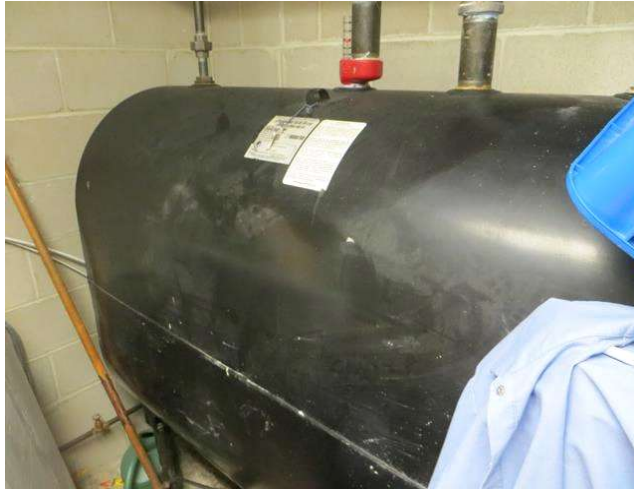
Component covers 275 gallon diesel fuel storage tanks located in basement storage room. Steel tank holds fuel for backup generator. No major issues reported. Tank may be without cathodic protection, but fuel usage is low so introduction of water in tank with fuel deliveries should be low also. Cathodic protection should be considered. Useful life increased from 30 to 35 years to reflect low refill frequency.

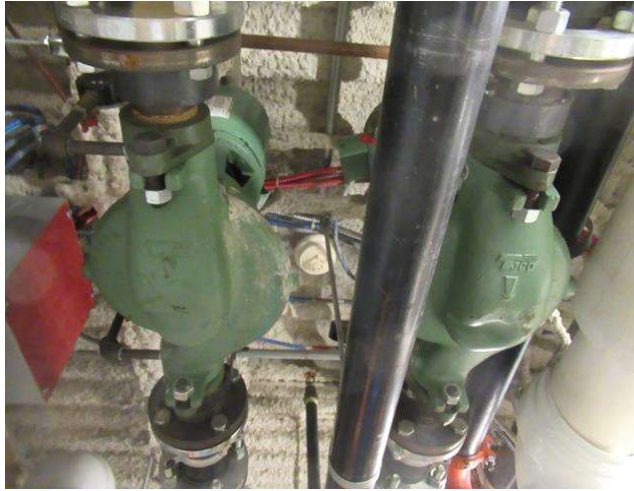
Component budget covers (2) circulation pumps for boiler water. In winter, boiler water is fed into condenser water loop with valves that control the temperature of the condenser water to 68F. Condenser water circulates to unit heat pumps.

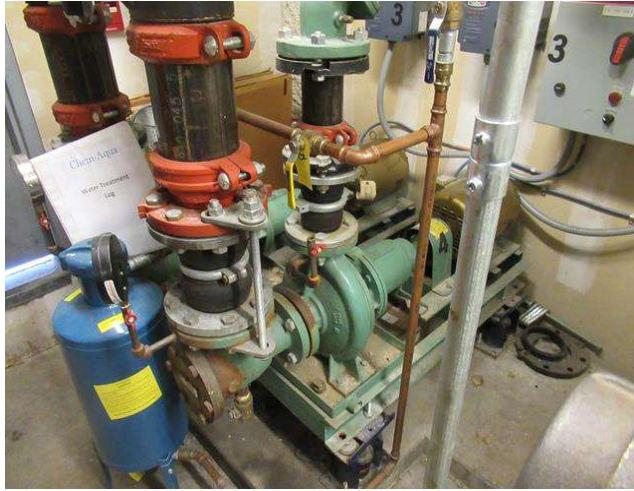
Component budget covers (2) circulation pumps for condenser water loop supplying hot and cold water to unit and common heat pumps. No issues reported by management. Pumps and motors appear original to construction. Variable frequency drives (VFDs) are used for soft start of motors to extend pump & motor life. There is no controller so pumps operate at a constant speed/flow. Useful life for pumps extended to to account for VFDs.

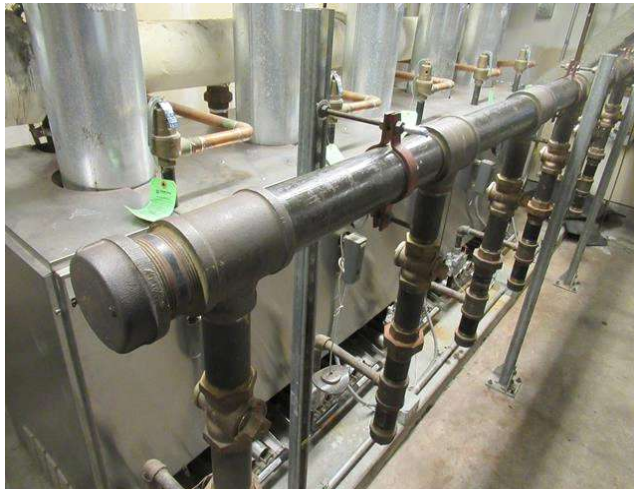
Component budget covers (5), HydroTherm MultiTemp, standard-efficiency (80%) boilers installed at original construction. Boilers provide hot water for building space heating.

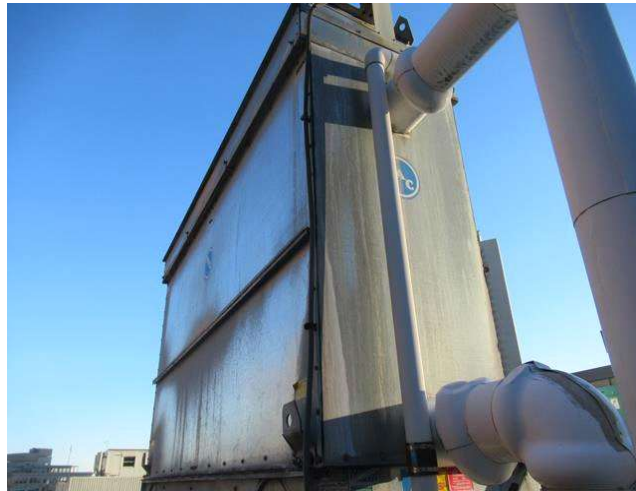
Component budget covers replacement of cooling tower which provides chilled water for building cooling. Condenser water circulation pumps are a separate component.

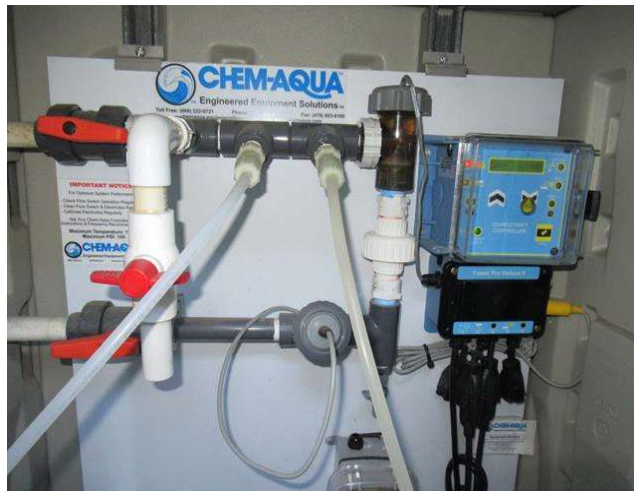
Component budget covers replacement of cooling tower water treatment system. No issues reported.

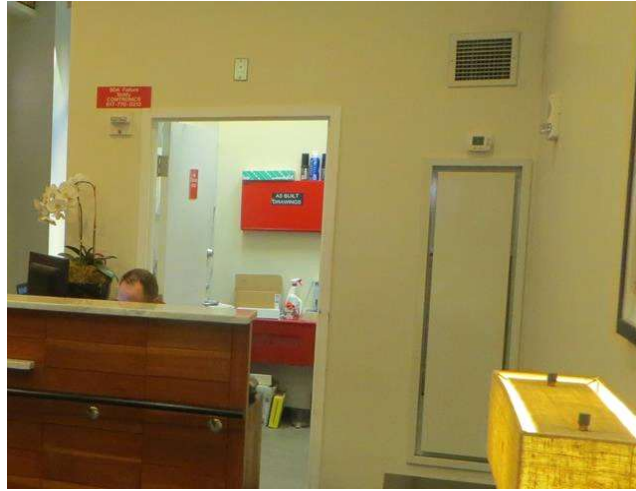
Component budget covers replacement of heat pump in wall behind concierge desk in main lobby. Heat pump was replaced by service contractor in 2017 at a cost of \$5315. No current issues reported. Inflation added to current cost.

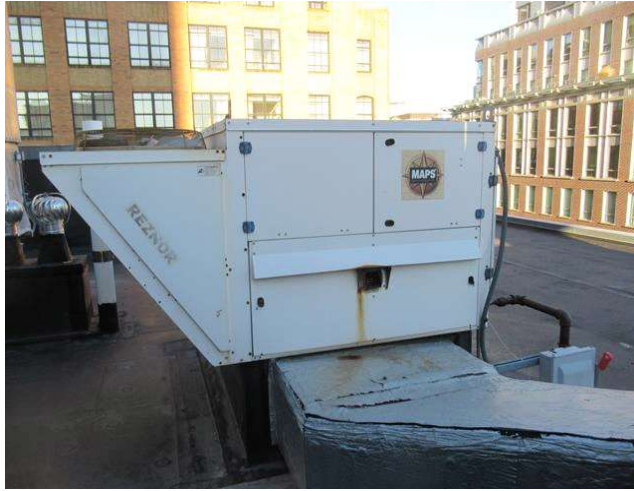
Component budget covers rooftop unit (RTU) providing heating and cooling for hallways. Unit also provides 100% ventilation/fresh air to building.

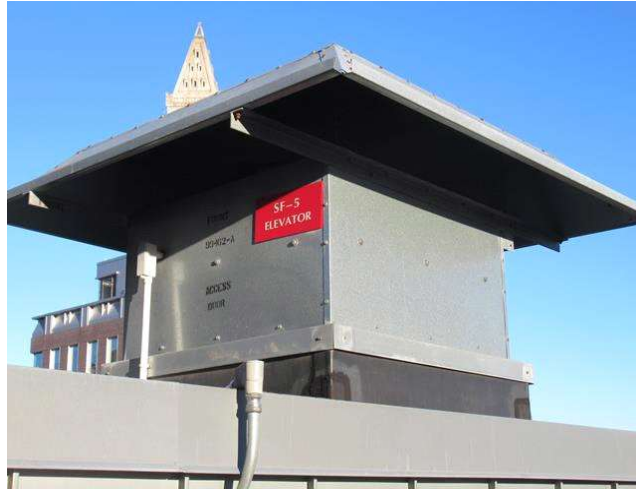
Category	090 Equipment	Quantity	6 fans
Photo Date	January 2021	Unit Cost	\$5,000.00
		% of Replacement	100.00%
		Current Cost	\$30,000.00
Placed In Service	01/08	Future Cost	\$58,434.00
Useful Life	40		
		Assigned Reserves at FYB	\$0.00
Remaining Life	27	Monthly Member Contribution	\$47.64
Replacement Year	2048	Monthly Interest Contribution	\$0.10
		Total Monthly Contribution	\$47.74

Component budget covers stairwell pressurization and exhaust fans for fire department smoke control. Quantity from smoke control panel in lobby office closet. Useful life reflects light use with intermittent operation.

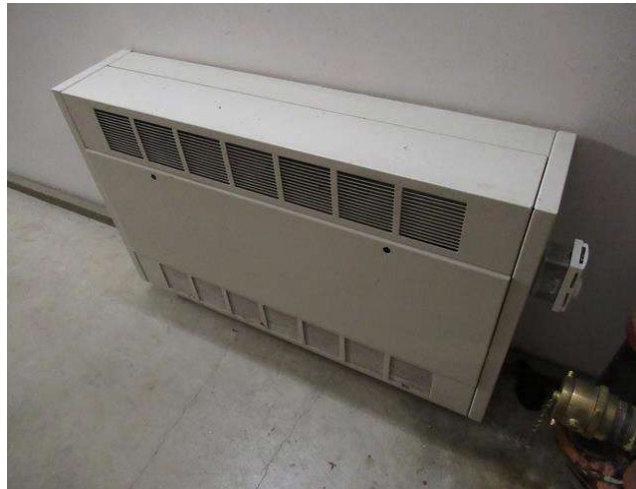
Component budget covers replacement of unit heater located at bottom of stairwell adjacent to rear stairwell exit. No current issues reported.

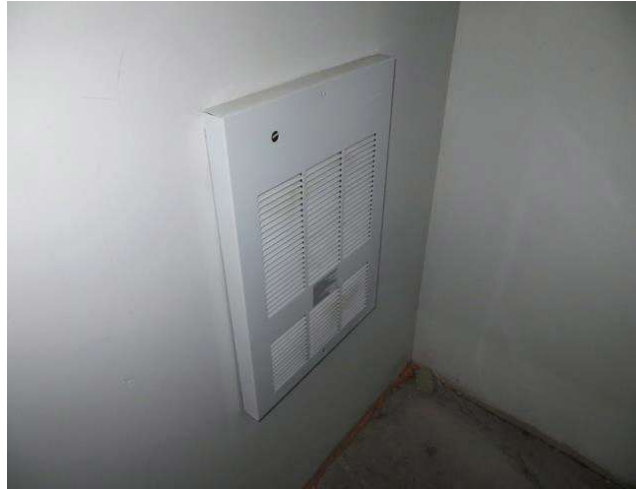
Category	090 Equipment	Quantity	11 heaters
Photo Date	January 2021	Unit Cost	\$1,000.00
		% of Replacement	10.00%
		Current Cost	\$1,100.00
Placed In Service	01/21	Future Cost	\$1,214.19
Useful Life	4		
		Assigned Reserves at FYB	\$0.00
Remaining Life	4	Monthly Member Contribution	\$9.36
Replacement Year	2025	Monthly Interest Contribution	\$0.02
		Total Monthly Contribution	\$9.38

Component budget covers periodic replacement of electric unit heaters located in storeroom and stairwells. Several heater thermostats and one heater have been replaced by service contractor. No current issues reported. Quantity per service contractor.

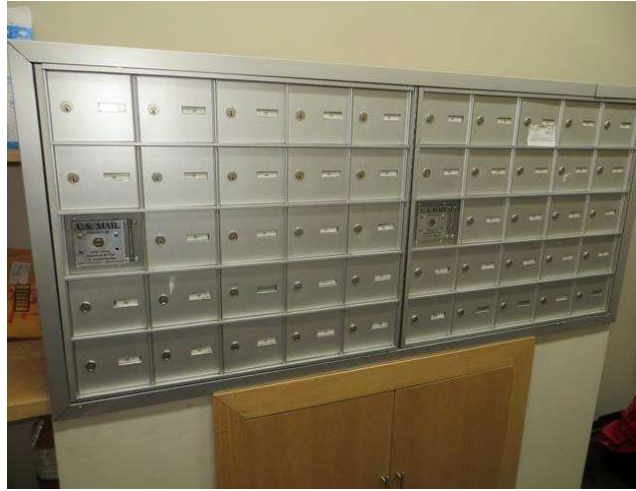
Category	090 Equipment	Quantity	1 total
Photo Date	January 2021	Unit Cost	\$3,400.00
		% of Replacement	100.00%
		Current Cost	\$3,400.00
Placed In Service	01/08	Future Cost	\$5,173.50
Useful Life	30		
		Assigned Reserves at FYB	\$0.00
Remaining Life	17	Monthly Member Contribution	\$7.78
Replacement Year	2038	Monthly Interest Contribution	\$0.01
		Total Monthly Contribution	\$7.79

Component budget covers 25-door USPS-STD-4B+ horizontal recessed mailboxes in building rear hall. Mailboxes were in good condition at site visit.

2	25-door mailboxes	@	\$1,500.00	=	\$3,000.00
1	installation allowance	@	\$400.00	=	\$400.00
			TOTAL	=	\$3,400.00

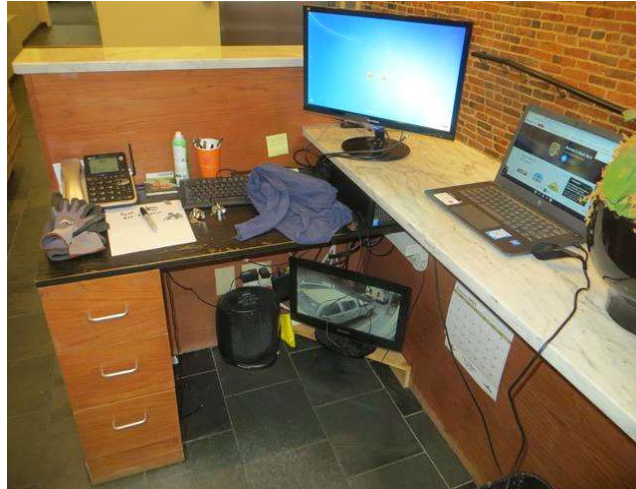
Category	090 Equipment	Quantity	1 allowance
Photo Date	January 2021	Unit Cost	\$2,500.00
		% of Replacement	100.00%
		Current Cost	\$2,500.00
Placed In Service	01/18	Future Cost	\$2,626.56
Useful Life	5		
		Assigned Reserves at FYB	\$0.00
Remaining Life	2	Monthly Member Contribution	\$41.68
Replacement Year	2023	Monthly Interest Contribution	\$0.08
		Total Monthly Contribution	\$41.76

Component budget covers periodic replacement allowance for office equipment used by concierge and building manager. No issues reported. Allowance should be revised, based on association experience, in future reserve study updates.

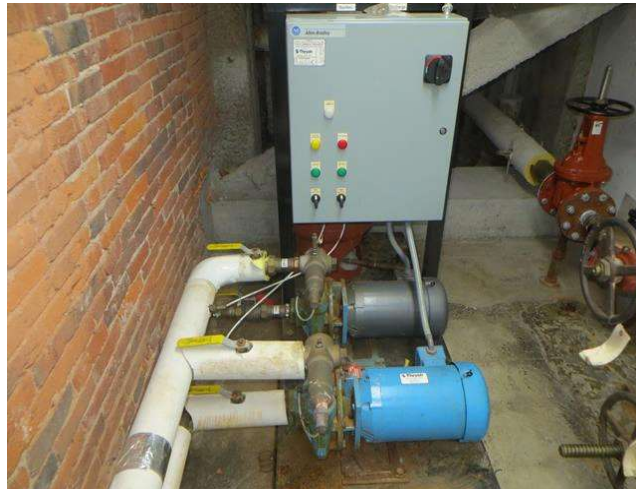
Category	090 Equipment	Quantity	1 duplex system
Photo Date	January 2021	Unit Cost	\$45,000.00
		% of Replacement	100.00%
		Current Cost	\$45,000.00
Placed In Service	01/08	Future Cost	\$68,472.82
Useful Life	30		
		Assigned Reserves at FYB	\$0.00
Remaining Life	17	Monthly Member Contribution	\$102.92
Replacement Year	2038	Monthly Interest Contribution	\$0.21
		Total Monthly Contribution	\$103.13

Component budget covers Thrush domestic water duplex booster pumps. Pumps are powered by 7.5 hp motors. Cost from similar association includes vertical removable-bladder hydropneumatic pressure tank.

Control panels may also have individual components that need periodic replacement (electrical contactors are an example).
