RESERVE ANALYSIS REPORT

Sample Condominium

Boston, Massachusetts

February 16, 2021

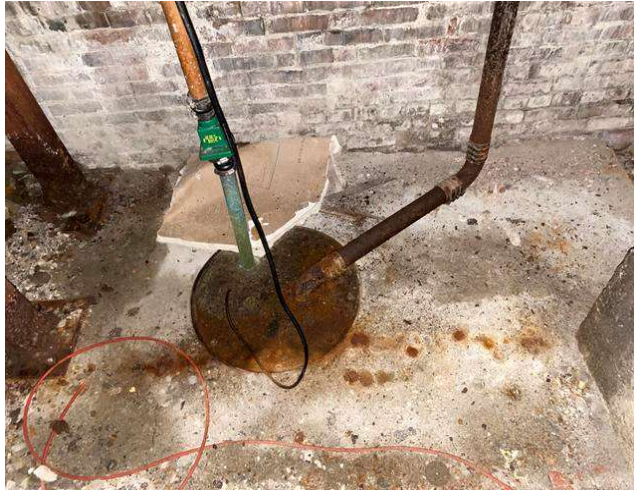
Category	090 Equipment	Quantity	1 pump system
Photo Date	January 2021	Unit Cost	\$1,750.00
		% of Replacement	100.00%
		Current Cost	\$1,750.00
Placed In Service	01/08	Future Cost	\$1,838.59
Useful Life	15		
		Assigned Reserves at FYB	\$0.00
Remaining Life	2	Monthly Member Contribution	\$29.18
Replacement Year	2023	Monthly Interest Contribution	\$0.06
		Total Monthly Contribution	\$29.23

Component budget covers pump in basement. No issues reported by management.

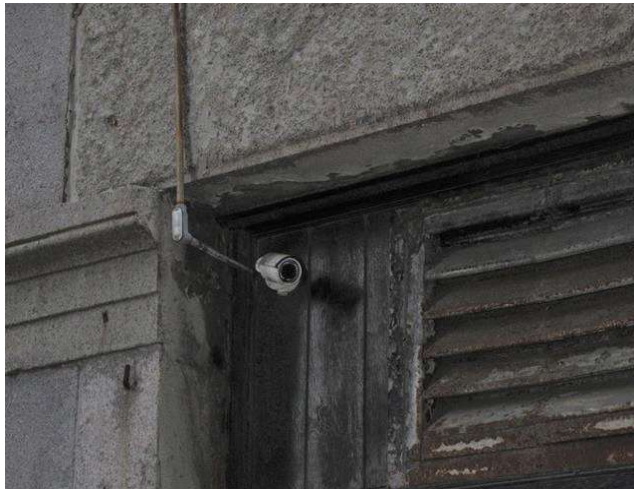
Category	090 Equipment	Quantity	1 system upgrade
Photo Date	January 2021	Unit Cost	\$5,000.00
		% of Replacement	100.00%
		Current Cost	\$5,000.00
Placed In Service	01/20	Future Cost	\$5,519.06
Useful Life	5		
		Assigned Reserves at FYB	\$0.00
Remaining Life	4	Monthly Member Contribution	\$42.56
Replacement Year	2025	Monthly Interest Contribution	\$0.09
		Total Monthly Contribution	\$42.65

Component budget covers periodic upgrade of surveillance systems. Specific system information not available. Allowance should be adjusted, based on association experience and needs, in future reserve study updates.

Replacement is about \$1200 per camera, including installation, for higher quality IP cameras. Useful life of cameras is about 5-7 years for outdoor and 10+ for indoor for new IP cameras that use CAT5 wiring with fewer connections. Most surveillance systems are replaced to improve picture quality and other performance measures rather than failure of the system.
