# RESERVE ANALYSIS REPORT

## Sample Village Condominium

Sample, Massachusetts

September 25, 2021

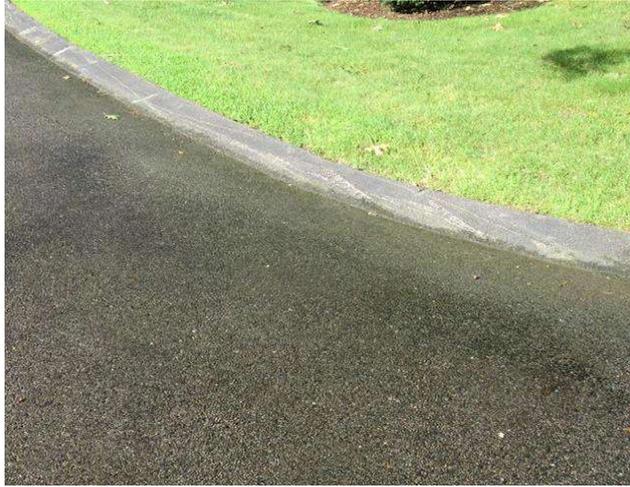
Component budget covers roadway asphalt berm/curbing. Asphalt berms were in generally good condition at site inspection. Some minor damage from plowing and other impacts were noted. Placed-in-service date for Steepletree asphalt project used.

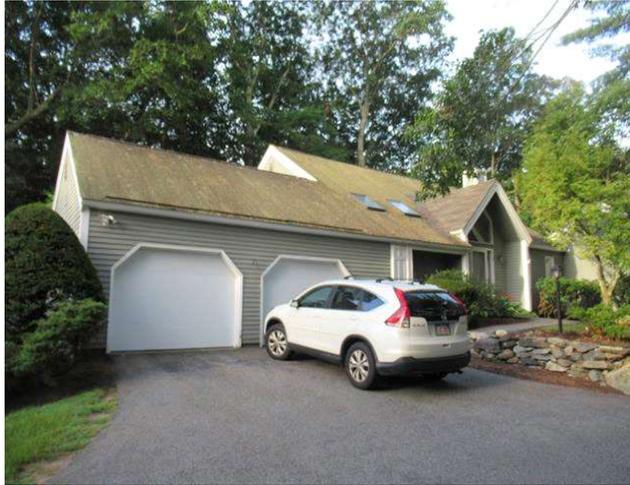
Component budget covers rebuild of asphalt driveways and parking areas. Asphalt is in generally good condition with some cracks observed. Roads are listed separately. Differentiation between roads and driveways not clear in some areas. See additional general comments listed under "Asphalt - Overlay, C".

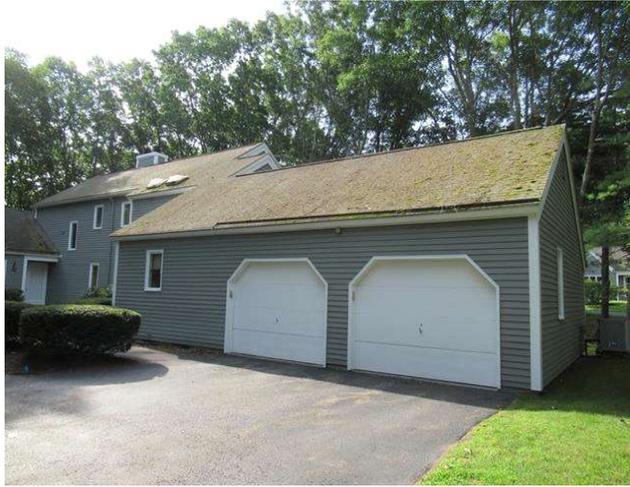
Component budget covers rebuild of asphalt driveways and parking areas including pool parking area. Asphalt is in generally good condition with some cracks observed. Roads are listed separately. Differentiation between roads and driveways not clear in some areas. See additional general comments listed under "Asphalt - Overlay, C".

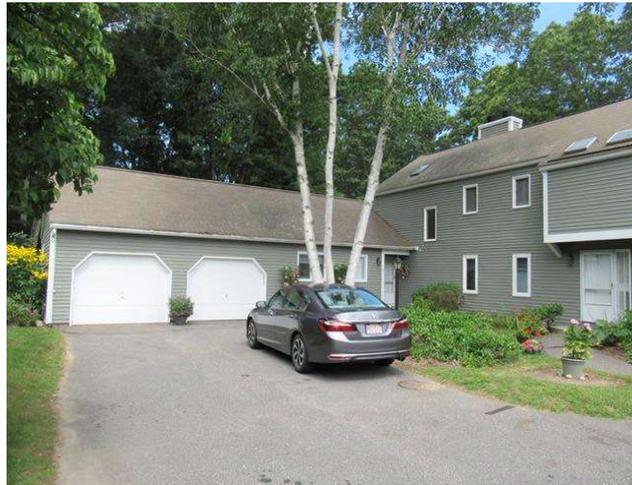
Component budget covers rebuild of asphalt driveways and parking areas. Asphalt is in generally good condition with some cracks observed. Roads are listed separately. Differentiation between roads and driveways not clear in some areas. See additional general comments listed under "Asphalt - Overlay, C".

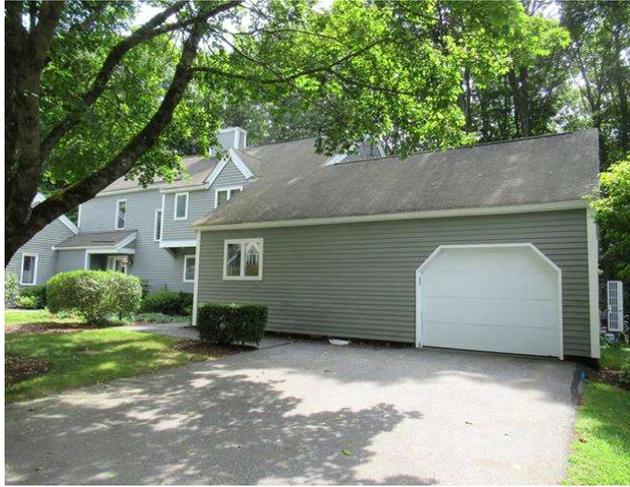
Component budget covers rebuild of asphalt driveways and parking areas. Asphalt is in generally good condition with some cracks observed. Roads are listed separately. Differentiation between roads and driveways not clear in some areas. See additional general comments listed under "Asphalt - Overlay, C".

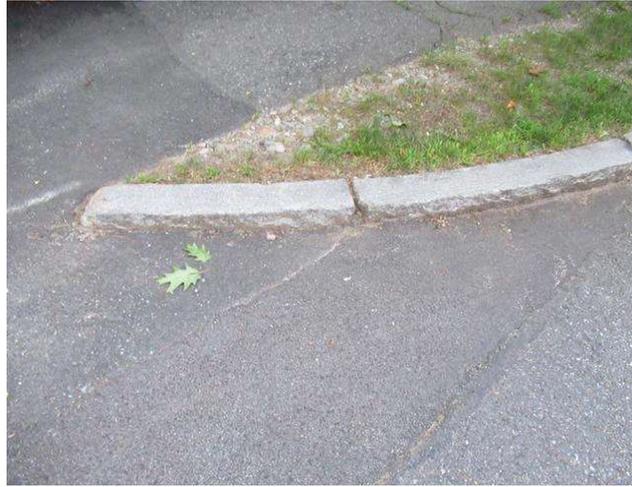
Component covers granite curbing on roadway areas. Curbs were in good condition during site inspection. No damage or displaced sections were observed. Component listed for inventory purposes.

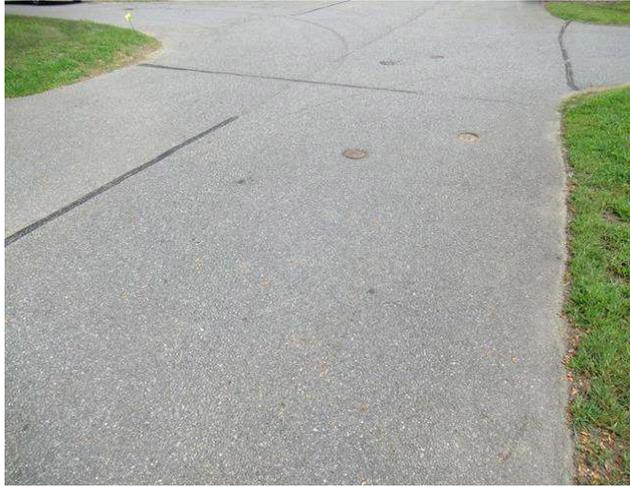
Component budget is for regular maintenance of asphalt areas before asphalt overlay. Three year cycle is recommended due to current pavement condition. Asphalt is in generally good condition. Some cracks and patches in asphalt were evident during site inspection. Most cracks have not been sealed. Component budget should be revised based on association experience as pavement ages.

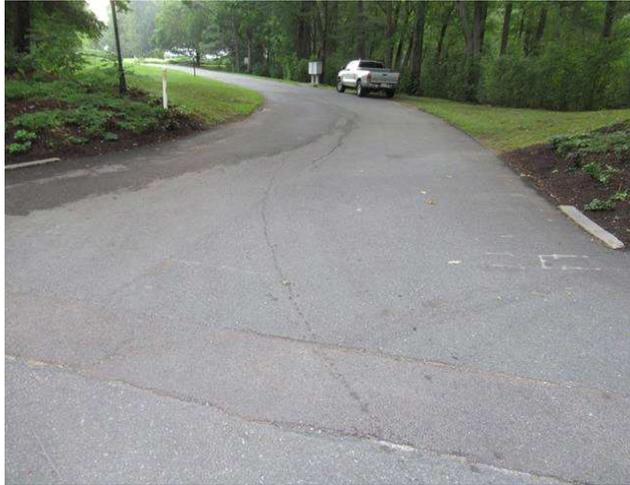
Component budget covers overlay of roadway asphalt areas. Asphalt was installed in 2016, per client, and is in good condition. Some cracks visible at site inspection. Cracks have not been sealed. Driveways are listed separately.

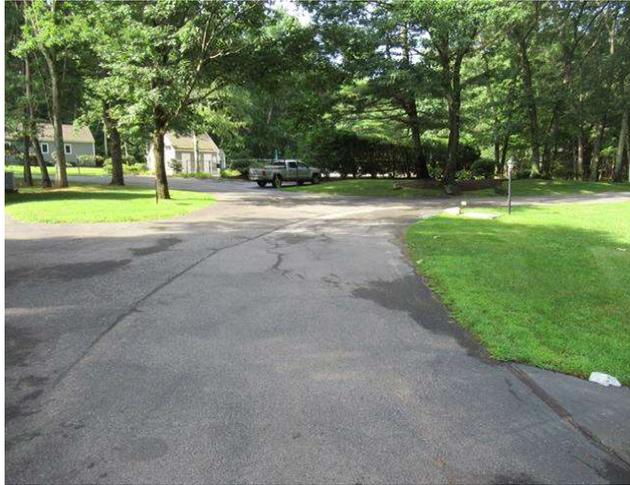
Component budget covers overlay of roadway asphalt road areas. Asphalt was replaced in 2013, per client. Asphalt is in generally good condition. Numerous cracks evident during site inspection. Most cracks have been sealed. Driveways are listed separately. Differentiation between road and driveways not clear in some areas.

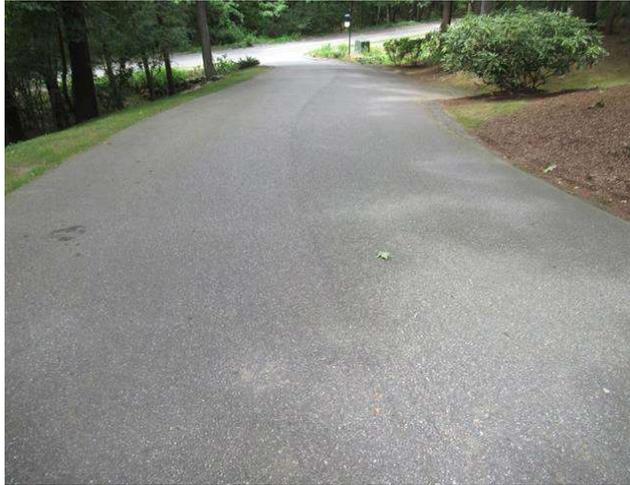
Component budget covers overlay of roadway asphalt road areas. Asphalt was replaced in 2011, per client. Asphalt is in very good condition. Numerous cracks and repairs evident during site inspection. Some cracks have been sealed. Driveways are listed separately. Differentiation between road and driveways not clear in some areas.

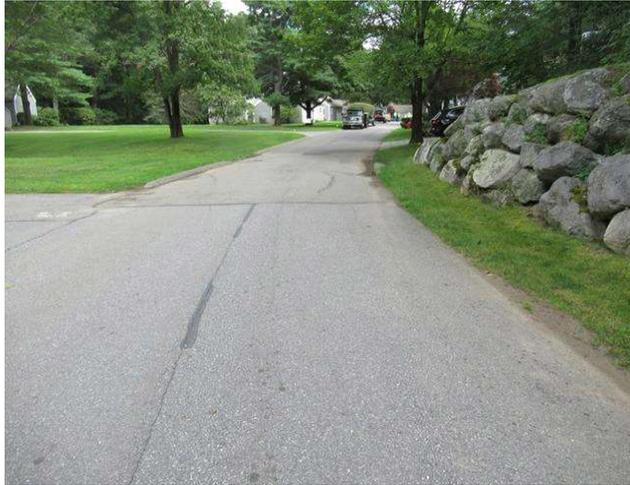
Component budget covers overlay of roadway asphalt road areas. Asphalt was replaced in 2009, per client. Asphalt is in generally good condition. Cracks and prior patch repairs evident during site inspection. Some cracks have been sealed. Driveways are listed separately. Differentiation between road and driveways not clear in some areas.

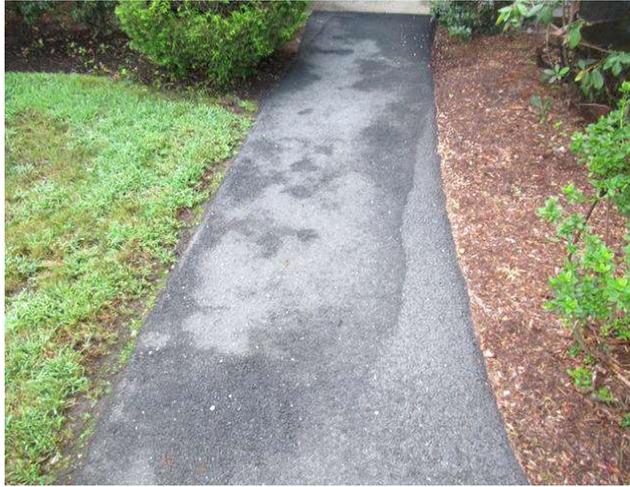
Component budget covers replacement of unit front asphalt walkways. Walks were in generally good condition at site visit. Walks should be evaluated at least annually for safety and repairs should be made immediately. Walkways assumed to have been replaced with street asphalt projects. Average placed-in-service date used.

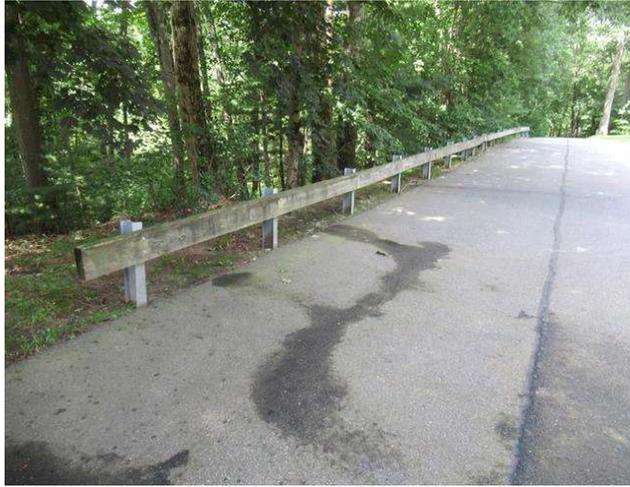
Component budget covers replacement of wood guardrail along roadway opposite S units 16, 17, & 18. Guardrail was in fair condition with one broken section in need of replacement. Several steel posts were leaning, but still generally functional. Wood rails will need replacement more frequently than galvanized steel posts. Useful life based on steel posts. Replace wood rails as needed from operating budget.

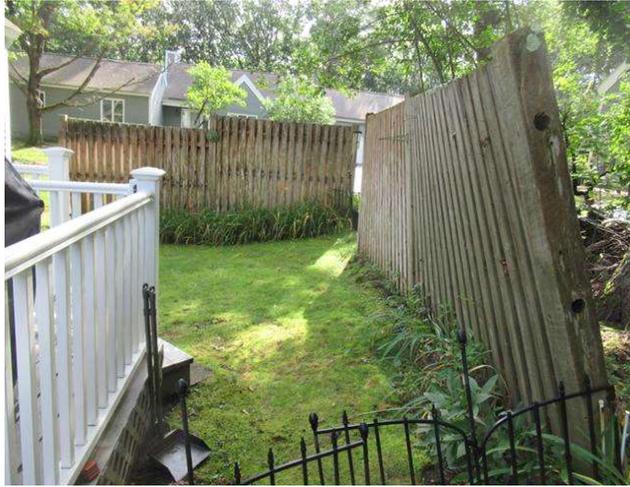
Component budget covers replacement of wood privacy barriers installed in side and rear yards of units. Each 6' tall fence is comprised of 1, 2, or 3 8' long sections. Total number of sections is 23 for a total length of 184'. Barriers were generally in poor condition. Some were leaning and should be repaired. Resetting, cleaning, and sealing wood fences could extend service life. Placed-in-service date per client.

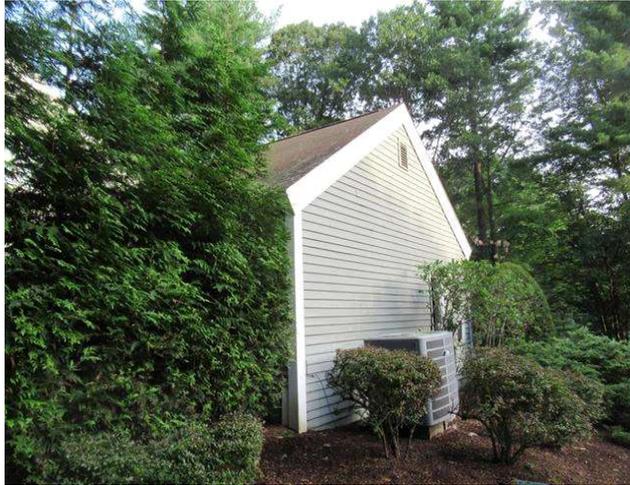
Component budget covers periodic tree removal and installation of new landscaping to replace overgrown plants and trees. Many trees are close to buildings throughout community and will eventually need to be removed. Many trees have recently been removed to reduce shading of roofs. Allowance should be adjusted, based on association experience, in future reserve study updates.

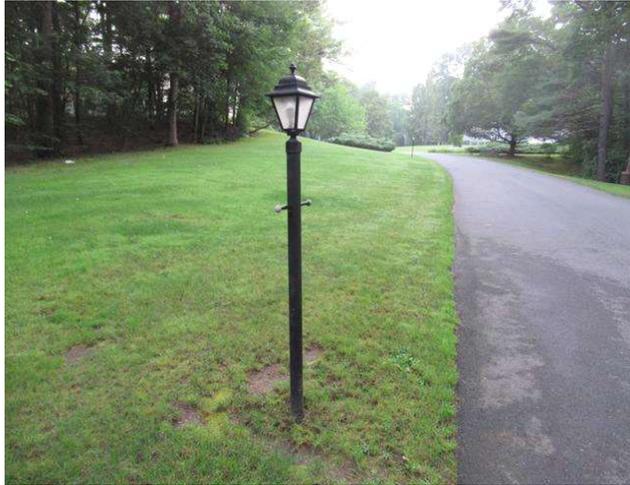
Component budget covers replacement of post lights located throughout community. Post lights were in generally good condition at site visit. New fixtures were installed in 2009, per client. Quantity per client.

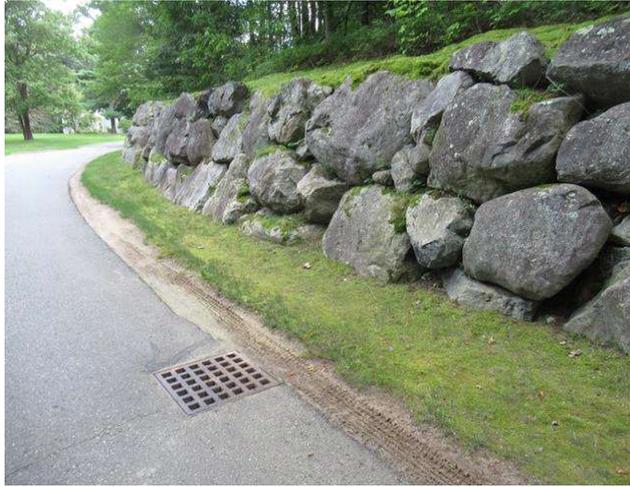
Component budget covers periodic repair and replacement of retaining walls around association. Walls were in generally good condition at site visit. Most walls were stone. A few walls were constructed from pressure-treated wood. Some wood retaining walls were leaning and decaying. Replacement of wood retaining walls will be required in near future. Walls should be evaluated annually and minor repairs funded by operating budget.

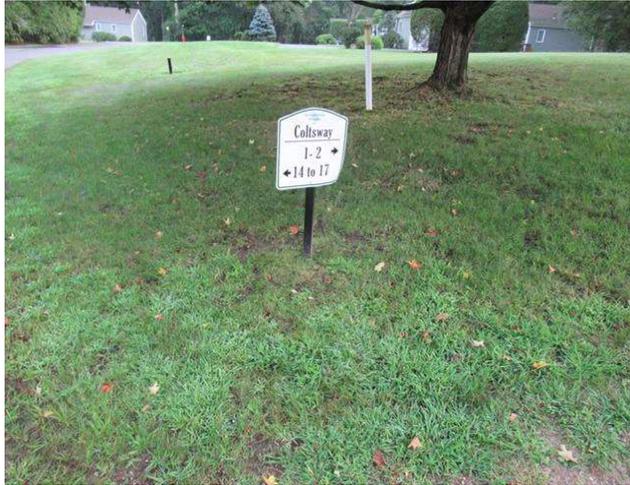
Component budget covers replacement of signs installed in community. Signs were in good condition at site visit. The actual date this component was placed into service is not available. For budgeting purposes, this date has been estimated based on its condition at our most recent site visit.

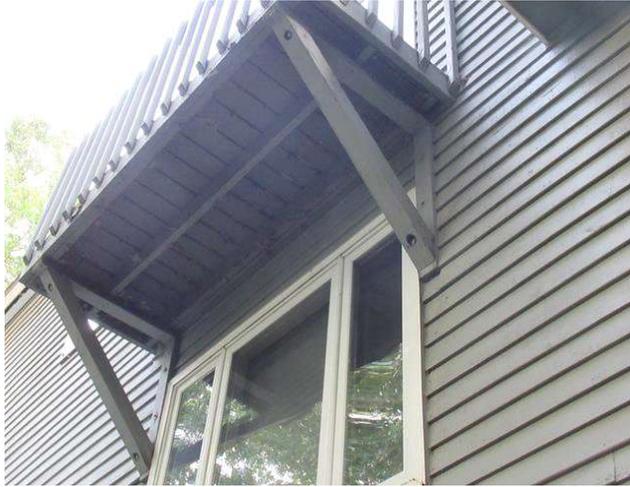
Component budget covers replacement of unit balcony structure only. Unit owners are responsible for railings and deck boards. There were originally 17 balconies, but 3 were replaced with sliding doors and railings by owners. Balcony structures appeared to be in good condition at site visit, but are nearing end of service life for framing. Balconies should be inspected in detail this year to ensure safety and confirm when replacements may be required.

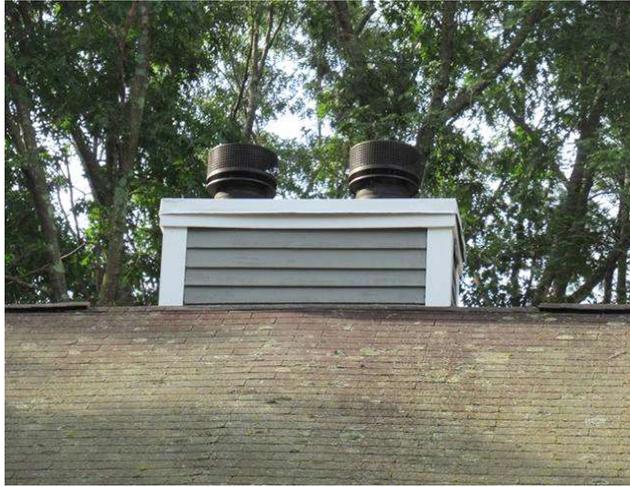
Component budget covers replacement of chimney caps on all buildings. Overall, caps appeared to be in good condition at site visit. Chimney caps were replaced in 2007, per client. Typically, stainless steel caps are recommended. Caps at association are EPDM rubber membrane with a useful life of about 20 years. With maintenance, useful life may be able to be extended. Check with roofing company to confirm. Chimney cap inspections are recommended on annual basis and can be combined with recommended roofing inspections.

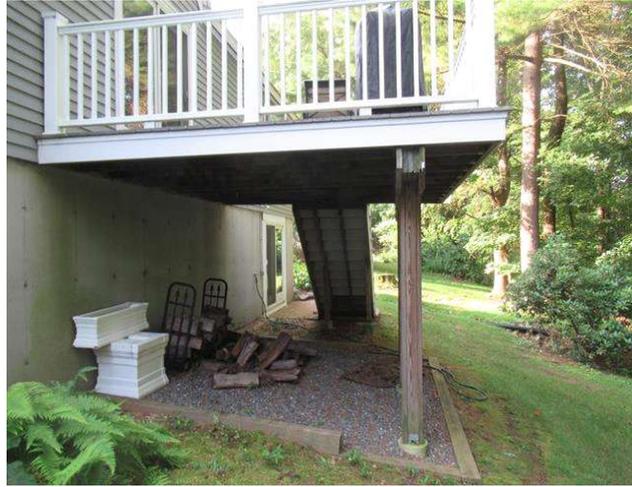
Component budget covers periodic partial replacement of deck and stair structure only on units originally built with decks. Listing of units with original decks is included in master deed. Unit owners are responsible for railings and deck boards. There were originally 23 decks. When unit owners convert decks to screen/glassed in porches owners become responsible for entire structure. For decks that have been enlarged, only the original part is included in component quantity. If the configuration is unclear, quantity is included.

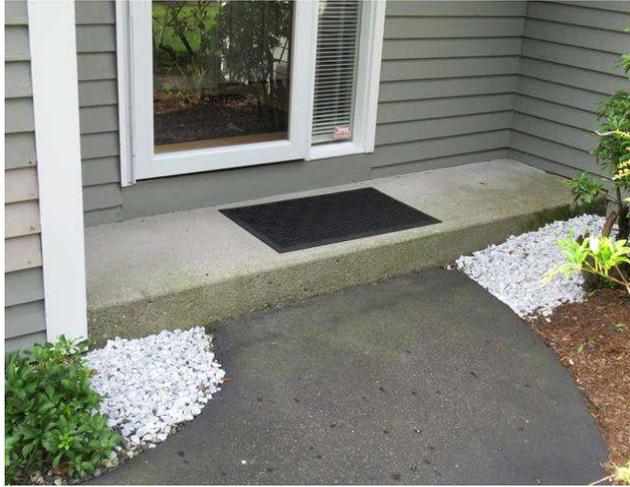
Component budget covers periodic replacement of unit front concrete landings/stoops over time. Landings were in good condition at site visit and no candidates for replacement were noted. Allowance should be revised, based on association experience, in future reserve study updates.

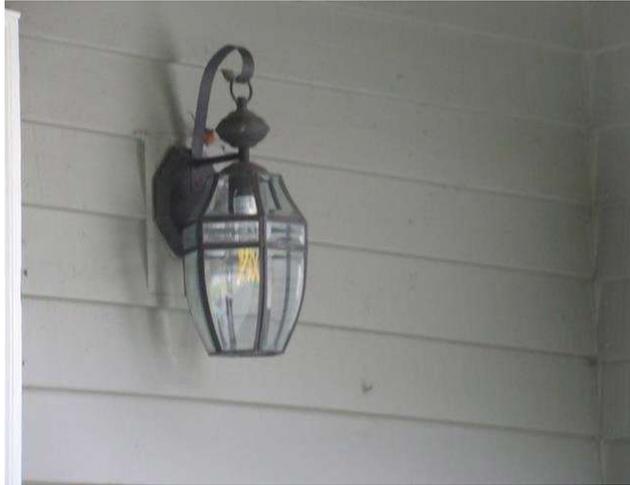
Component budget covers replacement of light fixtures on exterior of units. Fixtures are in generally good to fair condition. Lights are generally installed at exterior doors for each unit. Fixture type and location is inconsistent on some units. Approximate total used.

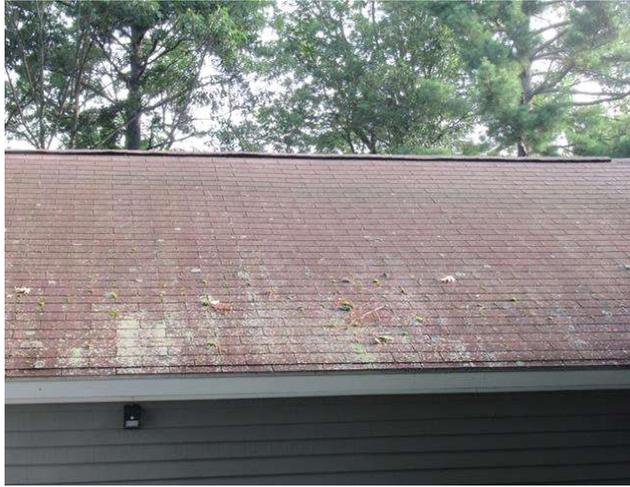
Component budget covers re-roofing association buildings. 3-tab asphalt shingle roofs were installed over existing roofing in 1997, per client. Cost includes removal of 2-layers of old roofing and replacement with architectural roof shingles. Shingles were in poor condition in many areas due to extensive growth of moss, lichen, and algae. Roofs are at end of expected service life. Association is planning to replace roofs in 2023. Cost assumes that current high material costs have begun to abate by the time project starts. Total for Indian Dawn includes pool house.

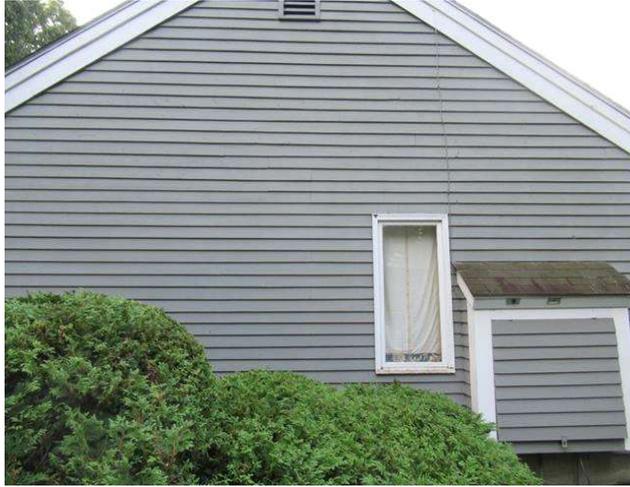
Component budget covers annual repairs of wood clapboard siding and trim on all buildings in association. Overall, siding was in good to fair condition at site visit. Buildings on I were in good condition after repairs and painting. Siding has basic trim details and is uniform throughout the association. Expected annual budget range of \$30,000 - \$40,000 provided by client.

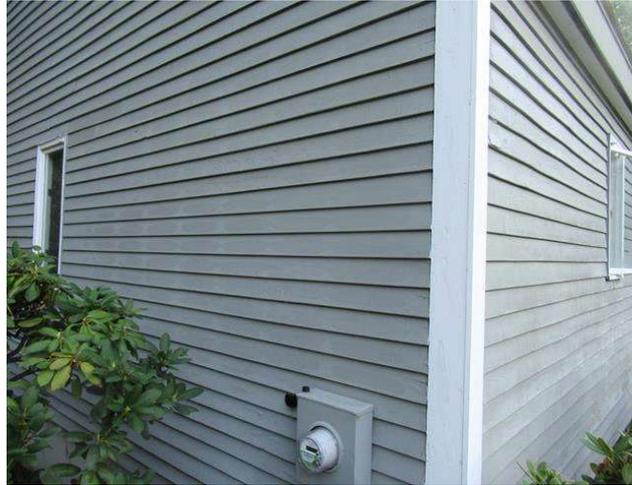
Component budget covers periodic major repairs of wood clapboard siding and trim on all buildings in association. Overall, siding was in good to fair condition at site visit. Siding has basic trim details and is uniform throughout the association. Pool house is included in I total.

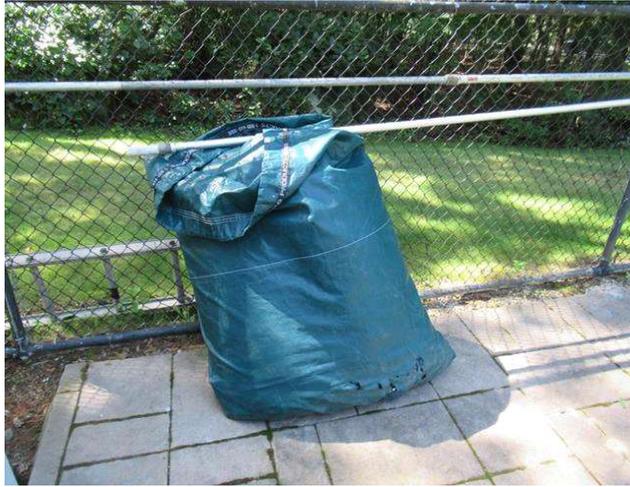
Component budget covers winter pool cover. Cover was stored during site visit. Per client, cover is in fair/adequate condition. Placed-in-service date estimated.

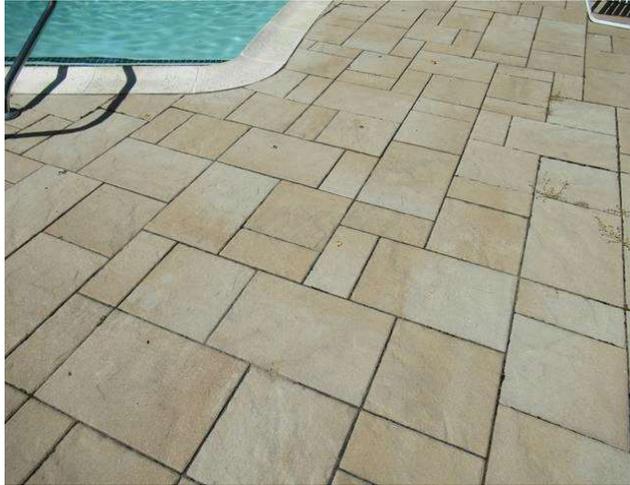
Component budget covers periodic partial re-setting of pool deck concrete pavers. Pool deck was in good condition. Some moss is growing in joints between pavers in shady areas. Paver deck was installed some time after 2015 prior reserve study that indicates poor concrete original pool deck. Irregular pool deck area measurement is approximate. Allowance should be revised, based on association experience, in future reserve study updates.

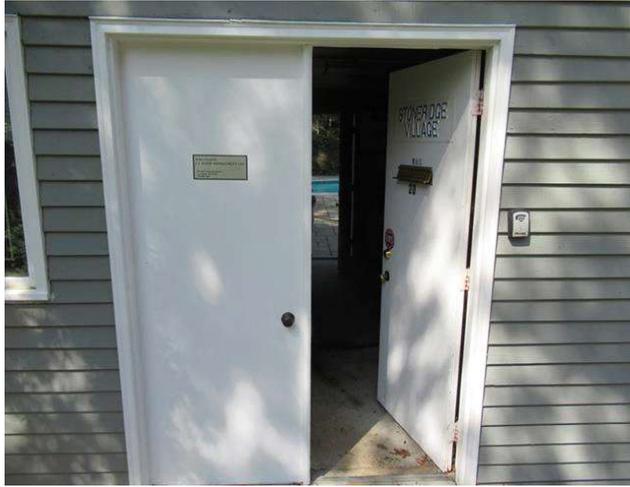
Component periodic budget allowance covers repair/replacement of exterior doors of pool house. Doors were in generally fair condition at site visit. Interior doors are currently unfunded.

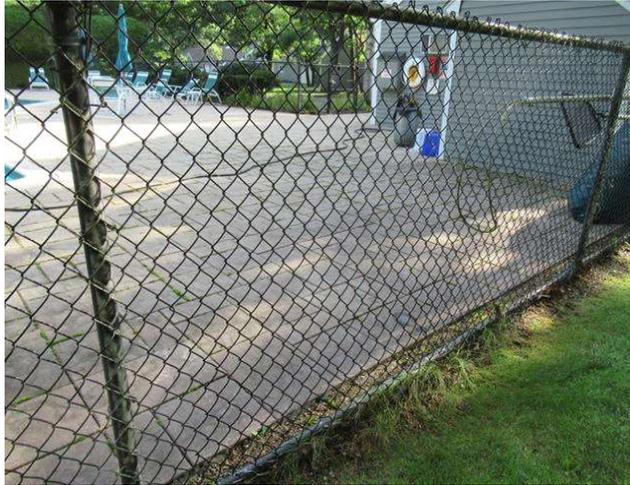
Component budget covers pool chain link fencing. Fencing was fair condition. Fence is functional, but paint is peeling/missing. Fence is original, per client. The remaining life of this component has been extended due to its condition at our most recent site visit.

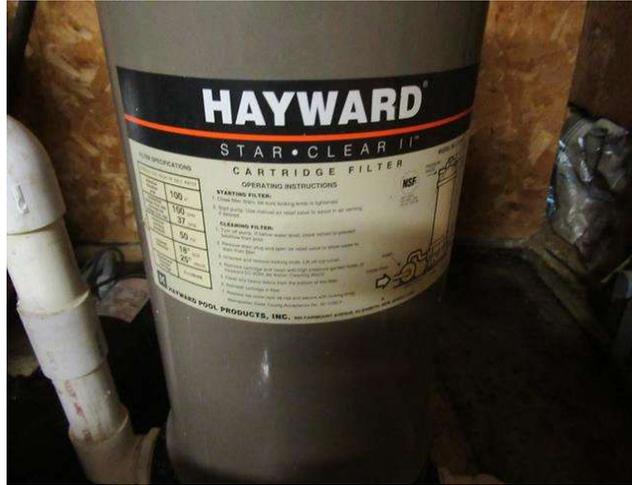
Component budget covers two cartridge pool filters. Filters appeared in good condition. No issues reported. Filters were installed in 1996, per client. The remaining life of this component has been extended due to its condition at our most recent site visit.

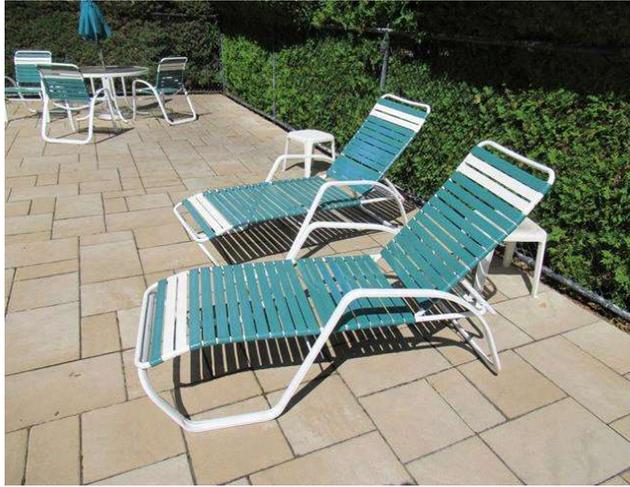
Component budget covers pool furnishings. Furnishings were in generally good condition.

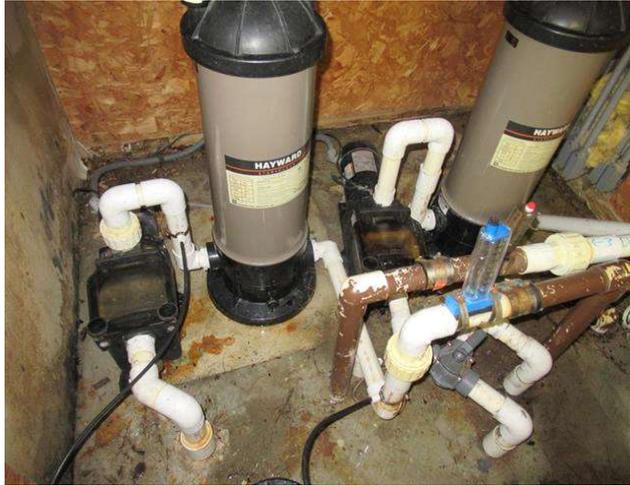
Component budget covers (2) 1 HP Hayward pumps. Pumps appeared to be in good condition at site visit. Component assumes that one pump will be replaced every 4 years.

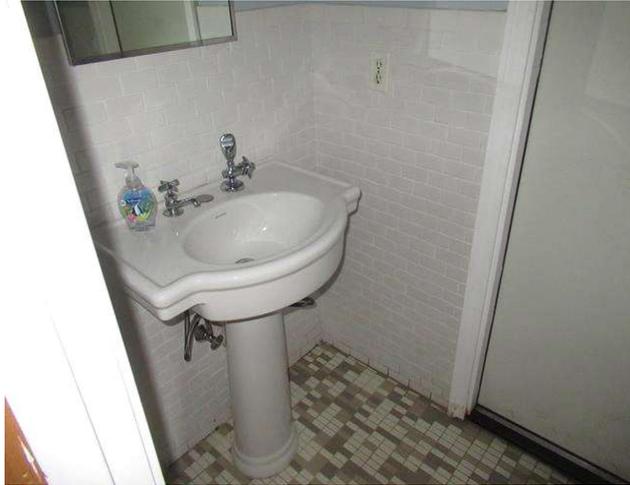
Component budget allowance covers renovation of two pool restrooms. Basic restrooms were in good condition at site visit. Restrooms were renovated in 2016, per client.

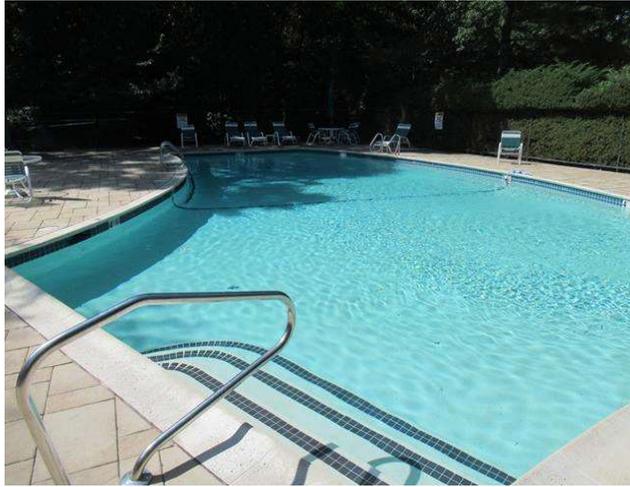
Component budget covers resurfacing pool plaster. Plaster surface, coping, water line tile, and skimmers were replaced in 2010, per client. Plaster surface was in good to fair condition at site visit. Remaining life extended to reflect condition.

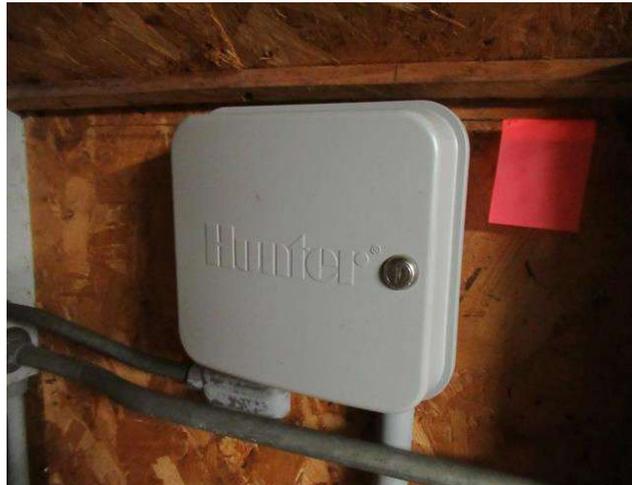
Component budget covers periodic allowance for partial replacement of irrigation system major components: controllers, backflow preventers & zone valves. An irrigation system is installed on each street. Systems on C and L use municipal water supply. Wells supply water for S and I. Allowance should be adjusted based on association experience.

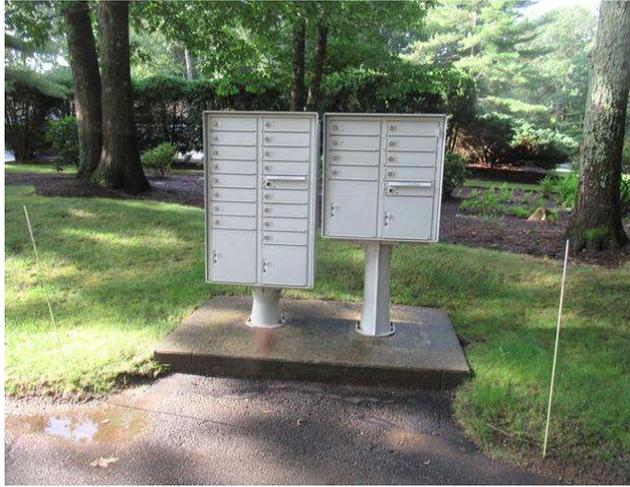
Component budget covers replacement of cluster mailboxes on each street. Mailboxes were in good condition at site visit. Installation in 2004, per client.

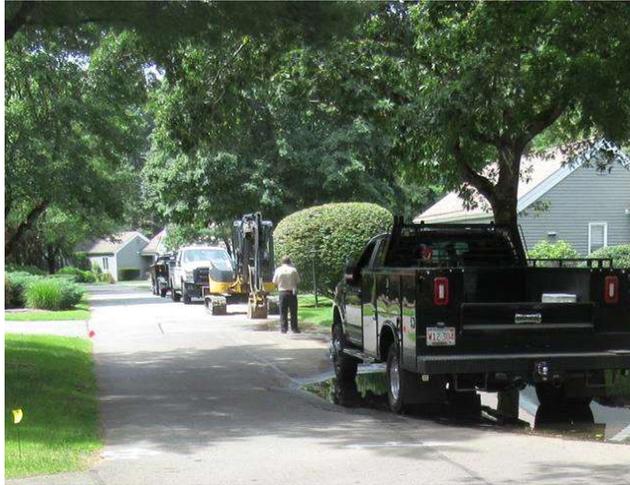
Association has been experiencing multiple municipal water line failures. Pipes are buried deep underground. Repairs are costly, \$10,000 - \$12,000 per incident. Repairs include new piping and asphalt repairs of roads, driveways, and walkways.

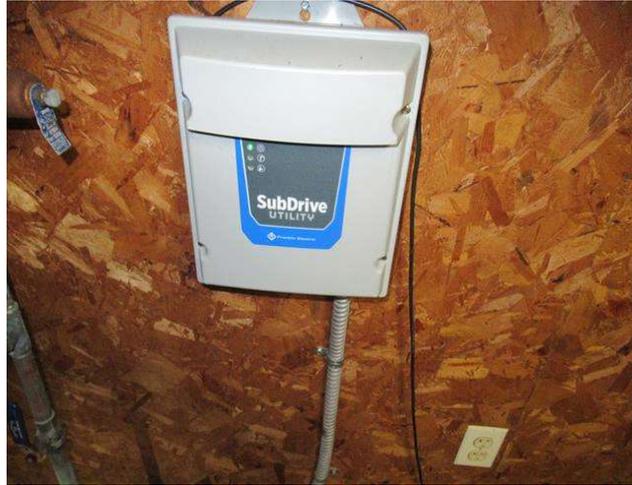
Component budget covers submersible well pumps and controls. Wells supply water for S and I. I well is powered by variable speed pump. The actual date this component was placed into service is not available. For budgeting purposes, this date is assumed to be 15 years after original well was drilled. Useful life increased to 20 years for variable speed pump. Allowance should be adjusted based on association experience.

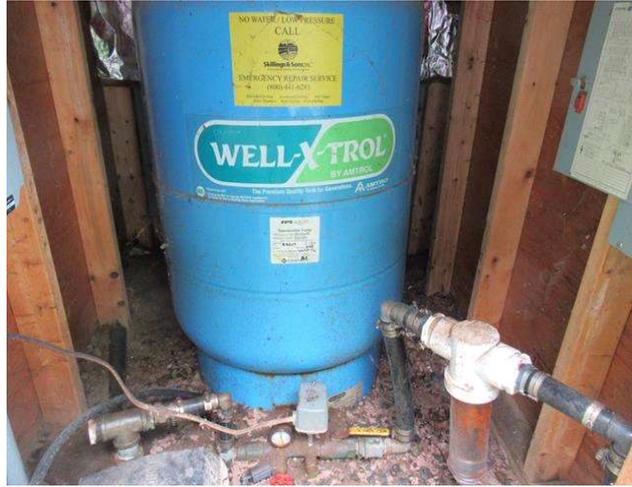
Component budget covers pressure tanks for wells. Wells supply water for S and I. The actual date this component was placed into service is not available. For budgeting purposes, this date has been estimated based on its condition at our most recent site visit.

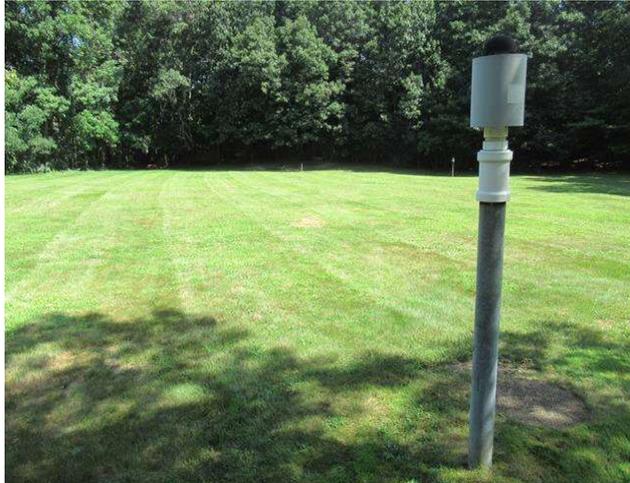
Component budget covers periodic partial replacement of septic system leach fields (soil absorption systems) starting in 2026 when fields are about 47 years old. It is impossible to predict failure with any accuracy. Recent Title V reports did not find any issues with leach fields. For simplicity, single component created for replacement. Component should be modified in future reserve study updates based on experience with septic system replacements.

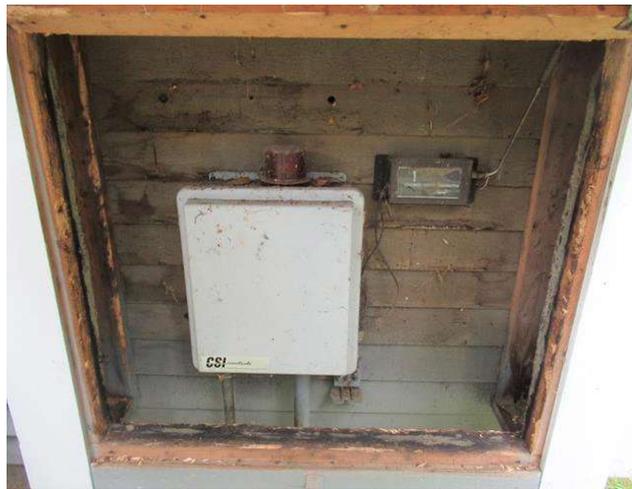
Component budget covers septic lift duplex pumps and controls. No information on pumps available. No issues reported. Pump useful life is typically between 10 and 15 years. Component assumes that one pump system is replaced every 4 years. Allowance should be revised, based on association experience, in future reserve study updates.

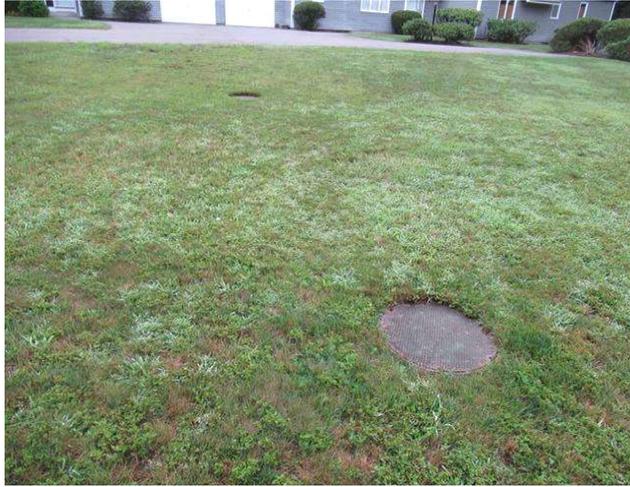
Component budget covers periodic replacement of concrete septic tanks and pump chamber tanks. Tank useful life is typically between 40 years and indefinite. No tank issues reported in Title V reports. A number of concrete distribution boxes have recently been replaced.
