RESERVE ANALYSIS REPORT

Sample Timeshare Association

Sample, New Jersey

January 15, 2018

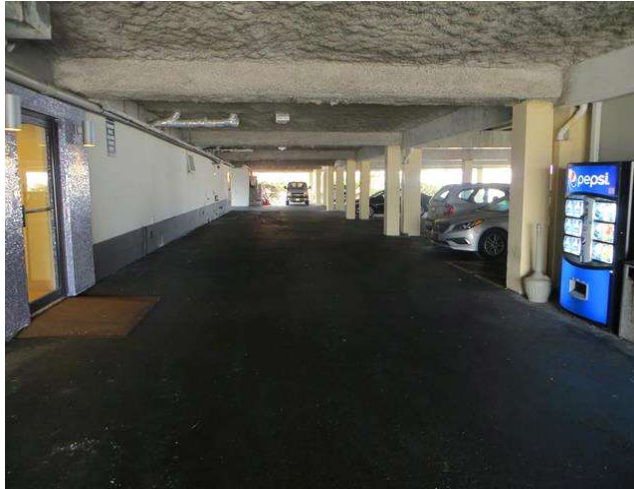
Asphalt was in generally good condition during site visit. Component is for overlay of asphalt areas on 20 year interval. Original 1987 paving was overlaid and restriped in 2006 per client. The actual condition of asphalt areas should be evaluated annually and appropriate repairs performed in a timely manner. Repairs to damaged areas will allow asphalt to achieve the expected useful life.

The current cost for this component was originally provided by prior reserve, and has been adjusted to allow for inflation where applicable. Cost of asphalt is volatile and follows price of oil.

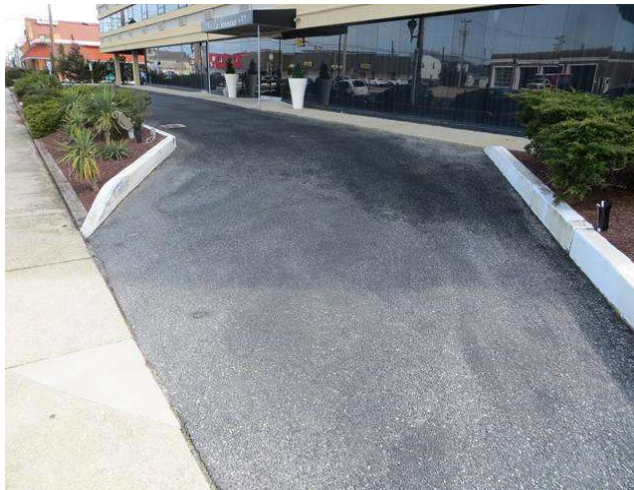
Asphalt, Repairs

A percentage of asphalt areas will require repair or replacement periodically. Component covers minor maintenance on 6 year interval. The actual condition of asphalt areas should be evaluated annually and appropriate repairs performed in a timely manner. Repairs to damaged areas will allow asphalt to achieve the expected useful life.

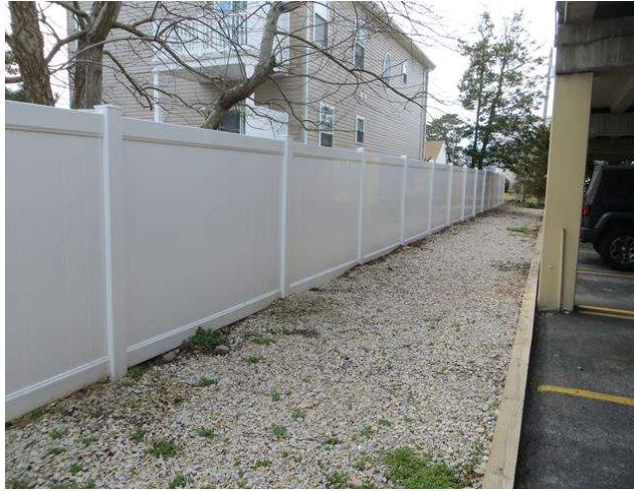
Vinyl fence was installed in 2016 at a cost of \$6500 (\$30.66 per lin. ft.) to replace wood stockade fence at rear of property per client. Linear footage provided by client.

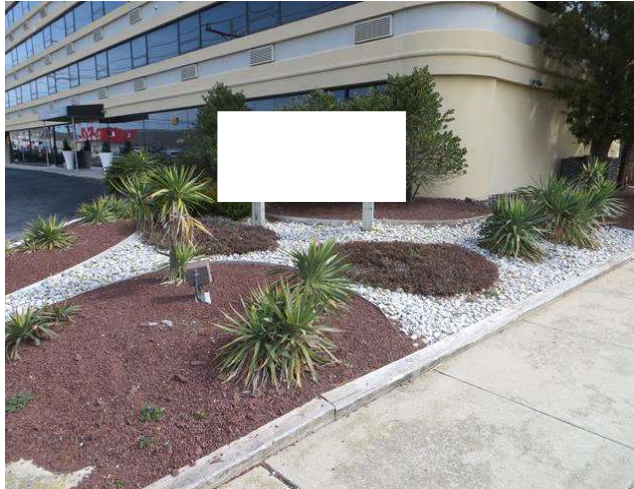
Component covers exterior monument signs. Signs were in acceptable condition during site visit. Useful life extended by 2 years per client.

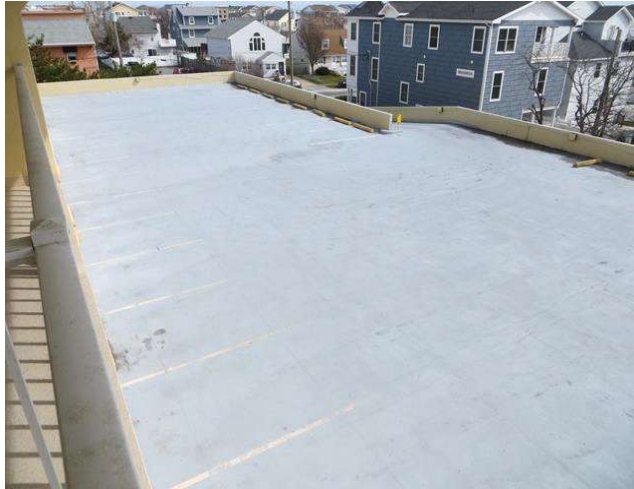
Component is for inspection and reapplication of sealer on 5 year interval. A separate component covers replacement of sealer after 10 years. Parking deck will be resealed for \$50,000 in 2018 per client.

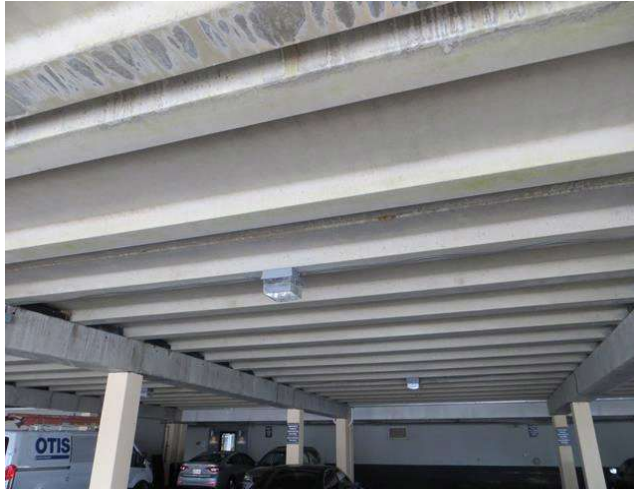
Component is for inspection and repairs on 2 year interval. A separate component covers major replacement after 50 years. Cost for component provided by client.

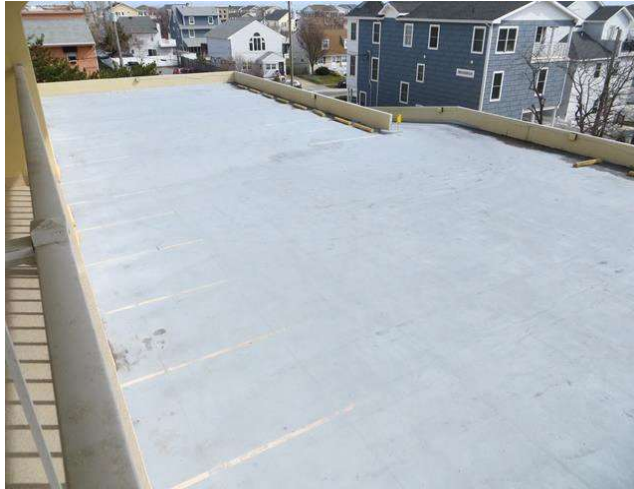
When originally installed in 1987, upper parking level concrete surface was not coated. In 2012, concrete was extensively prepared by grinding and stripping surface. Waterproof Sika sealer was then applied. Component is for replacement of sealer after 15 years. Replacement will not require as much prep work as original installation. A separate component covers inspection and reapplication of sealer on 5 year interval. Replacement interval provided by client.

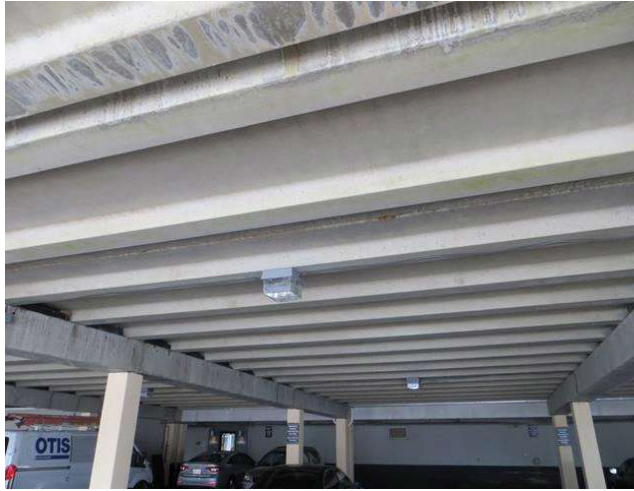
Component covers replacement of original 1987 upper parking level concrete pre-cast slab system. Current experience with pre-cast slabs is good. Client reports no major issues with structure. One area was repaired over the years. Since it is unlikely that entire structure will have to be replaced, replacement percentage set at 50%. Reduction confirmed by client.

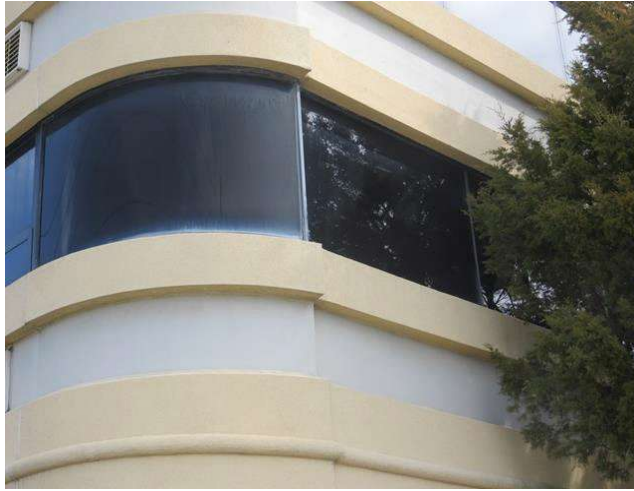
Component covers major maintenance of building exterior including Exterior Finish Insulation System (EIFS) coating on a 10 year cycle.

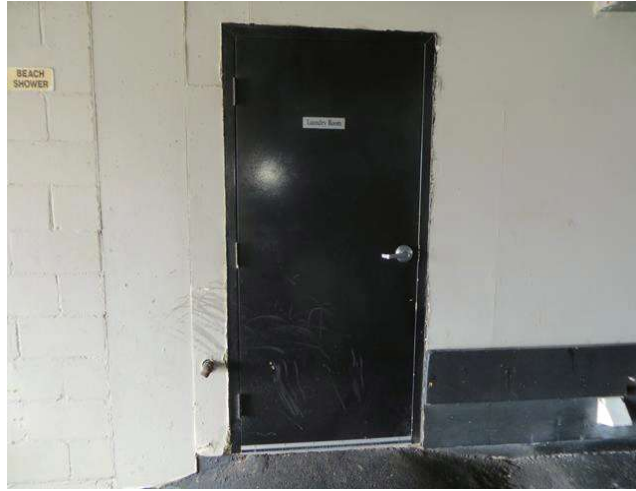
Component covers five exterior fire doors to parking garage. Two doors were replaced in 2016 per client for \$1900 per door. 2010 used as average placed-in service date for budgeting purposes.

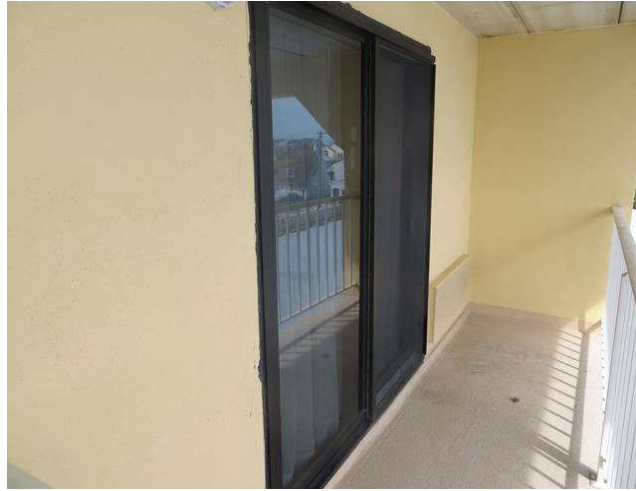
Balcony lights were replaced in 2013 per prior reserve study. Upgrade to LED lighting should be considered.

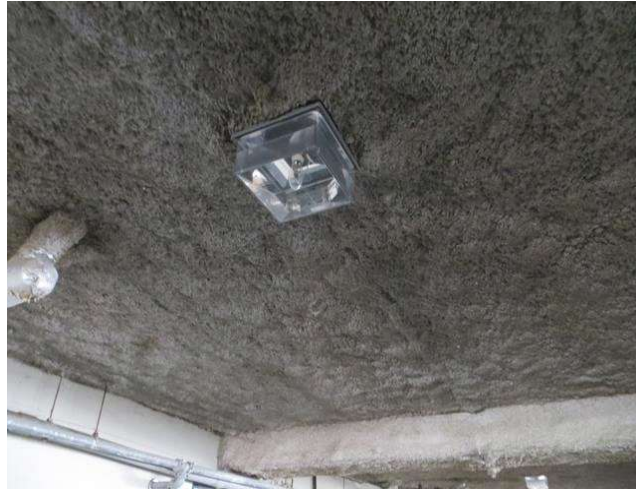
Category	040 Building Exterior	Quantity	18 lights
Photo Date	February 2017	Unit Cost	\$500.000
		% of Replacement	100.00%
		Current Cost	\$9,000.00
Placed In Service	01/04	Future Cost	\$10,135.46
Useful Life	20		
		Assigned Reserves at FYB	\$6,300.00
Remaining Life	6	Monthly Member Contribution	\$39.48
Replacement Year	2024	Monthly Interest Contribution	\$3.75
		Total Monthly Contribution	\$43.23

Lower parking level lights were replaced with in 2004 per prior reserve study.

Fixture cost for this component confirmed by client for LED replacements being considered.
Quantity from prior reserve study.

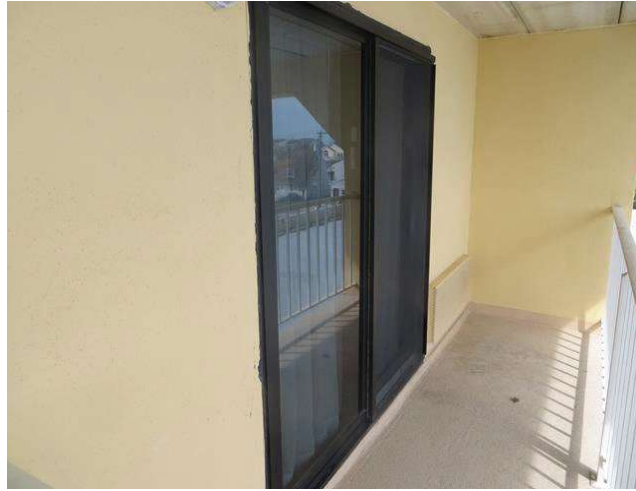
Component covers sliding glass doors onto balconies. Doors were replaced in 2014-2015 for a cost of \$85,000 per client. Quantity from prior reserve study.

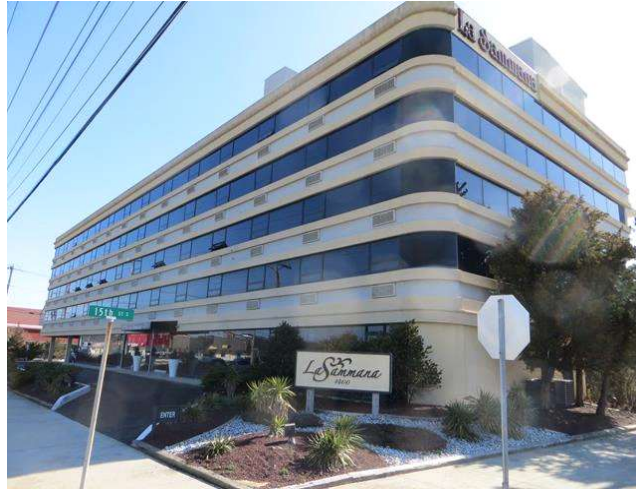
Component cover all building windows replaced in 2014-2015 for a total of \$133,000 per client. Useful life set at 20 years per client.

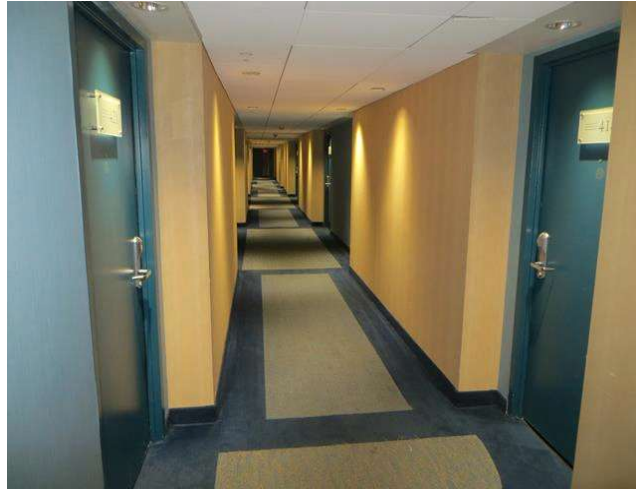
Category	040 Building Interior	Quantity	1 total
Photo Date	February 2017	Unit Cost	\$55,000.00
		% of Replacement	100.00%
		Current Cost	\$55,000.00
Placed In Service	01/17	Future Cost	\$65,730.09
Useful Life	10		
		Assigned Reserves at FYB	\$0.00
Remaining Life	9	Monthly Member Contribution	\$465.98
Replacement Year	2027	Monthly Interest Contribution	\$1.71
		Total Monthly Contribution	\$467.69

Client replaced (4) guest room floor corridor carpets in 2017-2018 for \$55,000.

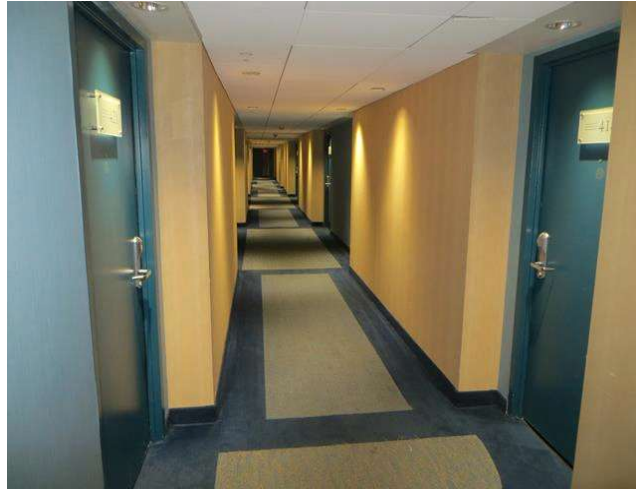
Ceiling tile was in good condition during site visit. No quantity listed in prior reserve study.

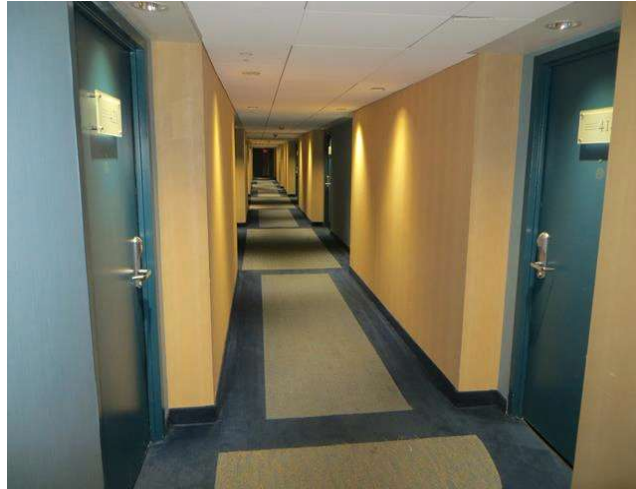
Component cover replacement of corridor light fixtures only. Replacement with LED fixtures being considered by client. Current fixtures have non-standard lamp base.

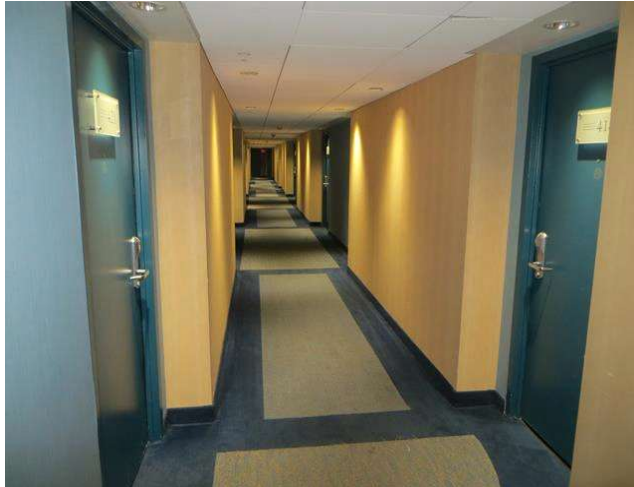
Category	040 Building Interior	Quantity	1 total
Photo Date	February 2017	Unit Cost	\$42,000.00
		% of Replacement	100.00%
		Current Cost	\$42,000.00
Placed In Service	01/17	Future Cost	\$50,193.89
Useful Life	10		
		Assigned Reserves at FYB	\$0.00
Remaining Life	9	Monthly Member Contribution	\$355.84
Replacement Year	2027	Monthly Interest Contribution	\$1.31
		Total Monthly Contribution	\$357.15

Client renovated (4) guest room floor corridor wall coverings in 2017-2018 for \$42,000. Painting guest room doors and jambs is included.

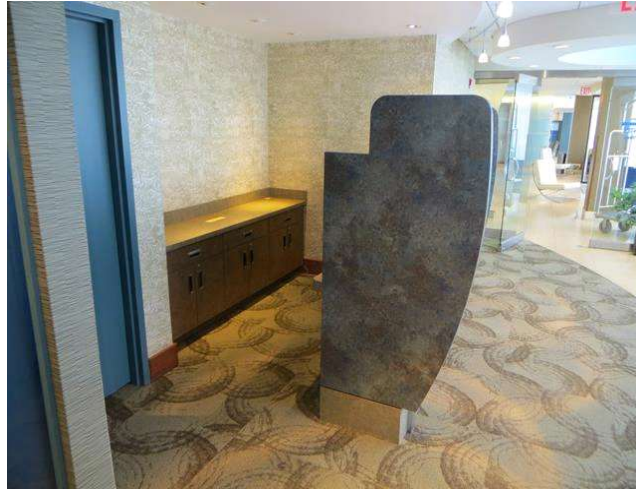
Category	040 Building Interior	Quantity	1 total
Photo Date	February 2017	Unit Cost	\$2,300.00
		% of Replacement	100.00%
		Current Cost	\$2,300.00
Placed In Service	01/15	Future Cost	\$2,641.98
Useful Life	10		
		Assigned Reserves at FYB	\$690.00
Remaining Life	7	Monthly Member Contribution	\$17.95
Replacement Year	2025	Monthly Interest Contribution	\$0.46
		Total Monthly Contribution	\$18.41

Carpet behind front desk installed in 2015 per client. This component does not include carpet in business center.

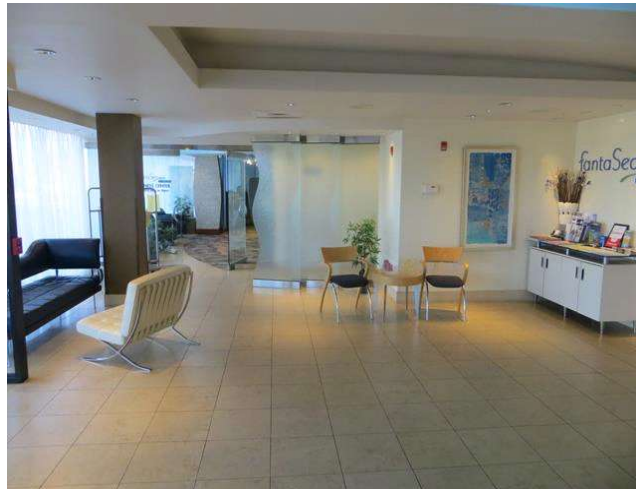
Category	040 Building Interior	Quantity	1 total
Photo Date	February 2017	Unit Cost	\$7,400.00
		% of Replacement	100.00%
		Current Cost	\$7,400.00
Placed In Service	01/04	Future Cost	\$8,333.60
Useful Life	20		
		Assigned Reserves at FYB	\$5,180.00
Remaining Life	6	Monthly Member Contribution	\$32.46
Replacement Year	2024	Monthly Interest Contribution	\$3.07
		Total Monthly Contribution	\$35.53

Tile installed in 2004 per prior reserve study. Replacement cost in 2012 \$6200 per prior reserve study. No quantity listed for updated unit pricing.

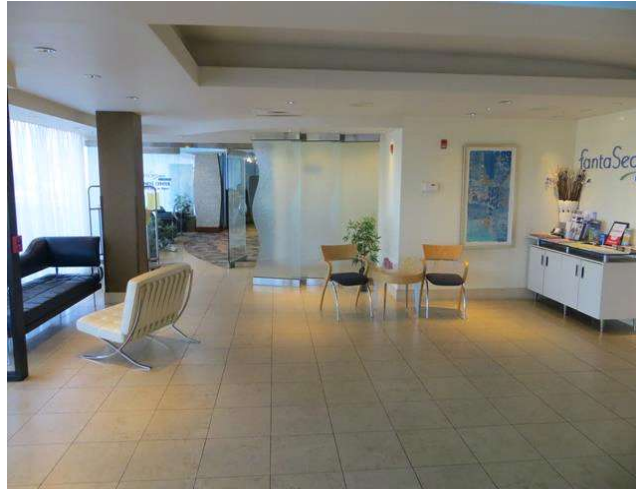
Category	040 Building Interior	Quantity	1 total
Photo Date	February 2017	Unit Cost	\$10,000.00
		% of Replacement	100.00%
		Current Cost	\$10,000.00
Placed In Service	01/03	Future Cost	\$13,458.68
Useful Life	15		
		Assigned Reserves at FYB	\$10,000.00
Remaining Life	0	Monthly Member Contribution	\$52.77
Replacement Year	2018	Monthly Interest Contribution	\$0.20
		Total Monthly Contribution	\$52.97

Wall covering in lobby was not included in 2013 lobby renovation.
 Wall covering will be replaced at a cost of \$10,000 in 2018 per client.

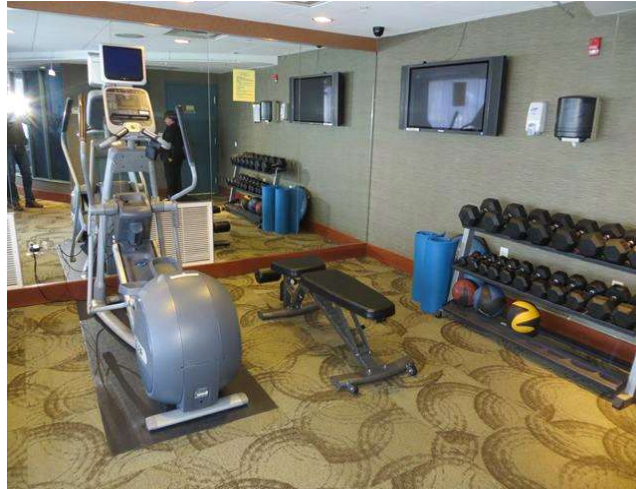
Category	040 Building Interior	Quantity	1 total
Photo Date	February 2017	Unit Cost	\$7,000.00
		% of Replacement	100.00%
		Current Cost	\$7,000.00
Placed In Service	01/14	Future Cost	\$7,883.14
Useful Life	10		
		Assigned Reserves at FYB	\$2,800.00
Remaining Life	6	Monthly Member Contribution	\$54.96
Replacement Year	2024	Monthly Interest Contribution	\$1.80
		Total Monthly Contribution	\$56.76

Carpet was replaced in 2014 at a cost of \$6300 per client.

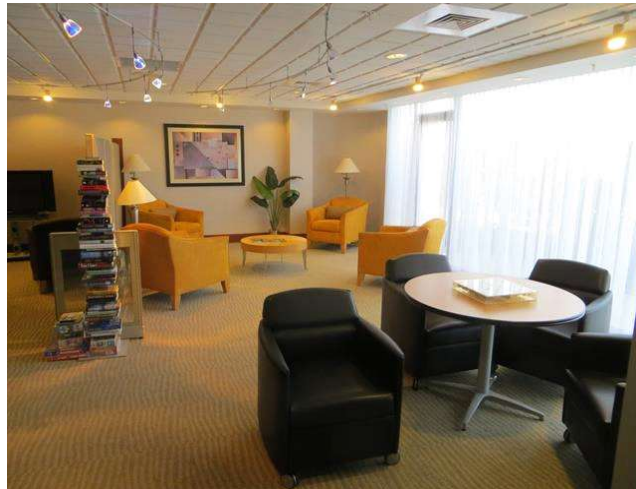
Category	040 Building Interior	Quantity	1 total
Photo Date	February 2017	Unit Cost	\$7,000.00
		% of Replacement	100.00%
		Current Cost	\$7,000.00
		Future Cost	\$8,201.62
Placed In Service	01/04	Assigned Reserves at FYB	\$7,000.00
Useful Life	8	Monthly Member Contribution	\$66.30
Adjustment	+6	Monthly Interest Contribution	\$0.24
Remaining Life	0	Total Monthly Contribution	\$66.55
Replacement Year	2018

Owner's lounge carpet will be replaced in 2018 per client.

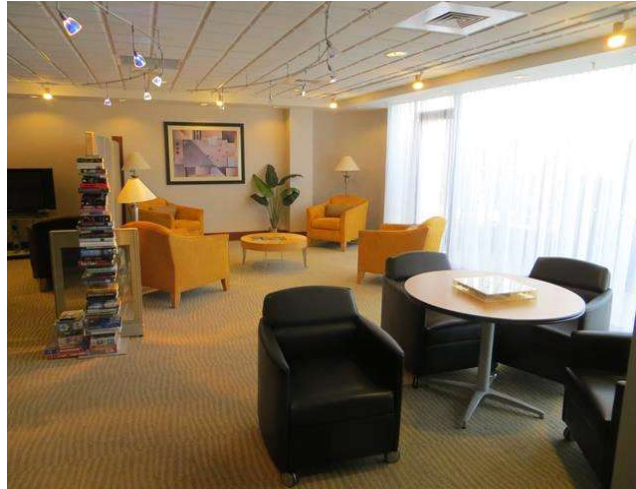
Ceiling tile was in good condition during site visit. No quantity listed in prior reserve study.

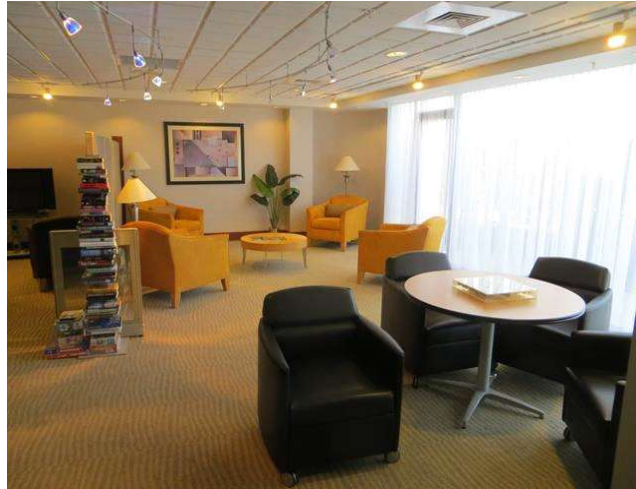
Furniture was in good condition during site visit. Owner's lounge furniture will be replaced in 2022 per client. No component for furniture listed in prior reserve study. Cost provided by client.

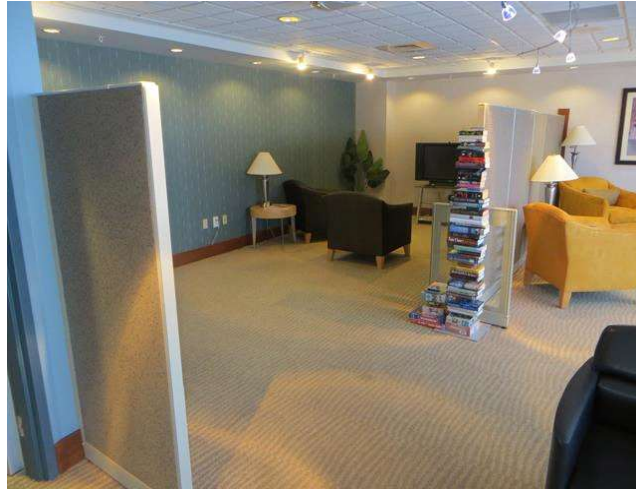
Category	040 Building Interior	Quantity	1 total
Photo Date	February 2017	Unit Cost	\$8,000.000
		% of Replacement	100.00%
		Current Cost	\$8,000.00
		Future Cost	\$8,659.46
Placed In Service	01/04	Assigned Reserves at FYB	\$6,222.22
Useful Life	10	Monthly Member Contribution	\$38.57
Adjustment	+8	Monthly Interest Contribution	\$3.70
Remaining Life	4	Total Monthly Contribution	\$42.27
Replacement Year	2022

Wall covering scheduled for replacement with furniture in 2022. The current cost for this component provided by client. No quantity listed in prior reserve study.

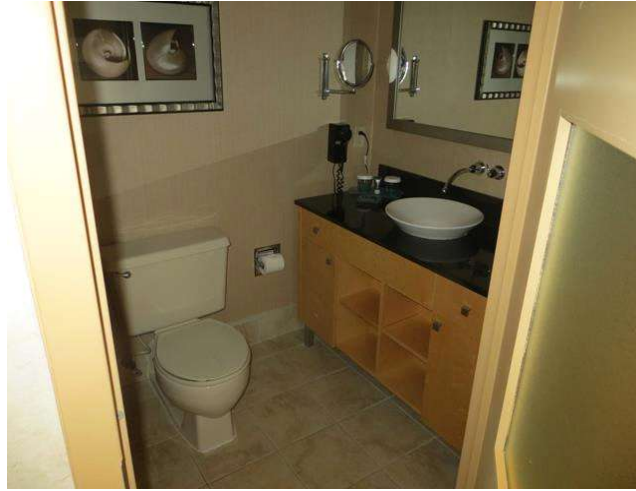
Category	060 Units	Quantity	103 LED lights
Photo Date	February 2017	Unit Cost	\$100.000
		% of Replacement	100.00%
		Current Cost	\$10,300.00
Placed In Service	01/08	Future Cost	\$12,555.64
Useful Life	10		
		Assigned Reserves at FYB	\$10,300.00
Remaining Life	0	Monthly Member Contribution	\$79.03
Replacement Year	2018	Monthly Interest Contribution	\$0.29
		Total Monthly Contribution	\$79.33

Component covers unit bathroom lighting. Per client, 103 lights will be replaced in 2018 at \$100 each. Useful life set at 10 years per client.

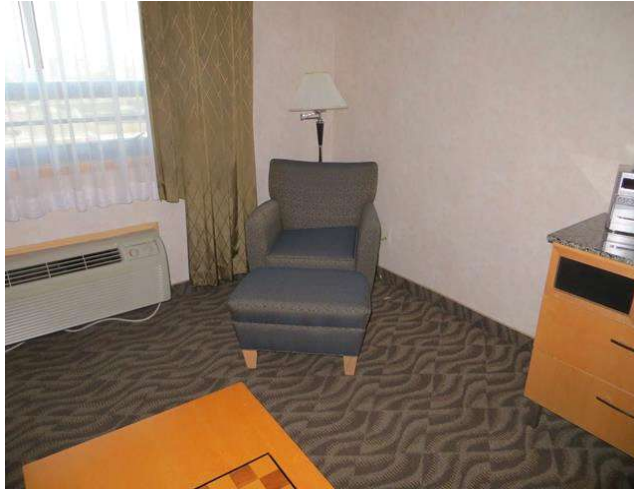
Category	060 Units	Quantity	1 units single floor
Photo Date	February 2017	Unit Cost	\$58,500.00
		% of Replacement	100.00%
		Current Cost	\$58,500.00
Placed In Service	01/15	Future Cost	\$67,198.11
Useful Life	10		
		Assigned Reserves at FYB	\$17,550.00
Remaining Life	7	Monthly Member Contribution	\$456.68
Replacement Year	2025	Monthly Interest Contribution	\$11.70
		Total Monthly Contribution	\$468.37

Carpets were replaced in units per floor at a cost of \$55,000 per client.

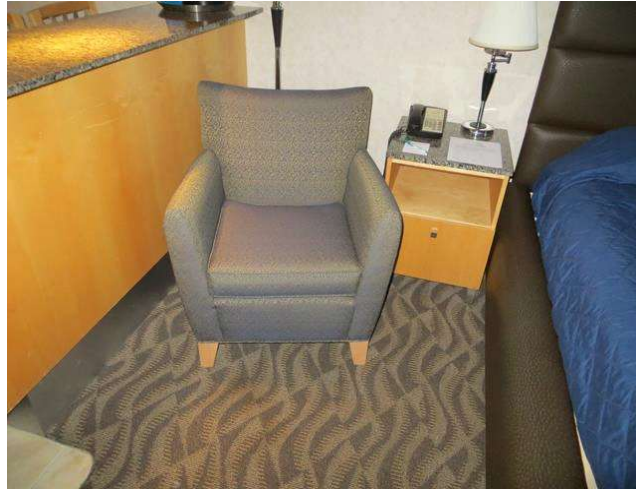
Category	060 Units	Quantity	1 units single floor
Photo Date	February 2017	Unit Cost	\$57,250.00
		% of Replacement	100.00%
		Current Cost	\$57,250.00
Placed In Service	01/16	Future Cost	\$67,077.50
Useful Life	10		
		Assigned Reserves at FYB	\$0.00
Remaining Life	8	Monthly Member Contribution	\$542.25
Replacement Year	2026	Monthly Interest Contribution	\$1.99
		Total Monthly Contribution	\$544.24

Carpets were replaced in units per floor at a cost of \$55,000 per client.

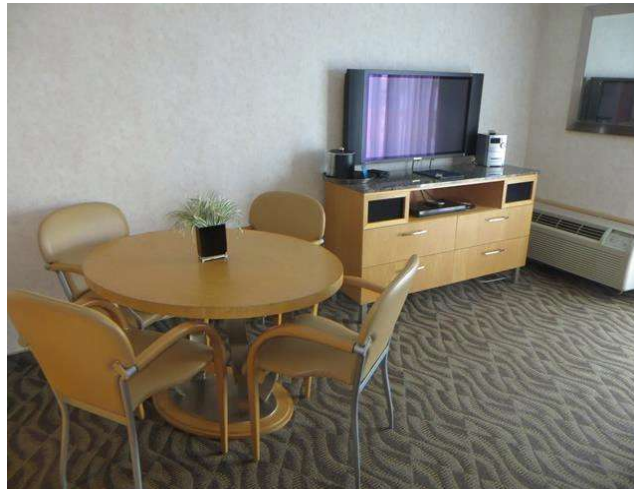
Category	060 Units	Quantity	1 units single floor
Photo Date	February 2017	Unit Cost	\$60,000.00
		% of Replacement	100.00%
		Current Cost	\$60,000.00
Placed In Service	01/14	Future Cost	\$67,569.75
Useful Life	10		
		Assigned Reserves at FYB	\$24,000.00
Remaining Life	6	Monthly Member Contribution	\$471.08
Replacement Year	2024	Monthly Interest Contribution	\$15.43
		Total Monthly Contribution	\$486.51

Carpets were replaced in units per floor at a cost of \$55,000 per client.

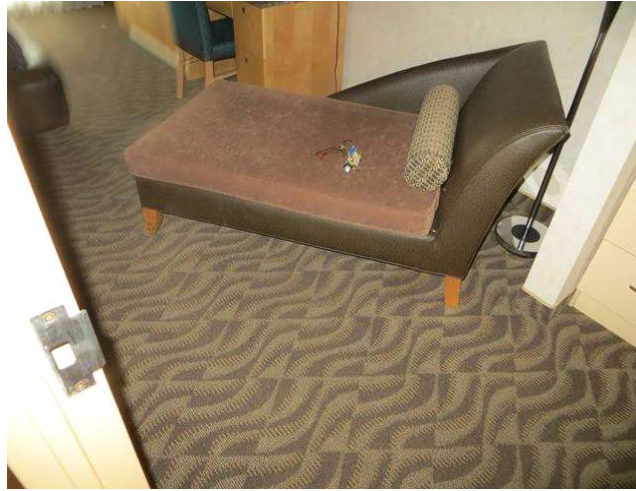
Category	060 Units	Quantity	1 units single floor
Photo Date	February 2017	Unit Cost	\$61,000.00
		% of Replacement	100.00%
		Current Cost	\$61,000.00
Placed In Service	01/13	Future Cost	\$67,348.93
Useful Life	10		
		Assigned Reserves at FYB	\$30,500.00
Remaining Life	5	Monthly Member Contribution	\$481.67
Replacement Year	2023	Monthly Interest Contribution	\$19.18
		Total Monthly Contribution	\$500.85

Carpets were replaced in units per floor at a cost of \$55,000 per client.

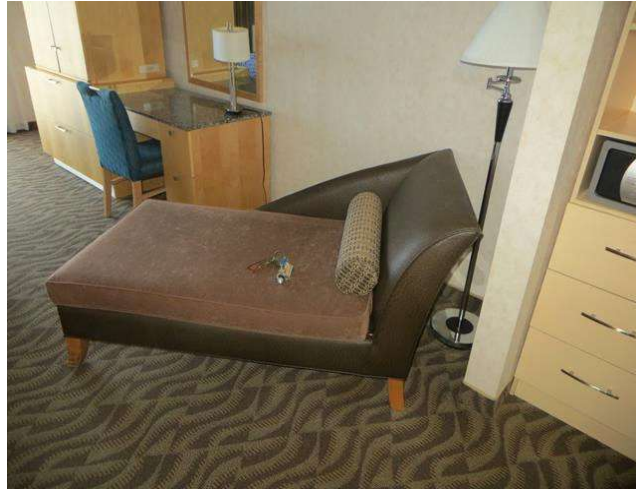
Category	060 Units	Quantity	1 allowance
Photo Date	February 2017	Unit Cost	\$50,000.00
		% of Replacement	100.00%
		Current Cost	\$50,000.00
Placed In Service	01/07	Future Cost	\$51,000.00
Useful Life	12		
		Assigned Reserves at FYB	\$45,833.33
Remaining Life	1	Monthly Member Contribution	\$344.28
Replacement Year	2019	Monthly Interest Contribution	\$27.43
		Total Monthly Contribution	\$371.72

Component cover furniture replacment allowance over three years.
 Prior furniture from 2005 renovation per client.
 Useful life of 12 years per client experience

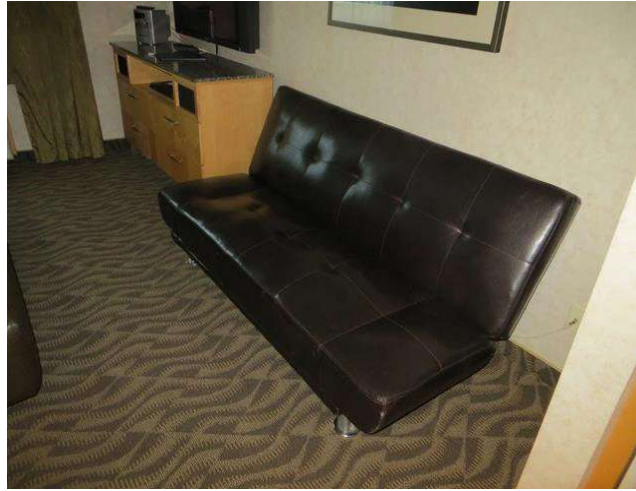
Category	060 Units	Quantity	1 allowance
Photo Date	February 2017	Unit Cost	\$50,000.00
		% of Replacement	100.00%
		Current Cost	\$50,000.00
Placed In Service	01/08	Future Cost	\$52,020.00
Useful Life	12		
		Assigned Reserves at FYB	\$41,666.67
Remaining Life	2	Monthly Member Contribution	\$342.38
Replacement Year	2020	Monthly Interest Contribution	\$25.04
		Total Monthly Contribution	\$367.42

Component cover furniture replacment allowance over three years.
 Prior furniture from 2005 renovation per client.
 Useful life of 12 years per client experience

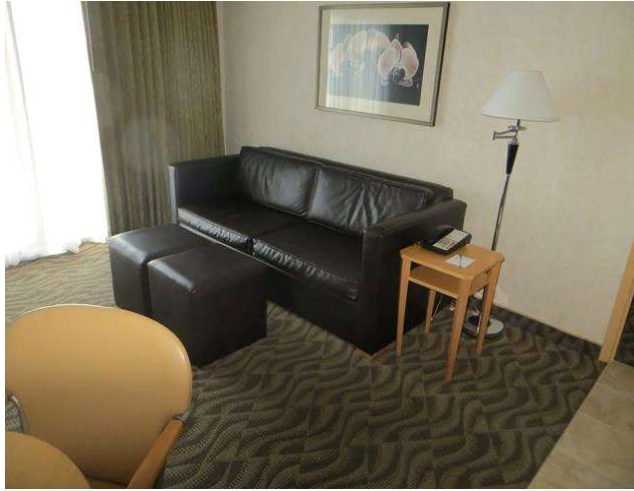
Category	060 Units	Quantity	1 allowance
Photo Date	February 2017	Unit Cost	\$50,000.00
		% of Replacement	100.00%
		Current Cost	\$50,000.00
Placed In Service	01/09	Future Cost	\$53,060.40
Useful Life	12		
		Assigned Reserves at FYB	\$37,500.00
Remaining Life	3	Monthly Member Contribution	\$340.47
Replacement Year	2021	Monthly Interest Contribution	\$22.65
		Total Monthly Contribution	\$363.13

Component cover furniture replacment allowance over three years.
 Prior furniture from 2005 renovation per client.
 Useful life of 12 years per client experience

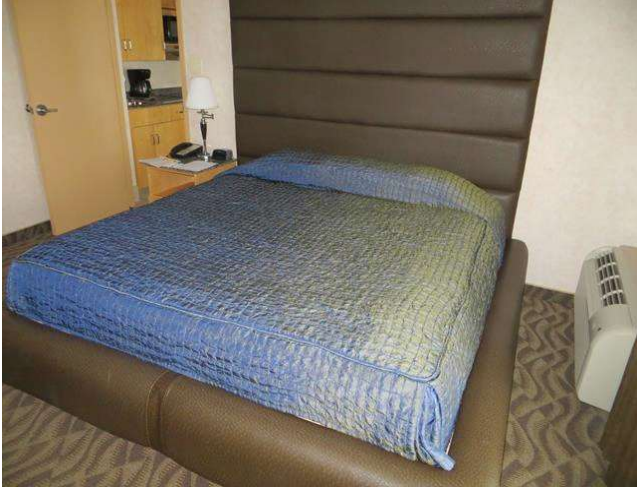
Category	060 Units	Quantity	12 mattresses
Photo Date	February 2017	Unit Cost	\$360.000
		% of Replacement	100.00%
		Current Cost	\$4,320.00
Placed In Service	01/13	Future Cost	\$4,769.63
Useful Life	5		
		Assigned Reserves at FYB	\$4,320.00
Remaining Life	0	Monthly Member Contribution	\$64.24
Replacement Year	2018	Monthly Interest Contribution	\$0.23
		Total Monthly Contribution	\$64.47

Component covers replacing 12 mattresses per year for 4 years and then repeating cycle starting every 5 years. Average current cost for mattress is \$360.

History:
 In 2016, (12) mattresses were replaced:
 - (6) king size @ \$400
 - (6) queen size @ \$320
 Tax not included in pricing.
 Same quantities were replaced in 2015.

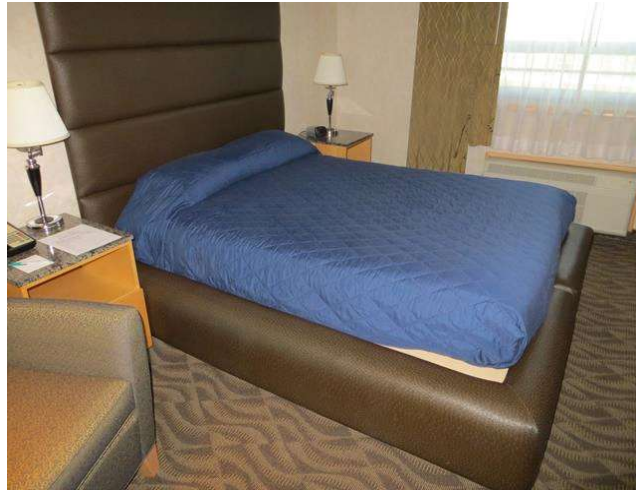
Category	060 Units	Quantity	12 mattresses
Photo Date	February 2017	Unit Cost	\$360.000
		% of Replacement	100.00%
		Current Cost	\$4,320.00
Placed In Service	01/14	Future Cost	\$4,406.40
Useful Life	5		
		Assigned Reserves at FYB	\$3,456.00
Remaining Life	1	Monthly Member Contribution	\$65.81
Replacement Year	2019	Monthly Interest Contribution	\$2.21
		Total Monthly Contribution	\$68.03

Component covers replacing 12 mattresses per year for 4 years and then repeating cycle starting every 5 years. Average current cost for mattress is \$360.

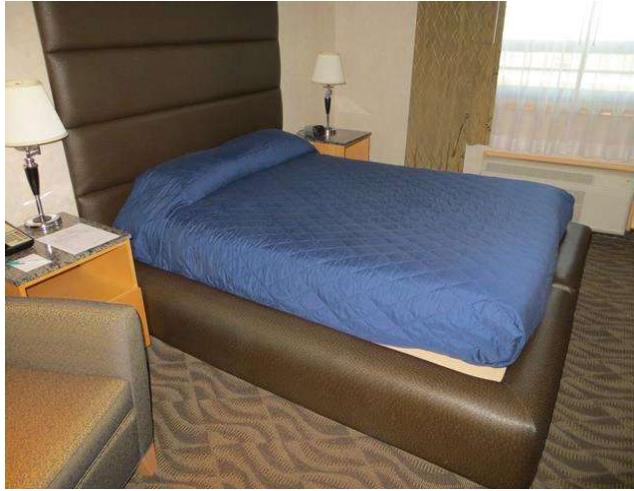
Category	060 Units	Quantity	12 mattresses
Photo Date	February 2017	Unit Cost	\$360.000
		% of Replacement	100.00%
		Current Cost	\$4,320.00
Placed In Service	01/15	Future Cost	\$4,494.53
Useful Life	5		
		Assigned Reserves at FYB	\$2,592.00
Remaining Life	2	Monthly Member Contribution	\$65.42
Replacement Year	2020	Monthly Interest Contribution	\$1.72
		Total Monthly Contribution	\$67.13

Component covers replacing 12 mattresses per year for 4 years and then repeating cycle starting every 5 years. Average current cost for mattress is \$360.

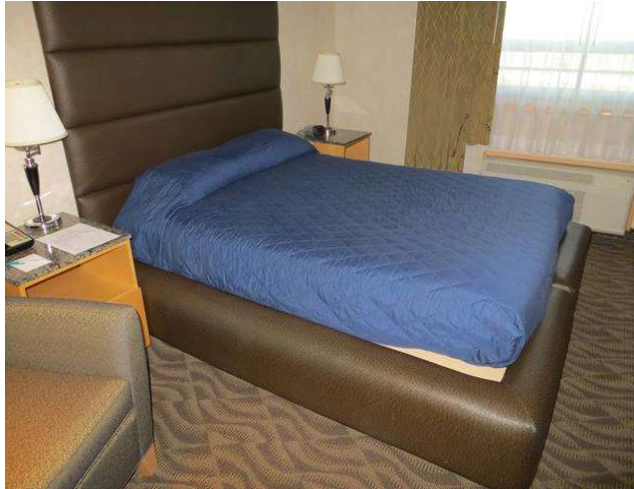
Category	060 Units	Quantity	12 mattresses
Photo Date	February 2017	Unit Cost	\$360.000
		% of Replacement	100.00%
		Current Cost	\$4,320.00
Placed In Service	01/16	Future Cost	\$4,584.42
Useful Life	5		
		Assigned Reserves at FYB	\$1,728.00
Remaining Life	3	Monthly Member Contribution	\$65.02
Replacement Year	2021	Monthly Interest Contribution	\$1.23
		Total Monthly Contribution	\$66.25

Component covers replacing 12 mattresses per year for 4 years and then repeating cycle starting every 5 years. Average current cost for mattress is \$360.

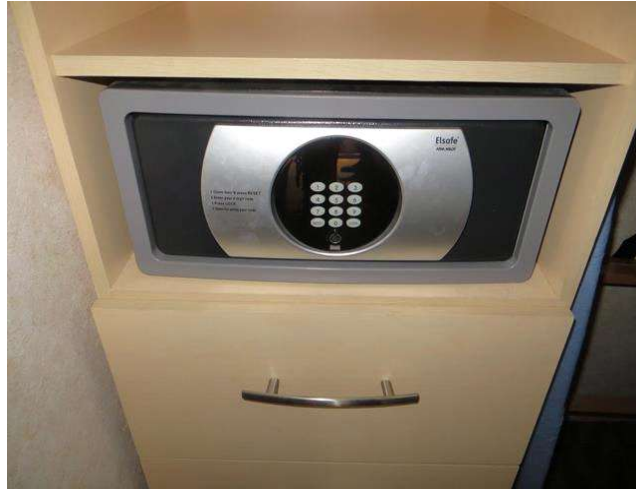
Category	060 Units	Quantity	15 safes
Photo Date	February 2017	Unit Cost	\$150.000
		% of Replacement	100.00%
		Current Cost	\$2,250.00
Placed In Service	01/03	Future Cost	\$3,028.20
Useful Life	15		
		Assigned Reserves at FYB	\$2,250.00
Remaining Life	0	Monthly Member Contribution	\$11.87
Replacement Year	2018	Monthly Interest Contribution	\$0.04
		Total Monthly Contribution	\$11.91

Component covers replacement of Elsafes in units on 4th floor. Replacement schedule and pricing per client.

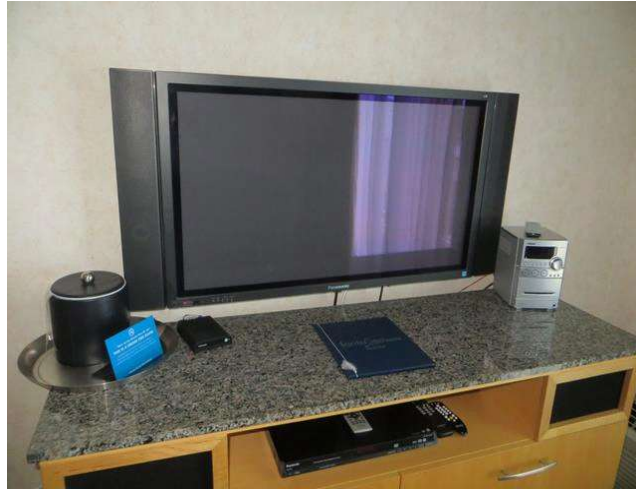
Category	060 Units	Quantity	51 total
Photo Date	February 2017	Unit Cost	\$300.000
		% of Replacement	100.00%
		Current Cost	\$15,300.00
Placed In Service	01/08	Future Cost	\$18,650.61
Useful Life	10		
		Assigned Reserves at FYB	\$15,300.00
Remaining Life	0	Monthly Member Contribution	\$117.40
Replacement Year	2018	Monthly Interest Contribution	\$0.43
		Total Monthly Contribution	\$117.83

Component covers 32" flat screen televisions to replace current models purchased in 2005. Schedule for replacement and cost per client.

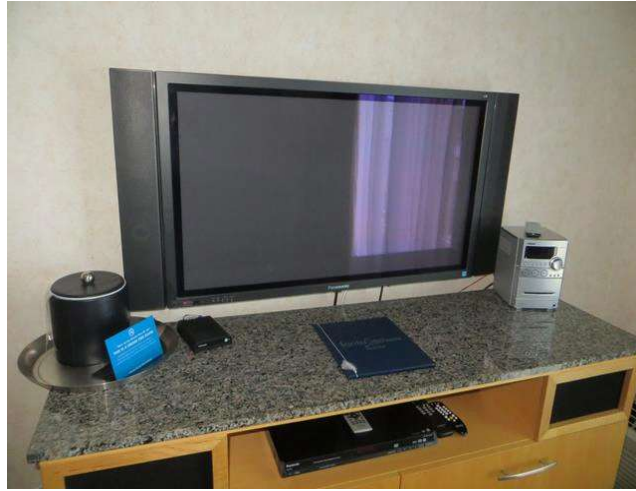
Category	060 Units	Quantity	16 total
Photo Date	February 2017	Unit Cost	\$500.00
		% of Replacement	100.00%
		Current Cost	\$8,000.00
Placed In Service	01/08	Future Cost	\$9,751.96
Useful Life	10		
		Assigned Reserves at FYB	\$8,000.00
Remaining Life	0	Monthly Member Contribution	\$61.39
Replacement Year	2018	Monthly Interest Contribution	\$0.22
		Total Monthly Contribution	\$61.61

Component covers 42" flat screen televisions to replace current models purchased in 2005. Schedule for replacement and cost per client.

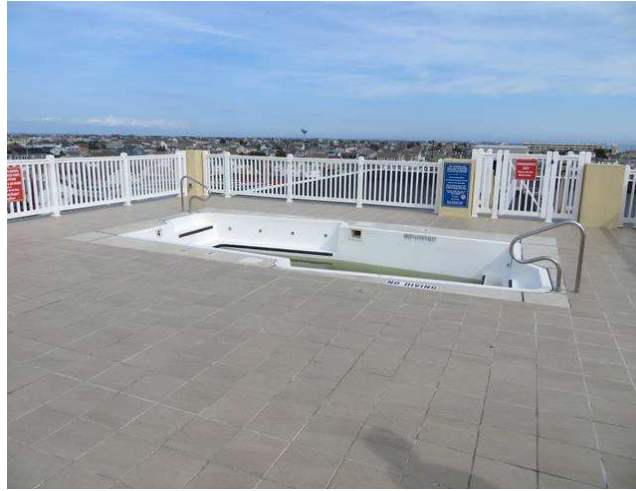
Pool deck area was renovated in 2016 for \$95,200 per client. Renovation was performed due to leaks in roof membrane under pool deck. Renovation included engineering study, new tile and roof membrane in pool area. Approximate 20% of roof covered by pool deck.

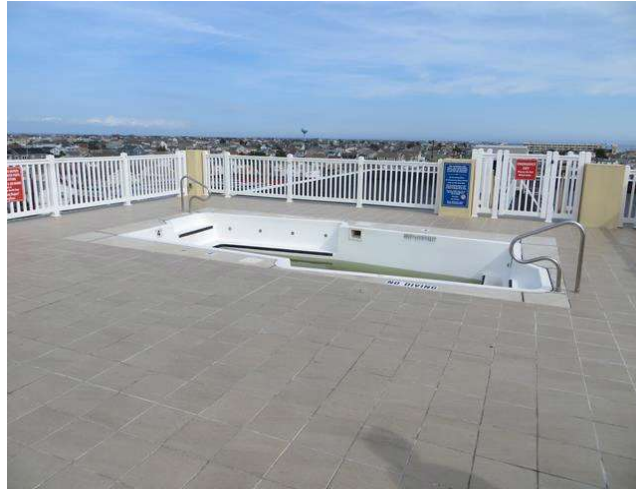
Pool access from north stair is protected by aluminum fence. Fence was in good condition during site visit. Component covers complete replacement of fencing. No quantity is listed in prior reserve study.

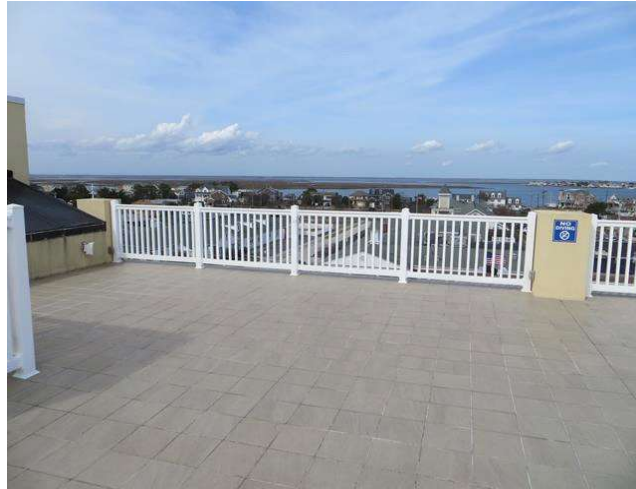
Pool access from south stair and pool area are protected by vinyl fence. Fence was in good condition during site visit. Component covers complete replacement of fencing. No quantity is listed in prior reserve study.

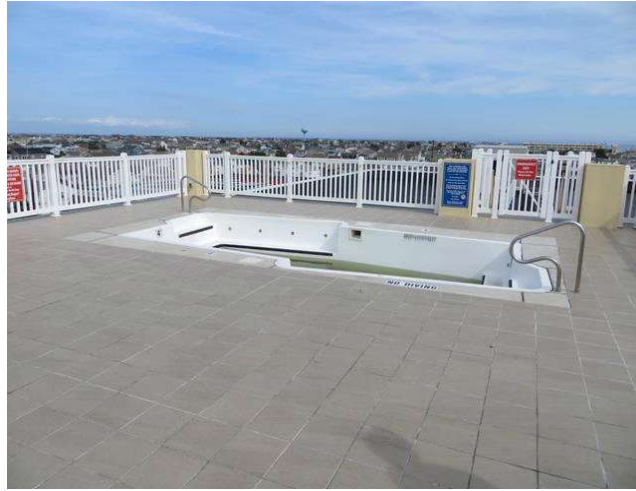
Component covers replacement of fiberglass tub-type pool. Useful life set at 30 years per client.

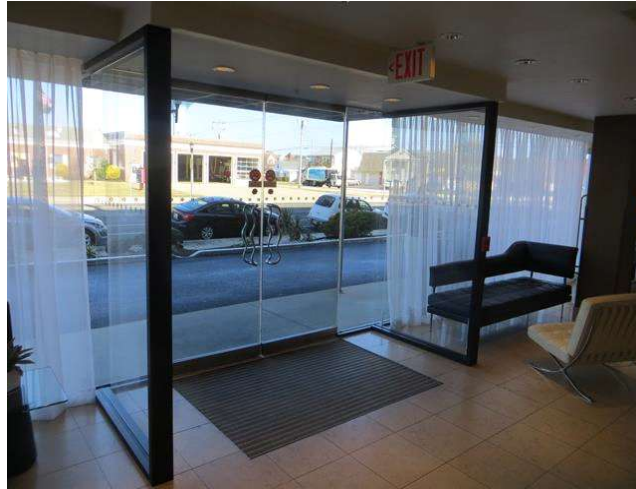
Category	080 Equipment	Quantity	1 total
Photo Date	February 2017	Unit Cost	\$18,000.00
		% of Replacement	100.00%
		Current Cost	\$18,000.00
Placed In Service	01/05	Future Cost	\$20,676.34
Useful Life	20		
		Assigned Reserves at FYB	\$11,700.00
Remaining Life	7	Monthly Member Contribution	\$78.56
Replacement Year	2025	Monthly Interest Contribution	\$6.96
		Total Monthly Contribution	\$85.52

Component covers replacement of door lock access system. No operational issues reported by client.

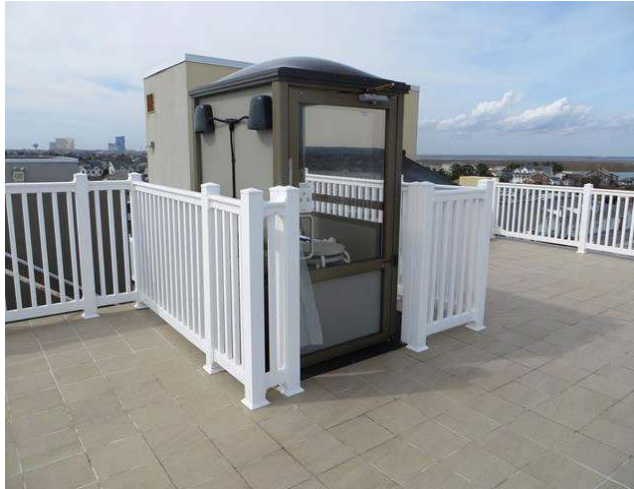
Category	080 Equipment	Quantity	1 lift
Photo Date	February 2017	Unit Cost	\$40,800.000
		% of Replacement	100.00%
		Current Cost	\$40,800.00
Placed In Service	01/16	Future Cost	\$47,803.70
Useful Life	10		
		Assigned Reserves at FYB	\$8,160.00
Remaining Life	8	Monthly Member Contribution	\$316.68
Replacement Year	2026	Monthly Interest Contribution	\$5.82
		Total Monthly Contribution	\$322.51

Component covers replacement of handicapped elevator system replaced in 2016 at a cost of \$39,000 per client.

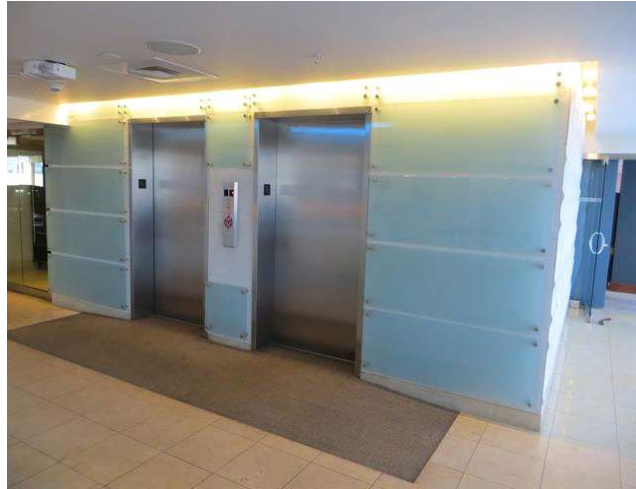
Component covers combined modernization of Otis hydraulic elevator systems for two elevators.

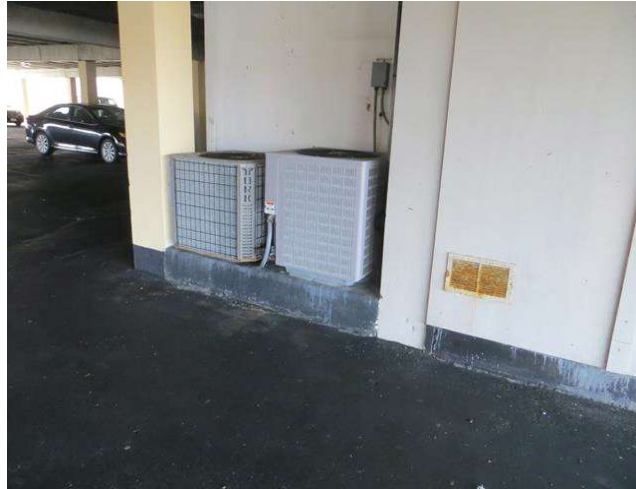
Category	080 Equipment	Quantity	2 split systems
Photo Date	February 2017	Unit Cost	\$11,400.000
		% of Replacement	100.00%
		Current Cost	\$22,800.00
Placed In Service	01/05	Future Cost	\$26,190.03
Useful Life	20		
		Assigned Reserves at FYB	\$14,820.00
Remaining Life	7	Monthly Member Contribution	\$99.51
Replacement Year	2025	Monthly Interest Contribution	\$8.83
		Total Monthly Contribution	\$108.33

No operational issues with system reported by client.

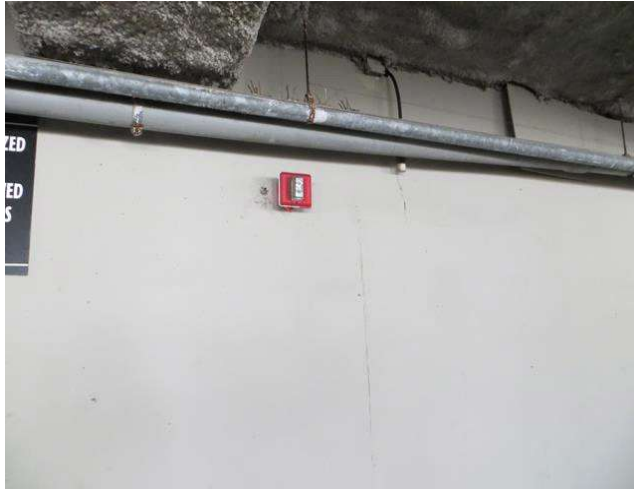
Component covers replacement of fire alarm devices only. Replacement of main fire alarm panel or other components are not included. Detectors, pull stations, alarm lights/sirens were replaced in 2014-2015 at a cost of \$23,000 per client.

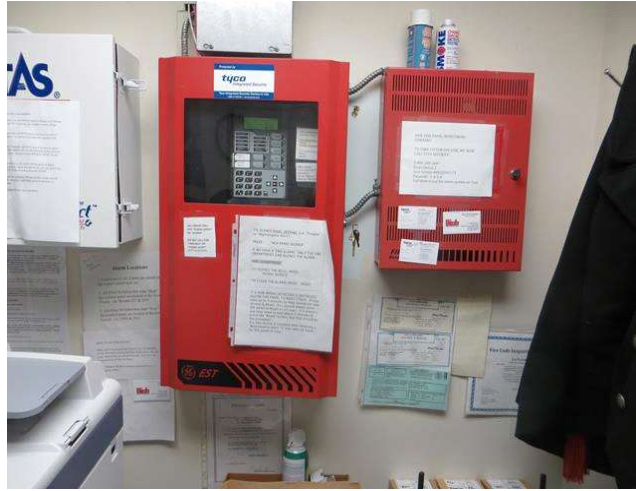
Component covers replacement of fire alarm main control panel only. Replacement of fire detectors, pull stations, or other components are listed as a separate component.

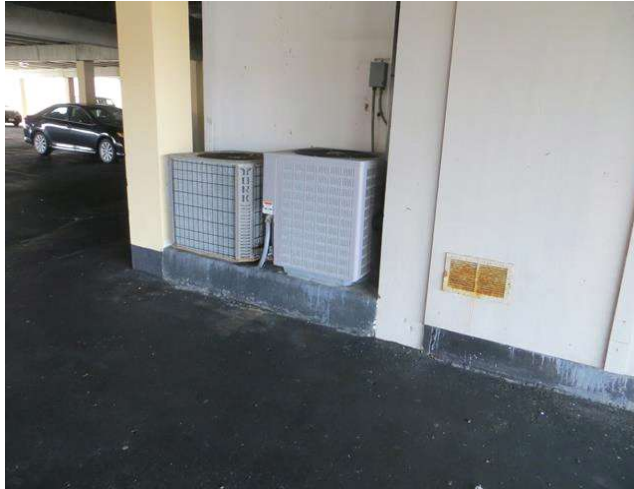
Category	080 Equipment	Quantity	1 split system
Photo Date	February 2017	Unit Cost	\$10,000.00
		% of Replacement	100.00%
		Current Cost	\$10,000.00
Placed In Service	01/04	Future Cost	\$11,261.62
Useful Life	20		
		Assigned Reserves at FYB	\$7,000.00
Remaining Life	6	Monthly Member Contribution	\$43.87
Replacement Year	2024	Monthly Interest Contribution	\$4.16
		Total Monthly Contribution	\$48.02

No operational issues with system reported by client.

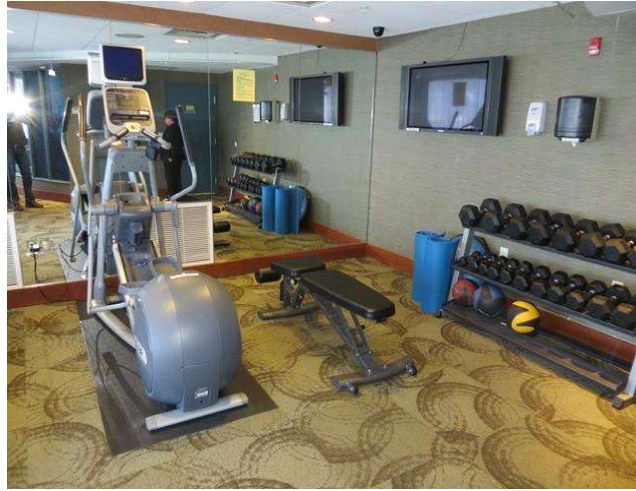
Category	080 Equipment	Quantity	1 total
Photo Date	February 2017	Unit Cost	\$26,400.00
		% of Replacement	100.00%
		Current Cost	\$26,400.00
Placed In Service	01/08	Future Cost	\$29,147.73
Useful Life	15		
		Assigned Reserves at FYB	\$17,600.00
Remaining Life	5	Monthly Member Contribution	\$147.09
Replacement Year	2023	Monthly Interest Contribution	\$10.58
		Total Monthly Contribution	\$157.67

Component covers replacement of exercise equipment in fitness center. No operational issues reported by client.

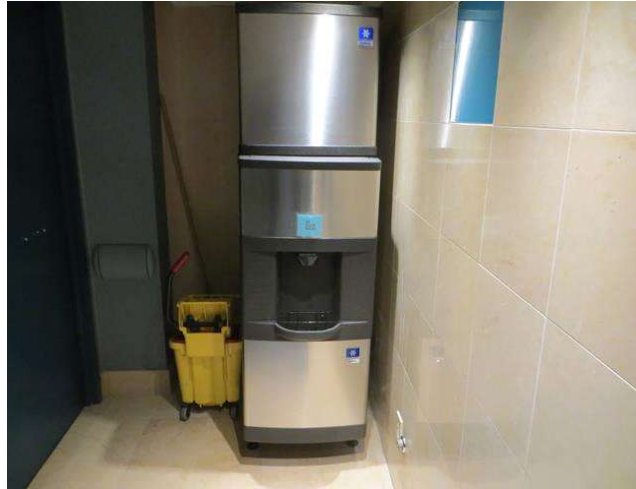
One ice machine cuber was replaced by client in 2016 for \$2900. The other three cubers will be replaced in 2019 per client.
