RESERVE ANALYSIS REPORT

Sample Timeshare Association

Sample, New Jersey

January 15, 2018

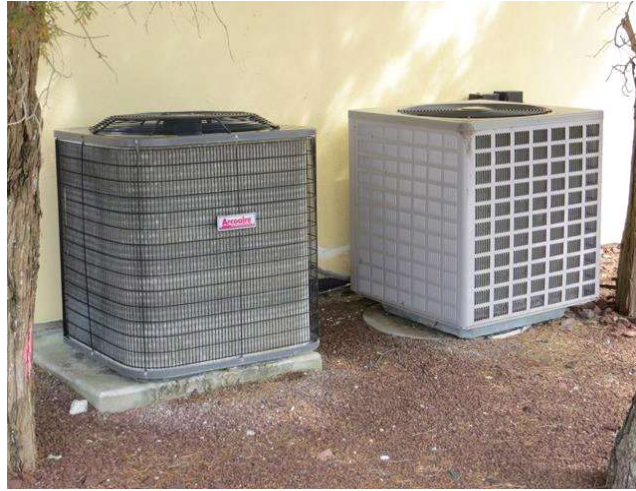
Category	080 Equipment	Quantity	1 split system
Photo Date	February 2017	Unit Cost	\$5,700.00
		% of Replacement	100.00%
		Current Cost	\$5,700.00
Placed In Service	01/11	Future Cost	\$7,373.56
Useful Life	20		
		Assigned Reserves at FYB	\$0.00
Remaining Life	13	Monthly Member Contribution	\$34.28
Replacement Year	2031	Monthly Interest Contribution	\$0.13
		Total Monthly Contribution	\$34.41

No operational issues with system reported by client.

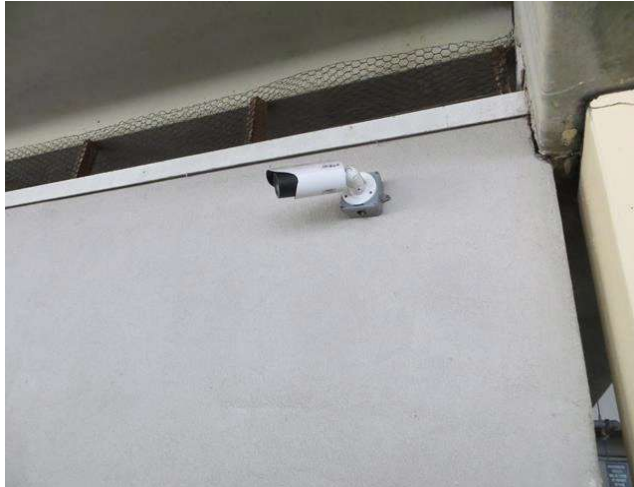
Category	080 Equipment	Quantity	1 system
Photo Date	February 2017	Unit Cost	\$17,000.000
		% of Replacement	100.00%
		Current Cost	\$17,000.00
Placed In Service	01/13	Future Cost	\$22,879.76
Useful Life	20		
		Assigned Reserves at FYB	\$0.00
Remaining Life	15	Monthly Member Contribution	\$89.71
Replacement Year	2033	Monthly Interest Contribution	\$0.33
		Total Monthly Contribution	\$90.05

Component covers replacement of security system replaced in 2013. No operational issues reported by client.

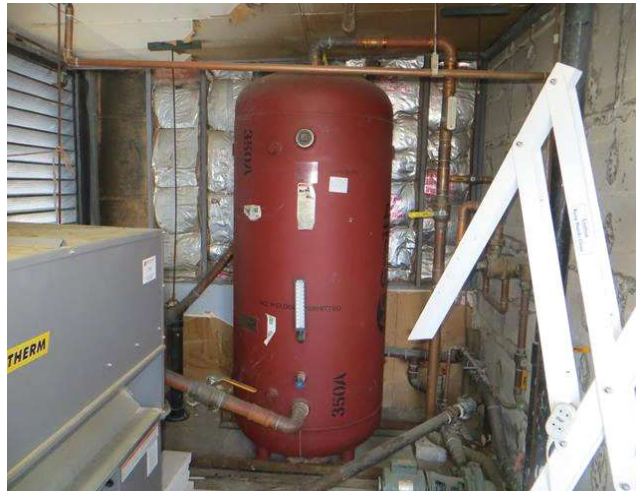
Water heater consists of boiler and storage tank. Both are located in mechanical room on south end of roof. Per client, original water heater life was 26 years. Cost to replace water heater was \$50,000 in 2013.
